SUBJECT: NRC INSPECTION REPORT 050-00312/08-001

Docket No.: 050-00312
License No.: DPR-54
Report No.: 050-00312/08-001
Licensee: Sacramento Municipal Utility District
Facility: Rancho Seco Nuclear Generating Station
Location: 14440 Twin Cities Road
Herald, California
Dates: April 14 through May 16, 2008
Inspectors: Emilio M. Garcia, Health Physicist
James L. Montgomery, Health Physicist
Accompanied by: Thomas H. Youngblood, Jr., Health Physicist Reactor
Decommissioning Branch, Office of Federal and State
Materials and Environmental Management Programs
Approved By: Jack E. Whitten, Chief
Nuclear Materials Safety Branch B
Attachments: Supplemental Information
Partial List of Documents Reviewed

Rancho Seco Nuclear Generating Station NRC Inspection Report 050-00312/08-001

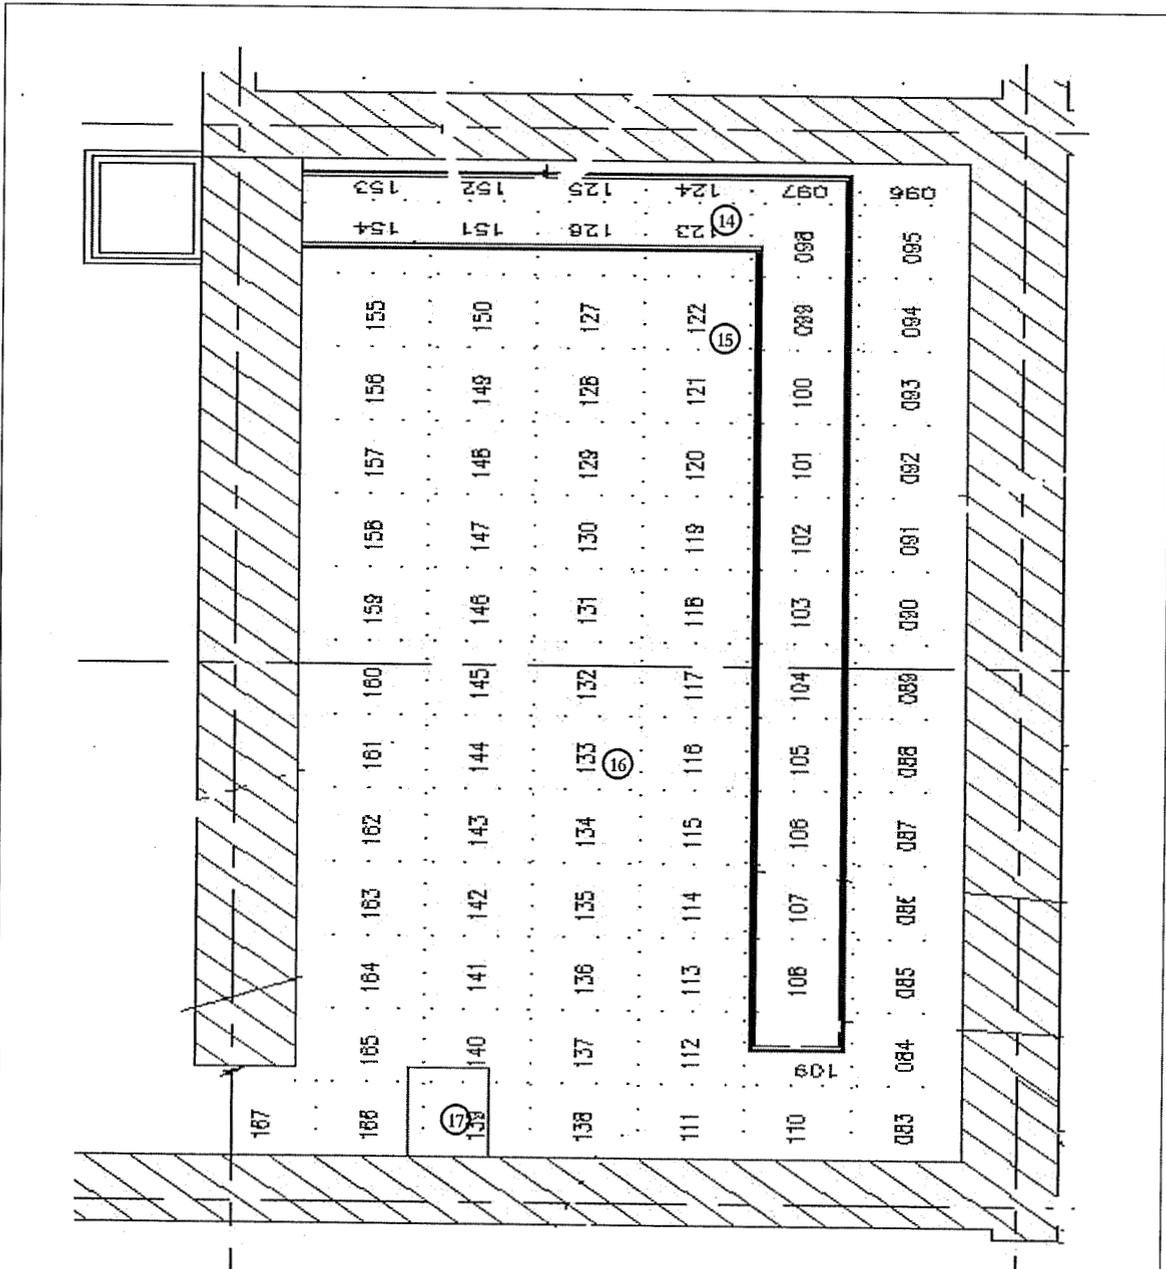
Figure 6: Survey Unit F8130201, Room 18 – Direct Measurement and Sample Locations

Beta and gamma surface scans identified several areas of elevated beta surface activity on the structural surfaces of the evaluated SUs with the Auxiliary Building. With one exception, additional investigation of these locations indicated that the majority of the elevated surface activity levels were attributable to localized areas of residual beta-gamma radiation within the matrix of the concrete media. In general, the elevated surface activity was limited to small areas that were interspersed throughout the rooms. The one exception was a discrete particle of Cs-137 and Co-60 that was found in Room 18. Direct measurements were performed at 26 locations. As mentioned above,

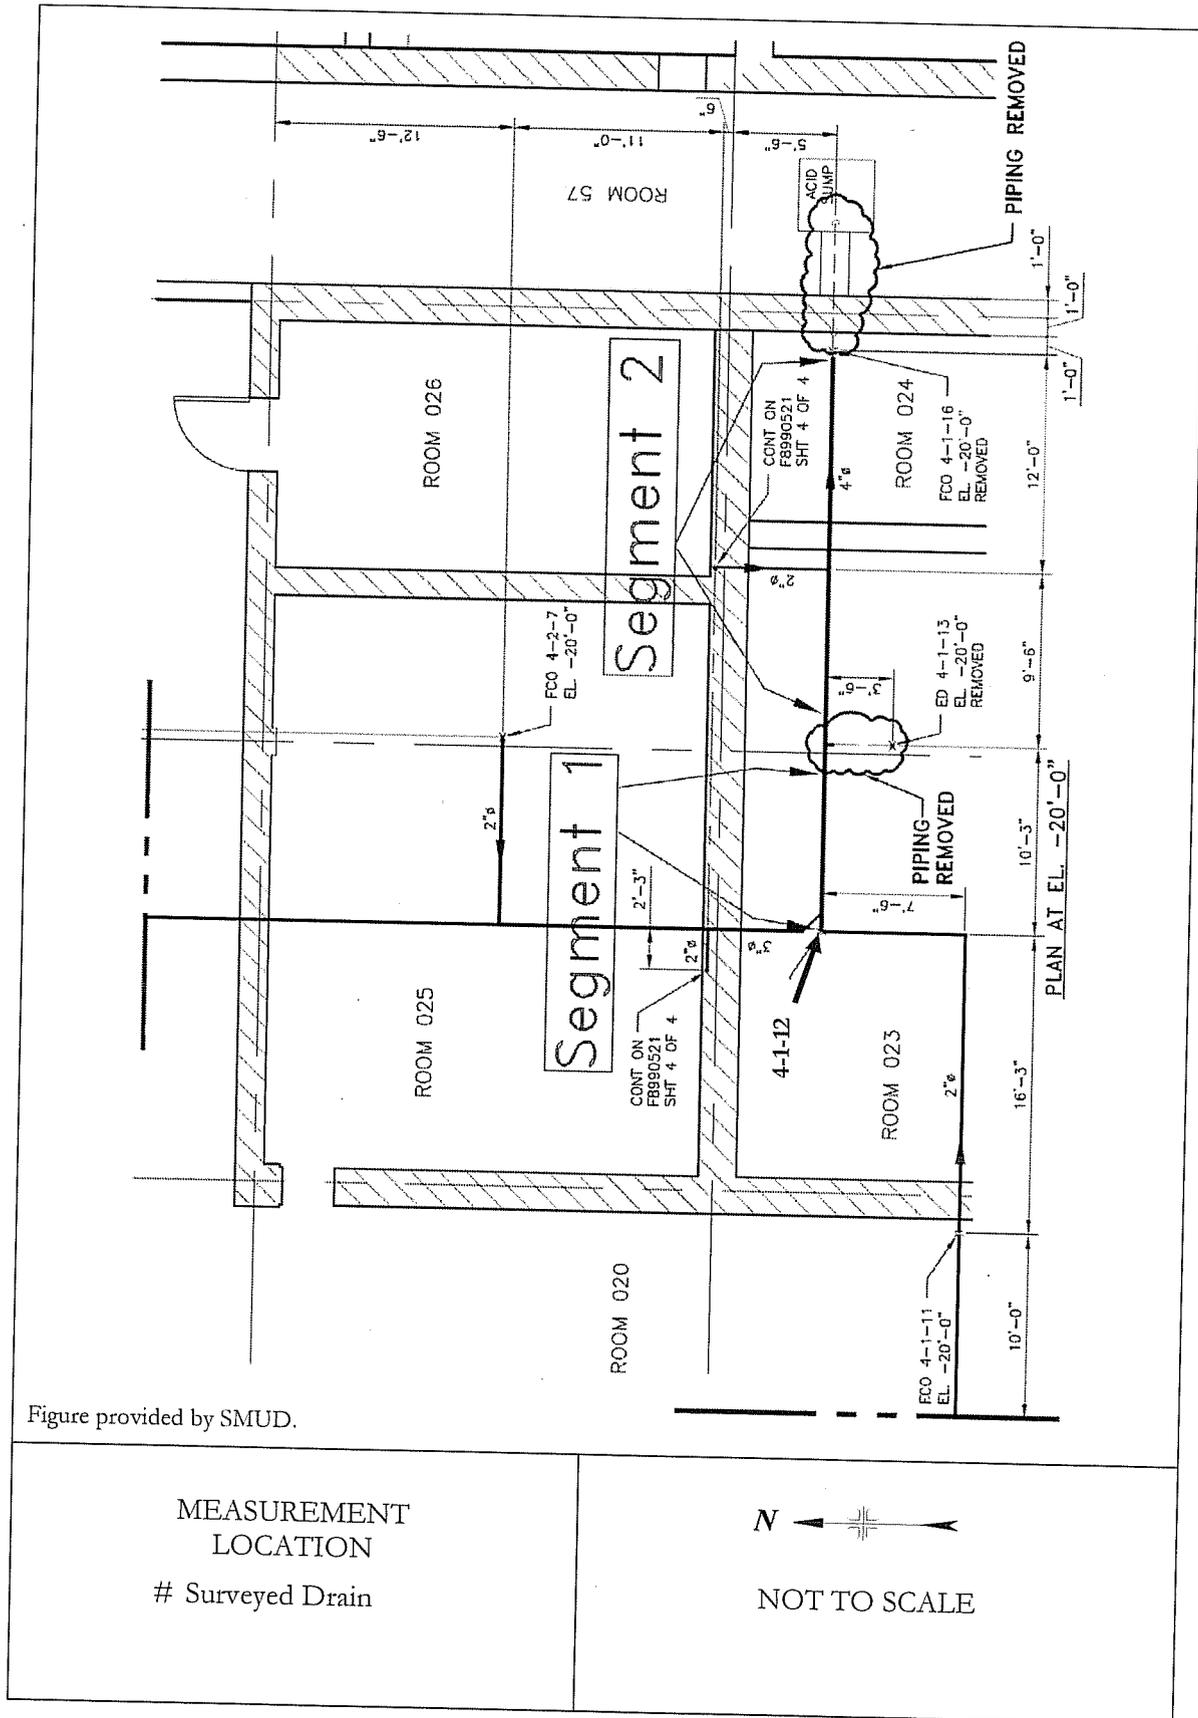
Figure 9: Survey Unit F8990521, Acid Waste Drains – Surveyed Drain 4-1-12, Segment 1

^fSMUD originally numbered incorrectly Acid Waste Drain Line 4-1-12, Segment 1 as 4-1-13. Due to discrepancies in the survey data, ORISE recommends further evaluation of this drain line and the instrumentation used to collect the preliminary FSS data.

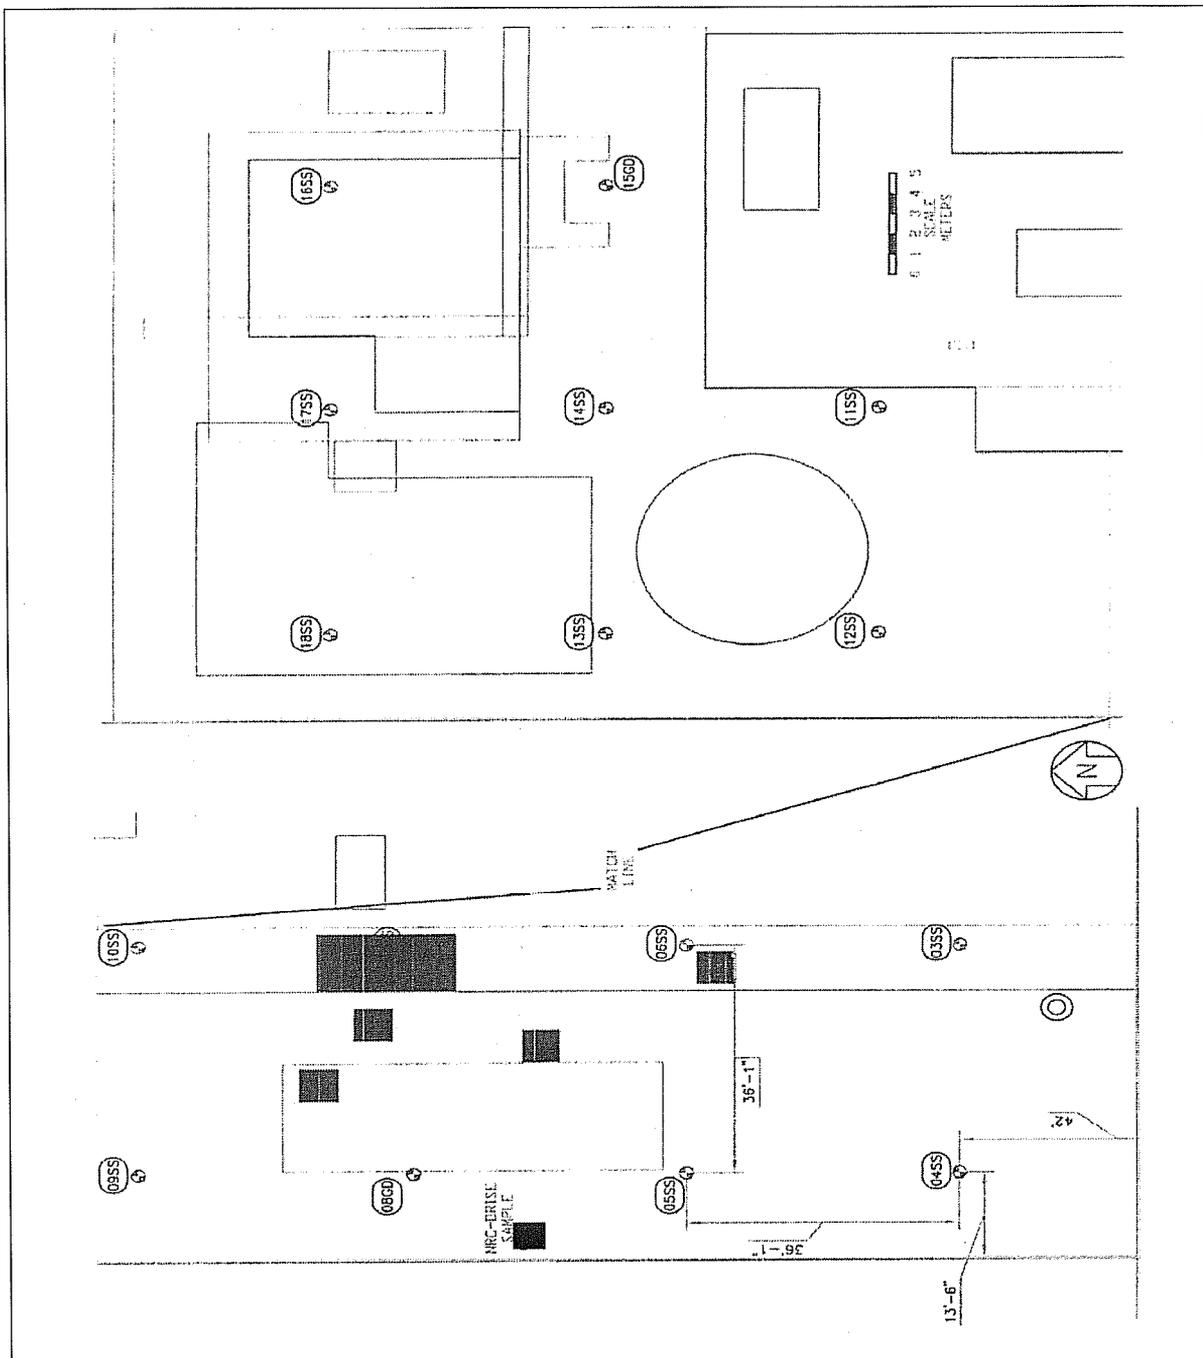
Figure 11: Outfall Area – Soil Sample Locations

these results the licensee decided that this area required additional remediation. After analysis of the soil samples by ORISE, the soil samples were returned to the licensee.
