NUCLEAR OPERATING CORPORATION

Subject: Docket No. 50-482: Licensee Event Report 2008-004-00, Loss of Power Event When the Reactor was De-fueled

4. TITLE
Loss of Offsite Power Event When the Reactor was De-fueled

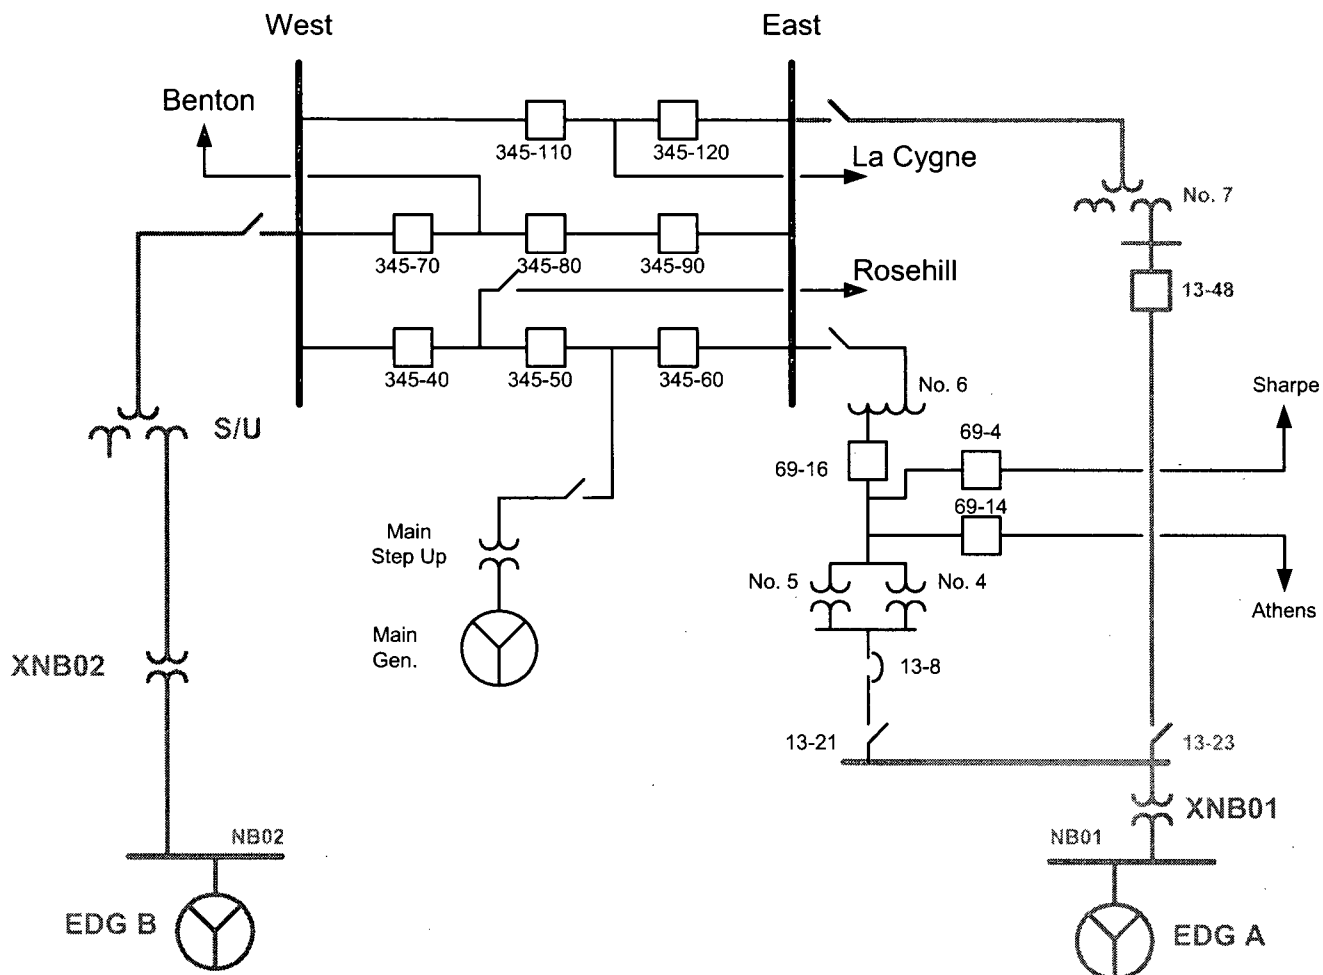
ONE LINE DIAGRAM

(Refer to Diagram on page 5 of 5)

one of WCGS owner companies, closed the wrong set of trip links on a 345 kV breaker during the Rose Hill transmission line transfer/breaker failure trip preventative maintenance (PM) testing. Instead of closing the Rose Hill transmission line trip links, the technician closed the Plant Startup (PSU) primary and backup trip links, which are associated to the WCGS startup transformer protection. When the links were closed, the breaker failure circuitry associated to the startup transformer was enabled. With the incorrect links in service and when the manual trip signal was generated as a part of the PM activity, the remaining off-site power connections to the West 345 kV bus were de-energized by the opening of their associated breakers. This inadvertent action tripped the West 345 kV bus and caused the LOOP.

The cause of the LOOP was initiated by a human performance error. A Westar Senior Relay Technician inadvertently closed the wrong set of failure trip links (Plant Startup (PSU) breaker failure links) on a Switchyard breaker during the Rose Hill transmission line transfer/breaker failure trip testing PM activities.
