THREE MILE ISLAND NUCLEAR STATION, UNIT 1 (TMI-1)  
OPERATING LICENSE NO. DPR-50  
DOCKET NO. 50-289

SUBJECT: LICENSEE EVENT REPORT (LER) NO. 2008-001-00  
" Decay Heat River Water System Pump (DR-P-1B) Failed to Start "

**4. TITLE:** Decay Heat River Water System Pump (DR-P-1B) Failed to Start

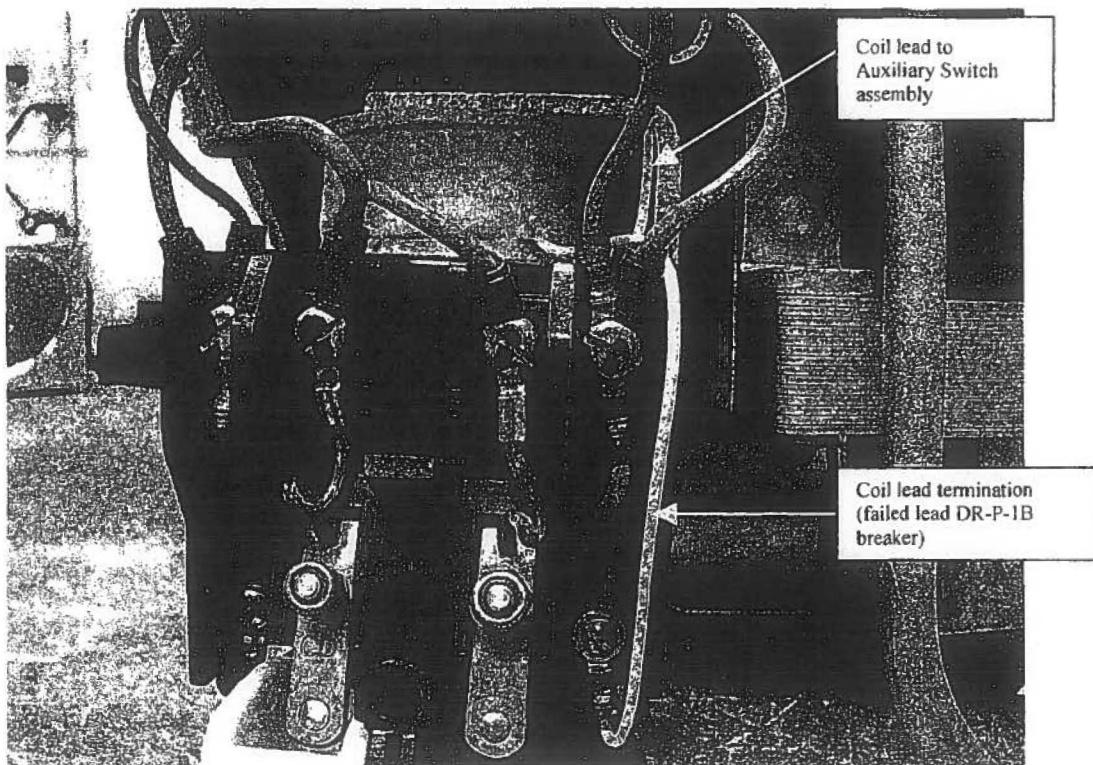
The X relay coil is mounted on the top section of the relay within a bracket assembly. The coil is not a snug fit in the bracket assembly and is free to float vertically within the bracket approximately 1/16". One

coil lead exits the coil next to the coil spool and connected to the breaker auxiliary switch assembly. The second coil exits the coil between the outer layer of tape wraps and is terminated to a terminal on the X relay assembly. This lead is formed with marginal slack when it is terminated on the relay connection terminal.

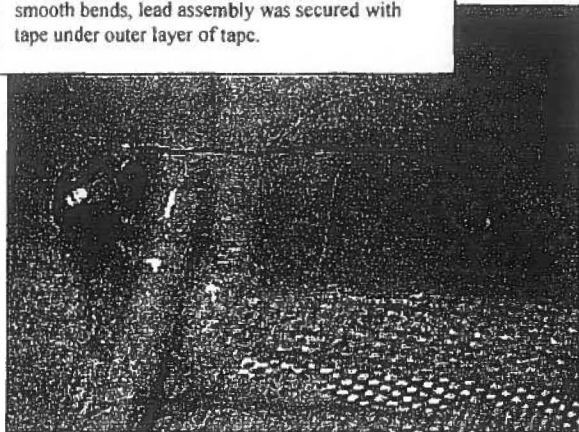
Comparison coil, magnet wire well formed with smooth bends, lead assembly was secured with tape under outer layer of tape.

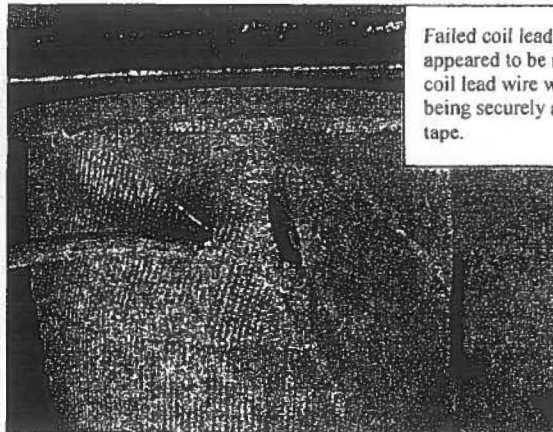
Failed coil lead, magnet wire appeared to be not as well formed, coil lead wire was observed as not being securely anchored by the tape.

The apparent cause of the X relay open circuit was a coil manufacturing defect. The coil strand wire failure occurred approximately 1/4 " away from the solder connection to the coil lead wire. The coil wire appeared to have twists instead of being formed smooth with no twist like the comparison relay coil. Since the wire burnt open at a flaw it can not be determined if a defect was introduced when either the varnish was removed by sanding or when the wire was formed and prepared for making the solder connection. The coil lead connection assembly was secured using clear tape and epoxy during the manufacturing process. The Westinghouse CDI for X relays does not specifically address verification of the coil leads being secure to prevent stress on the magnet wire. From inspection of other X relays the coil lead anchoring for the affected manufacturing lot does not appear to be as robust as other relays. However the coil lead anchoring for the comparison relay from the same manufacturing lot was determined to be adequate based on Exelon Power Labs testing. This indicates that the failed coil lead was likely not adequately anchored during manufacture, since the Lab test showed that considerable force can be applied to a properly secured coil lead without the lead becoming loose and subjecting the magnet wire to stress. Since the failed relay outer tape was cut to inspect the lead connection in the field, a detailed evaluation could not be completed.

If the solder joint was not securely anchored at this point where the end of the magnet wire is secured by the clear tape, a stress point is introduced that could stress the wire during every breaker operation. Since the coil assembly can move within the mounting bracket, the impact of the breaker opening or closing could result in movement of the solder joint, resulting in stress to the magnet wire at the point where it is secured by the clear tape. After several breaker operations the stress could weaken to the point of causing a high resistance connection and eventually open circuiting.

This relay failure is considered an isolated occurrence. There have been no similar failure occurrences at TMI-1 and there is no OPEX for a similar X relay coil failure. Inspections to verify that no additional coil manufacturing defects exist will be performed. All of the X relays from the same manufacturing lot as the failed relay will be inspected, and a representative X relay from each other manufacturing lot will be inspected.

The site procedure for inspection and testing of this type electrical breaker has been revised to include X relay inspection criteria for coil resistance measurement.

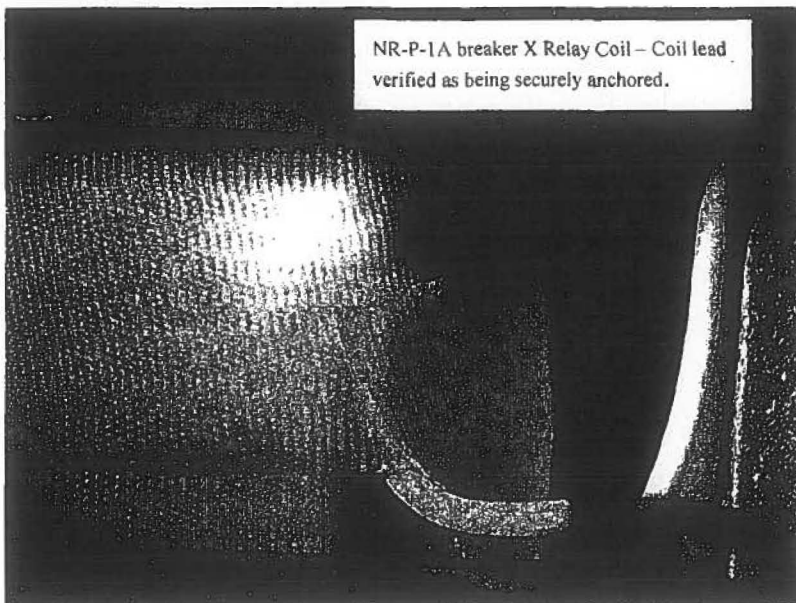
As an additional data point, the X relay coil leads for Nuclear Services River Water Pump "A" (NR-P-1A) were inspected during the breaker PM which was completed during March 2008. The leads were observed as being sufficiently anchored by the coil outer layer of tape to prevent stress on the lead to magnet wire connection. It is evident that the coils were not stressed either during the commercial grade dedication process or any wiring verification checks completed at TMI. The breaker counter showed 156 breaker operations since the X relay was replaced during refurbishment.
