Union of Concerned Scientists

June 20, 2008

Subject: NRC Special Inspection Report for RHRSW Valve Damage at Browns Ferry

Credit for Doing Less Now Than Was Unacceptable Before

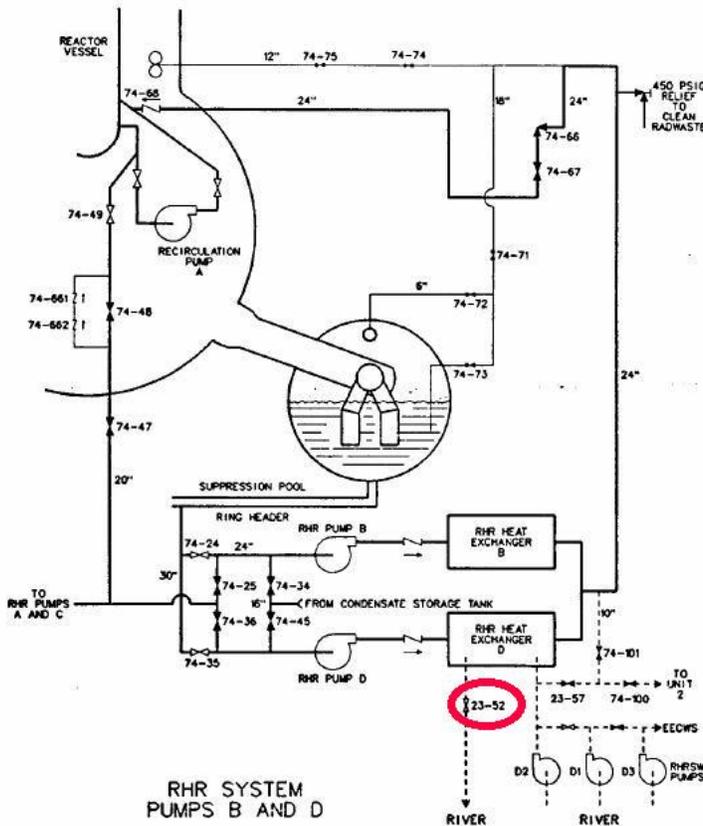
Schematic diagram of one loop of the Residual Heat Removal system

The valves in question are on the residual heat removal service water (RHRSW) outlet from the RHR heat exchangers. One such valve is circled in the graphic. Water from the RHR pumps flows through the RHR heat exchangers inside thousands of metal tubes. River water pumped by the RHRSW pumps enters the shells of the RHR heat exchangers and passes along the outside of the metal tubes. Heat flows through the tube walls to cool the RHR water and warm the RHRSW water. The subject valves open fully or partially to control the river water flow rate through the heat exchangers and close if one or more tubes break to prevent radioactively contaminated RHR water from reaching the river.
