LOCA testing of high burnup PWR fuel  
in the HBWR. Additional PIE on the  
cladding of the segment 650-5.

<b>Address</b> <b>Telephone</b> <b>Telefax</b>	<b>KJELLER</b> <b>NO-2027 Kjeller, Norway</b> <b>+47 63 80 60 00</b> <b>+47 63 81 xx xx</b>	<b>HALDEN</b> <b>NO-1751 Halden, Norway</b> <b>+47 69 21 22 00</b> <b>+47 69 21 22 01</b>	open
<b>Report number</b>		<b>Date</b>	
<b>IFE/KR/E-2008/004</b>		2008-04-11	
<b>Report title and subtitle</b>		<b>Number of pages</b>	
LOCA testing of high burnup PWR fuel in the HBWR. Additional PIE on the cladding of the segment 650-5.		35	
<b>Project/Contract no. and name</b>		<b>ISSN</b>	
Contract ML080150003		0333-2039	
<b>Client/Sponsor Organisation and reference</b>		<b>ISBN</b>	
NRC/RES		978-82-7017-704-2 (printed) 978-82-7017-705-9 (electronic)	
<b>Abstract</b>			
<p>IFA-650.5, a test with pre-irradiated fuel in the Halden Project LOCA test series, was conducted on October 23rd, 2006. The fuel rod had been used in a commercial PWR and had a high burnup, 83 MWd/kgU. Experimental arrangements of the fifth test were similar to the preceding LOCA tests. The peak cladding temperature (PCT) level was higher than in the third and fourth tests, 1050

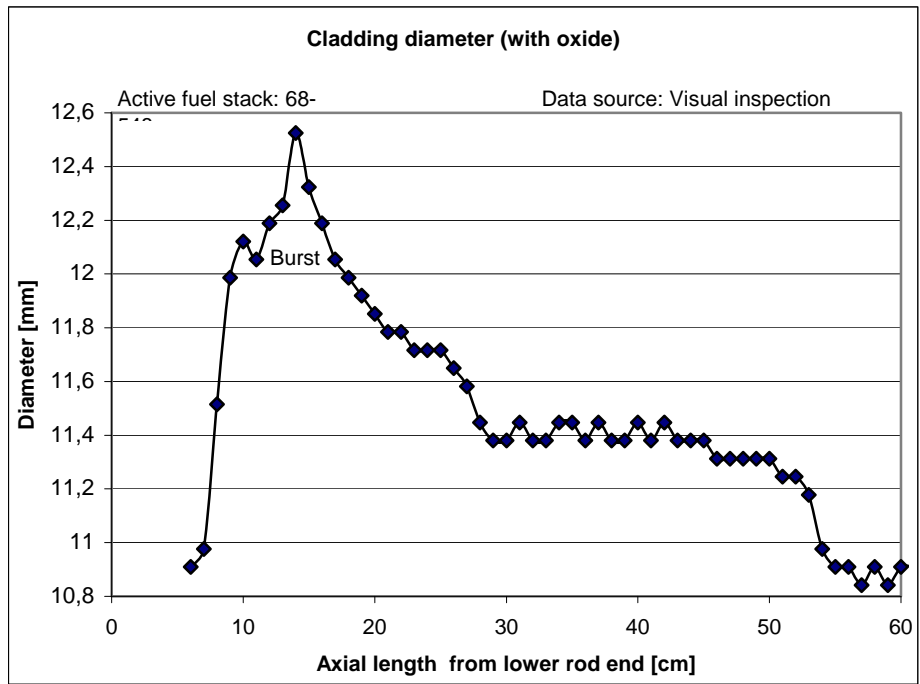
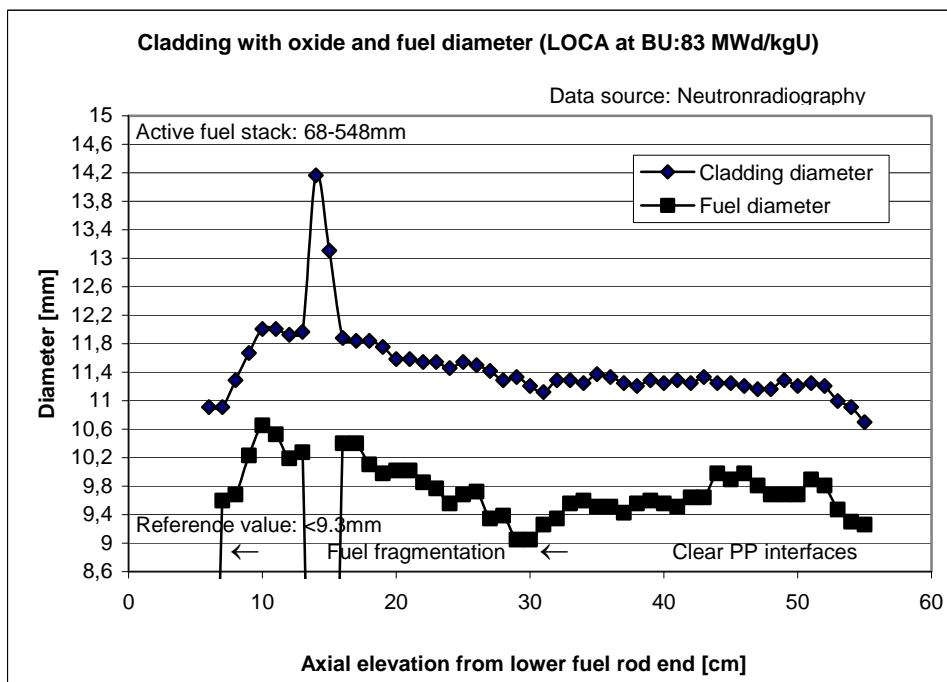
Diameter measurements, based on the visual inspection and neutronradiography were made to estimate the LOCA induced fuel diameter increase and the cladding distension. The results from the NDT observations and measurements were summarized in Fig. 4. Non-destructive PIE showed asymmetric cladding diameter increase with respect to the total axial length of the rod. In the lower end of the rod the cladding diameter increased steeply and rapidly to its maximum and burst. Burst of the cladding occurred without dramatic cladding distension / plastic deformation of the rod. In the balloon and burst zone the LOCA induced rod diameter increased from 10.8mm to 11.5mm in the upper and to 12.5mm in the lower part of the rod. Compared to the cladding in 650-4 the cladding of 650-5 showed a rather stiff and brittle behaviour. However, the low ductility was as expected due to the high burnup and high hydrogen content of the 650-5 cladding.

The axial fuel diameter variations assessed from neutronradiographs showed in the area with fuel fragmentation a diameter increase from 9.8 to 10.5mm below the clad burst, from there, the fuel diameter slope decreases slowly in the zone with fuel fragmentation to about 9.2mm in the middle

of the active fuel stack. From there and to the end of the active fuel stack the pellet-pellet interfaces were seen clearly in the neutronradiographs and the fuel diameter varied between 9.5 and 10.0mm.

Fig.4. Diameter and cladding distension data are based on NDT-PIE. The LOCA induced cladding defect/burst is in the lower part of the rod and well below the lower cladding TC.

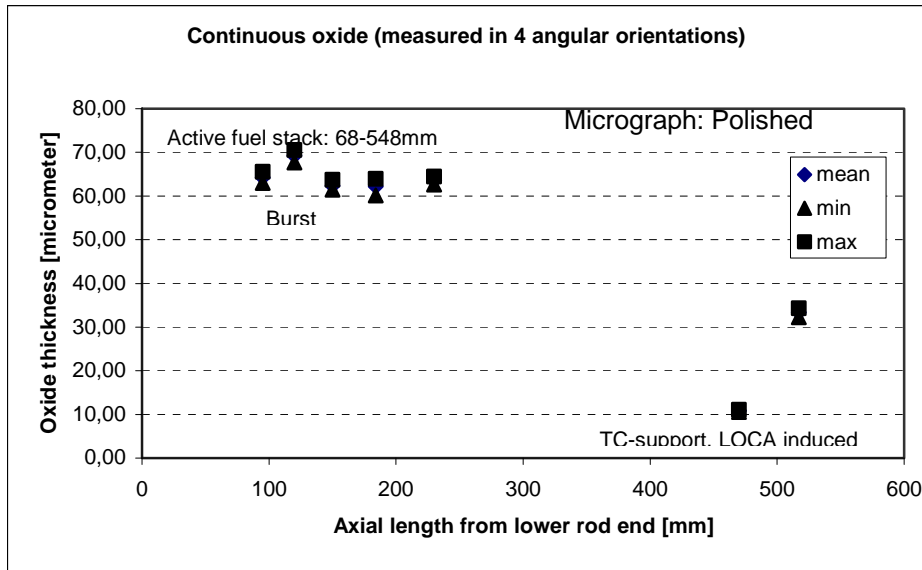
Fig. 5b Measured data for the continuous oxide and the LOCA induced oxide growth (11  $\mu\text{m}$ )

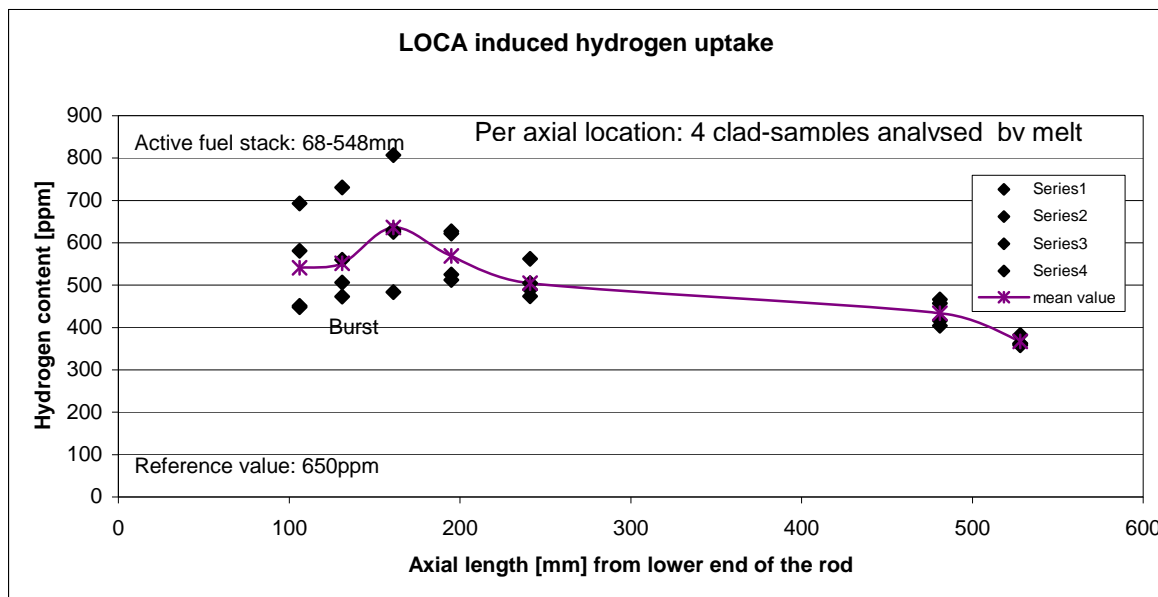
Fig. 7 shows typically arbitrary oriented hydrides in the Widmanstätten structure of the cladding. The graph in Fig. 7 represents the hydrogen content measured along the axial length of the rod. LOCA induced hydrogen uptake phenomena can be derived from the axial hydrogen content profile. From the hydrogen data the following can be stated:

Remarkable is a higher hydrogen content analysed in the samples from the balloon zone in the lower part of the rod, than elsewhere. Actually, the axial profile for hydrogen has the same shape and characteristics as the LOCA induced axial profile for the cladding diameter.

Fig. 7 Typical arbitrary oriented hydrides in the Widmanstätten structure of the cladding as seen in a cross-section from the balloon zone. The LOCA induced hydrogen uptake is illustrated in the hydrogen content profile measured along the axial length of the rod.

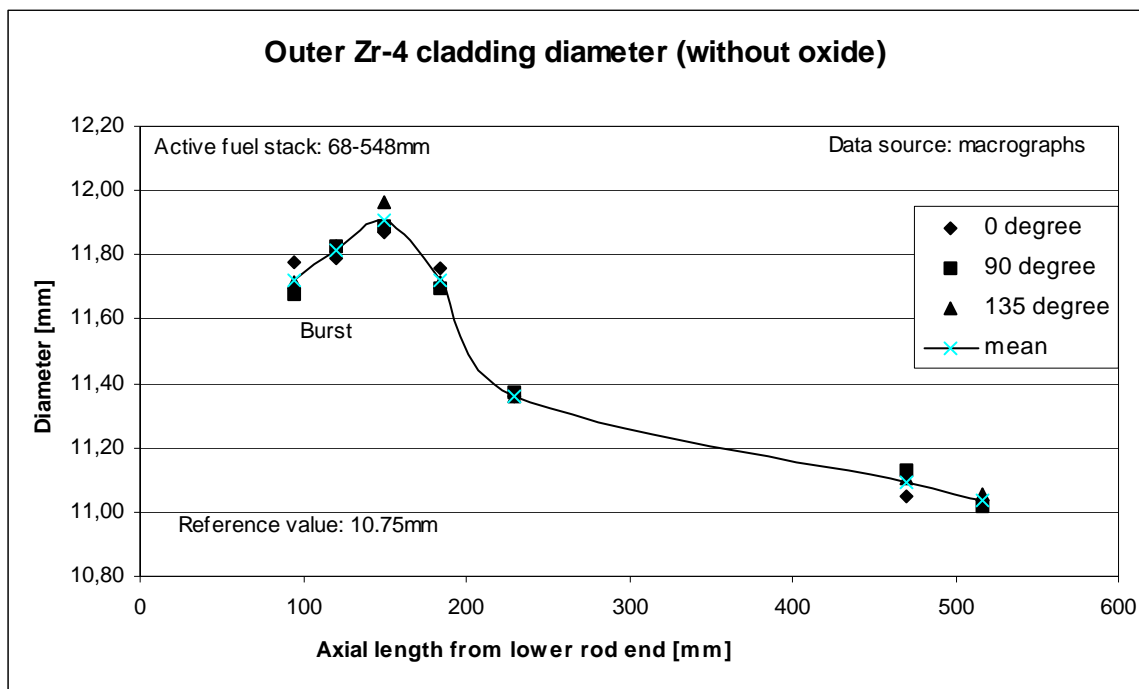
Cladding distension (hoop strain), wall thickness reduction and crack opening: Data for the mechanical properties of the cladding e.g. cladding distension (hoop strain), wall thickness reduction and crack opening were measured and are listed in Table 3 and plotted as axial profiles in Fig.9.

The cladding diameter measurements on IFA-650.5 show a relatively small strain in the rupture region, but they also show a relatively large strain along almost the whole length of the test specimen.

Fig 9. Axial profiles for diameter increase, cladding circumference (Hoop strain profile), cladding thickness / wall reduction.

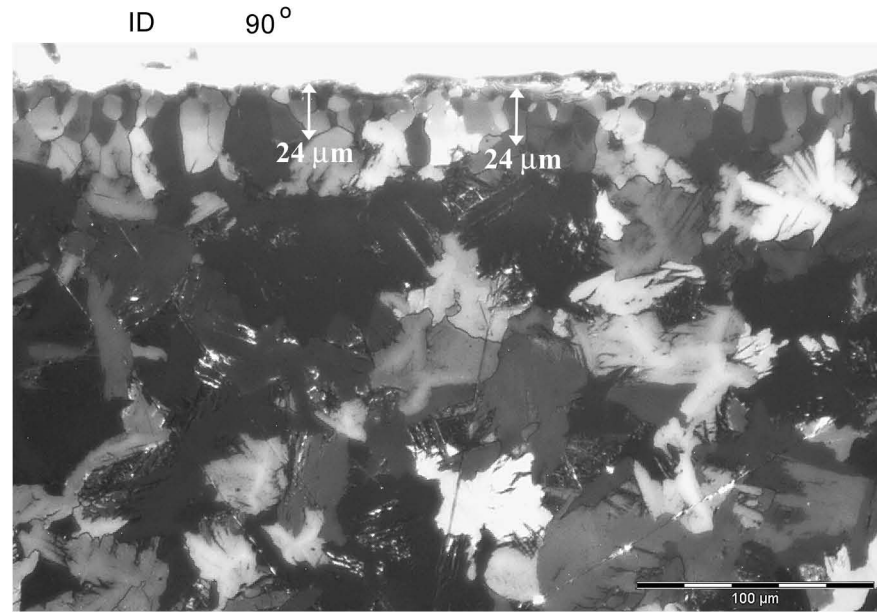
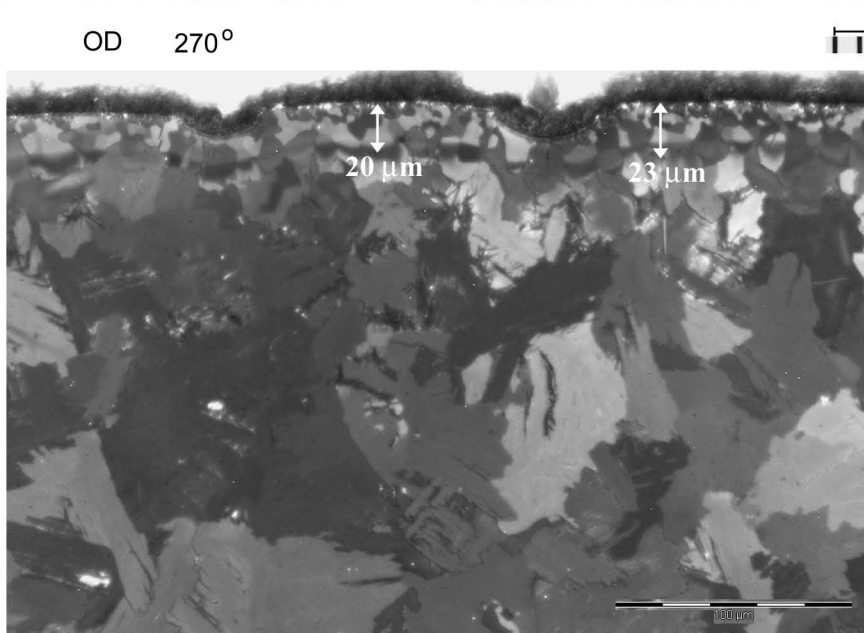
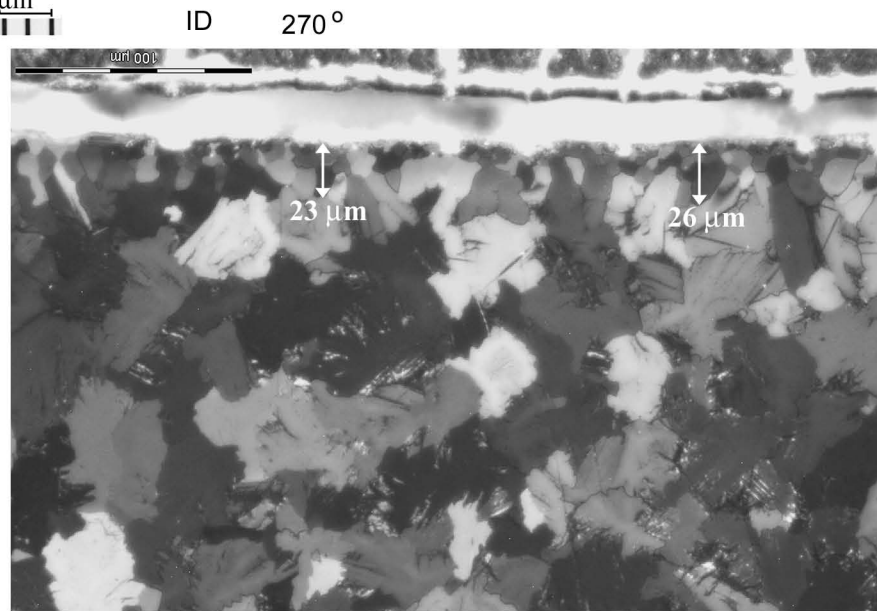
Fig. 3.5.22. Details showing the grain morphology of cladding and alpha layer on outer (OD) and inner (ID) surface. IFA-650-5 at axial position 230 mm (MC5) from lower end of fuel rod.

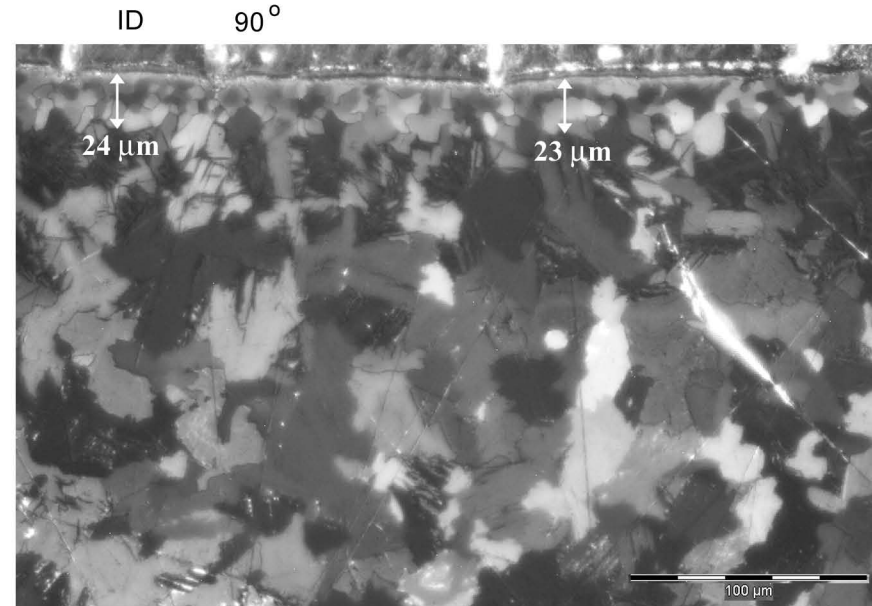
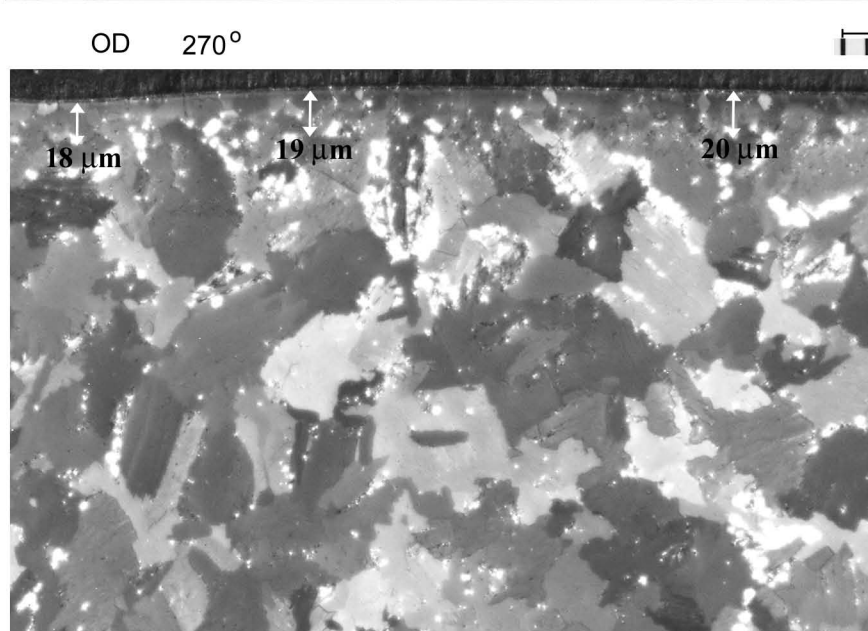
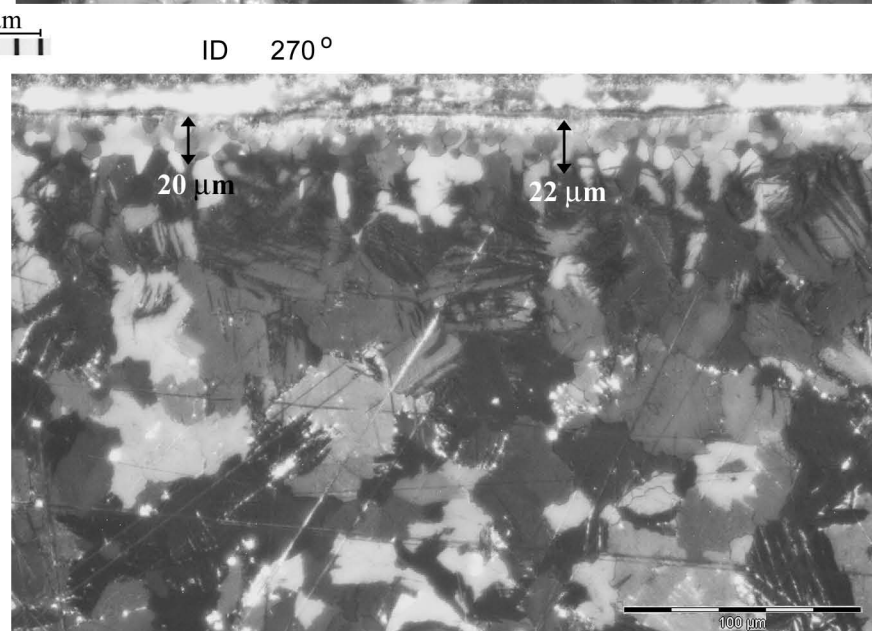
Fig. 3.5.23. Details showing the grain morphology of cladding and alpha layer on outer (OD) and inner (ID) surface. IFA-650-5 at axial position 470 mm (MC6) from lower end of fuel rod.
