THREE MILE ISLAND NUCLEAR STATION, UNIT 1 (TMI-1)
OPERATING LICENSE NO. DPR-50
DOCKET NO. 50-289

SUBJECT: 10 CFR 21 NOTIFICATION – IDENTIFICATION OF DEFECT
Issue Report 741412

Joslyn Clark Controls

- N/C (Normally Closed) open top contact assemblies
- Vendor Part Numbers:
 1. KPM-44
 2. KPM-46
 3. KPM-6A
 4. KPM-4A

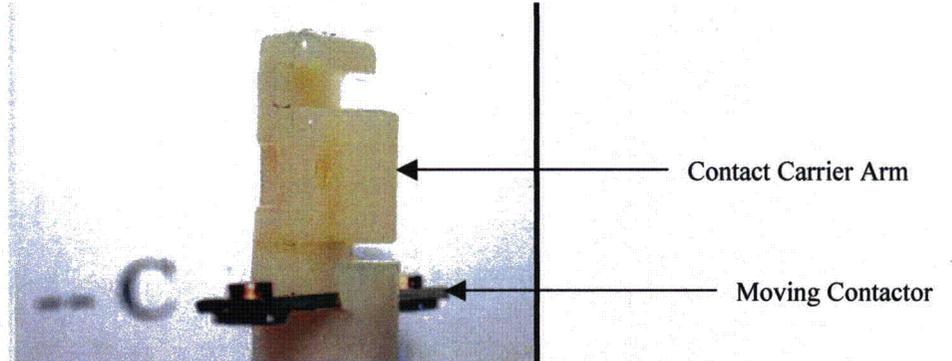
Moving contactor placed in slot of the contact carrier arm.

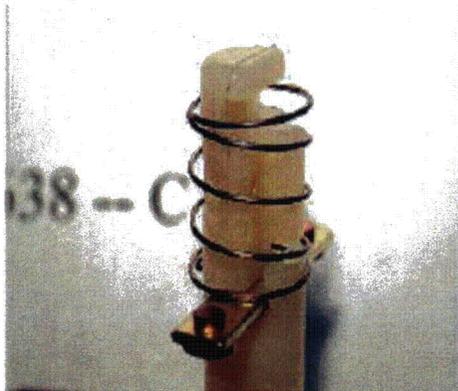
Moving contactor held in place by spring.

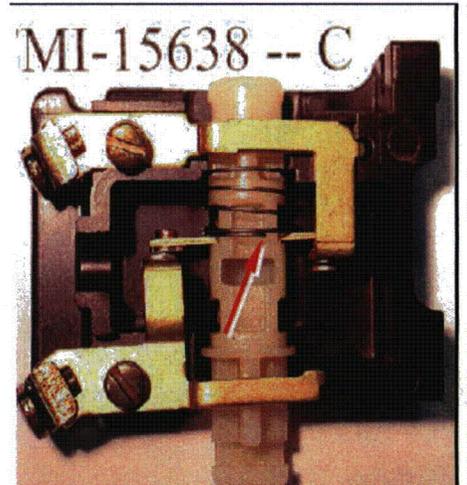
Properly assembled contact in housing.

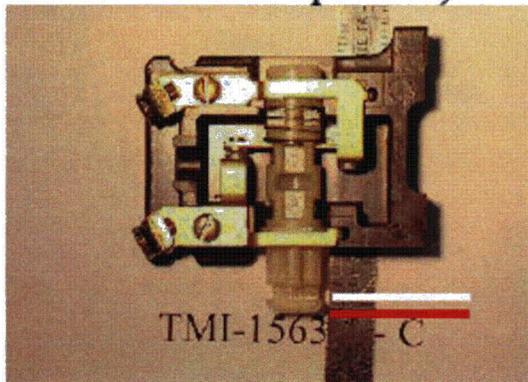
When the nylon carrier is allowed to drop to the full down position as demonstrated below in the picture on the left, the moving contactor is parallel with the lip of the slot, and there is a potential for the moving contactor to become hung-up on the lip of the slot. The nylon carrier is allowed to drop to the full down position prior to installation, and when the magnet kit and coil have been removed from the relay. Once installed in a relay, the magnet kit/coil keep the contact in the reference position as shown in the picture on the right, and the moving contactor cannot become hung-up on the lip of the slot.

Actuator in extreme full down position (-5/32 inch from installed reference position).

1. The Commercial Grade Dedication (CGD) plans as well as the maintenance procedures have been enhanced to prevent a relay from being placed into service with an improperly configured contact. The CGD plans have been revised such that the contacts are verified to be configured correctly during receipt inspection. Maintenance procedures have also been revised to ensure the contact configuration is correct after the relay is fully assembled and following maintenance involving magnet kit/coil replacement, contact replacement, or entire relay replacement. This type of maintenance creates a scenario where the contact carrier is allowed to drop down, which creates a potential for the moving contactor to get hung-up.

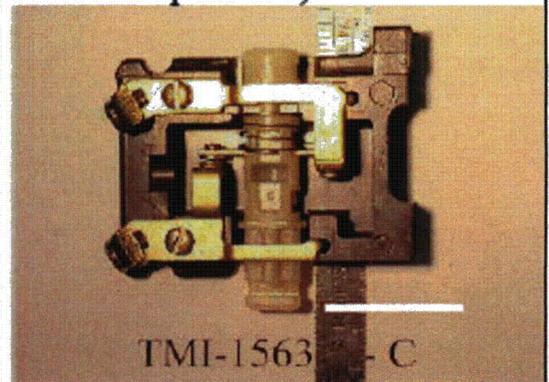
Actuator in installed down position (0.0 inches installed reference position).

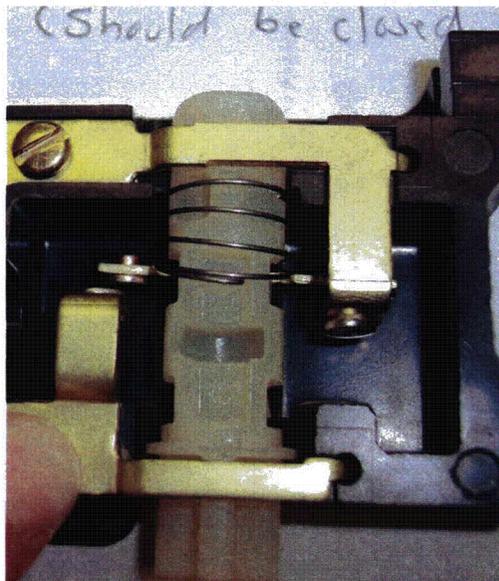
Moving contactor shown hung-up on the lip. Note the contact should be closed in this state, but is not able to fully close due to being hung-up.

The potential for a N/C Joslyn Clark contact to become hung-up does result in a substantial safety hazard since it jeopardizes the capability to actuate emergency core cooling components that are utilized to mitigate the consequences of accidents that could result in potential offsite exposure.

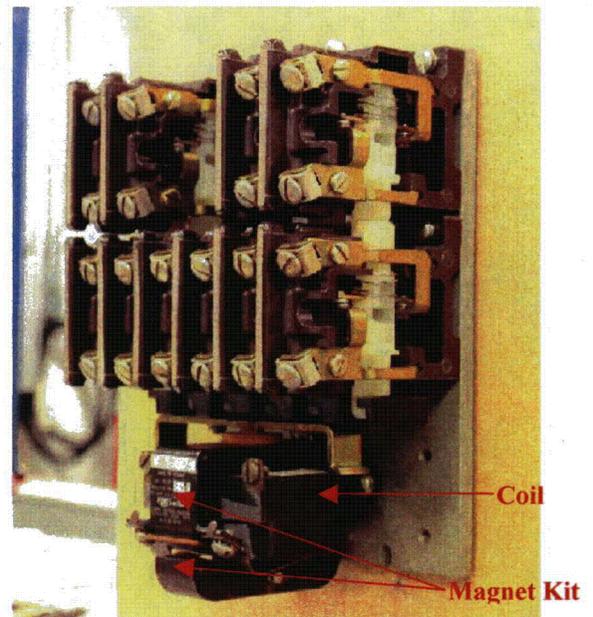
Fully assembled relay with magnet kit and coil.

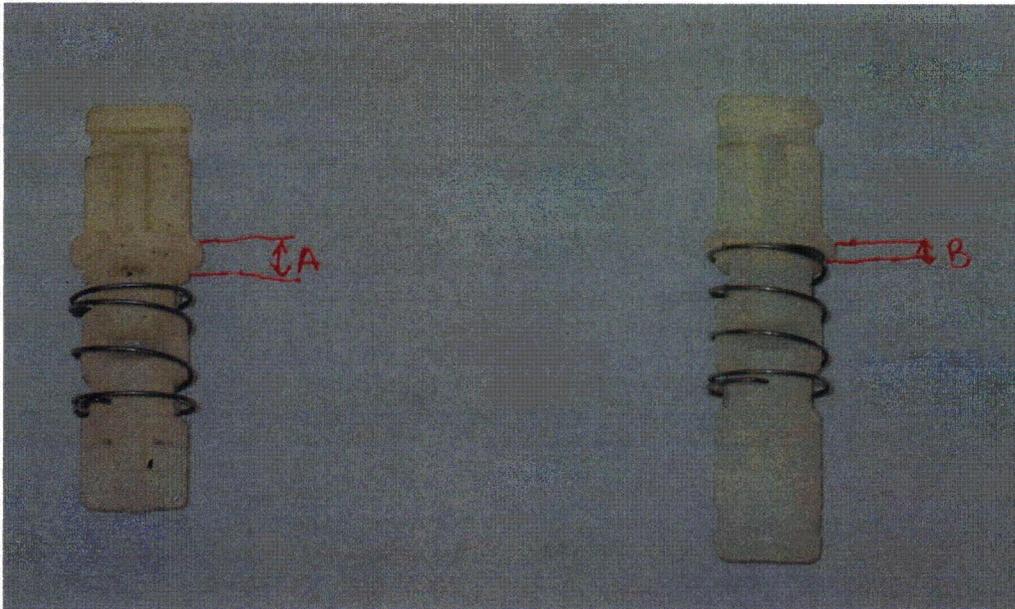
Only the open top N/C contact assemblies are subject to this vulnerability, due to the difference in the size of a retaining ring between the closed top and open top assemblies. The larger ring utilized in the closed top contact assemblies prevents the nylon arm from dropping down. (A in the picture below) The smaller ring utilized in the open-top assemblies allows the nylon arm to drop down. (B in the picture below)
