BROWNS FERRY NUCLEAR PLANT

UNITS 1 AND 2

APPROXIMATE TEMPERATURE ZONES

CEB-75-12

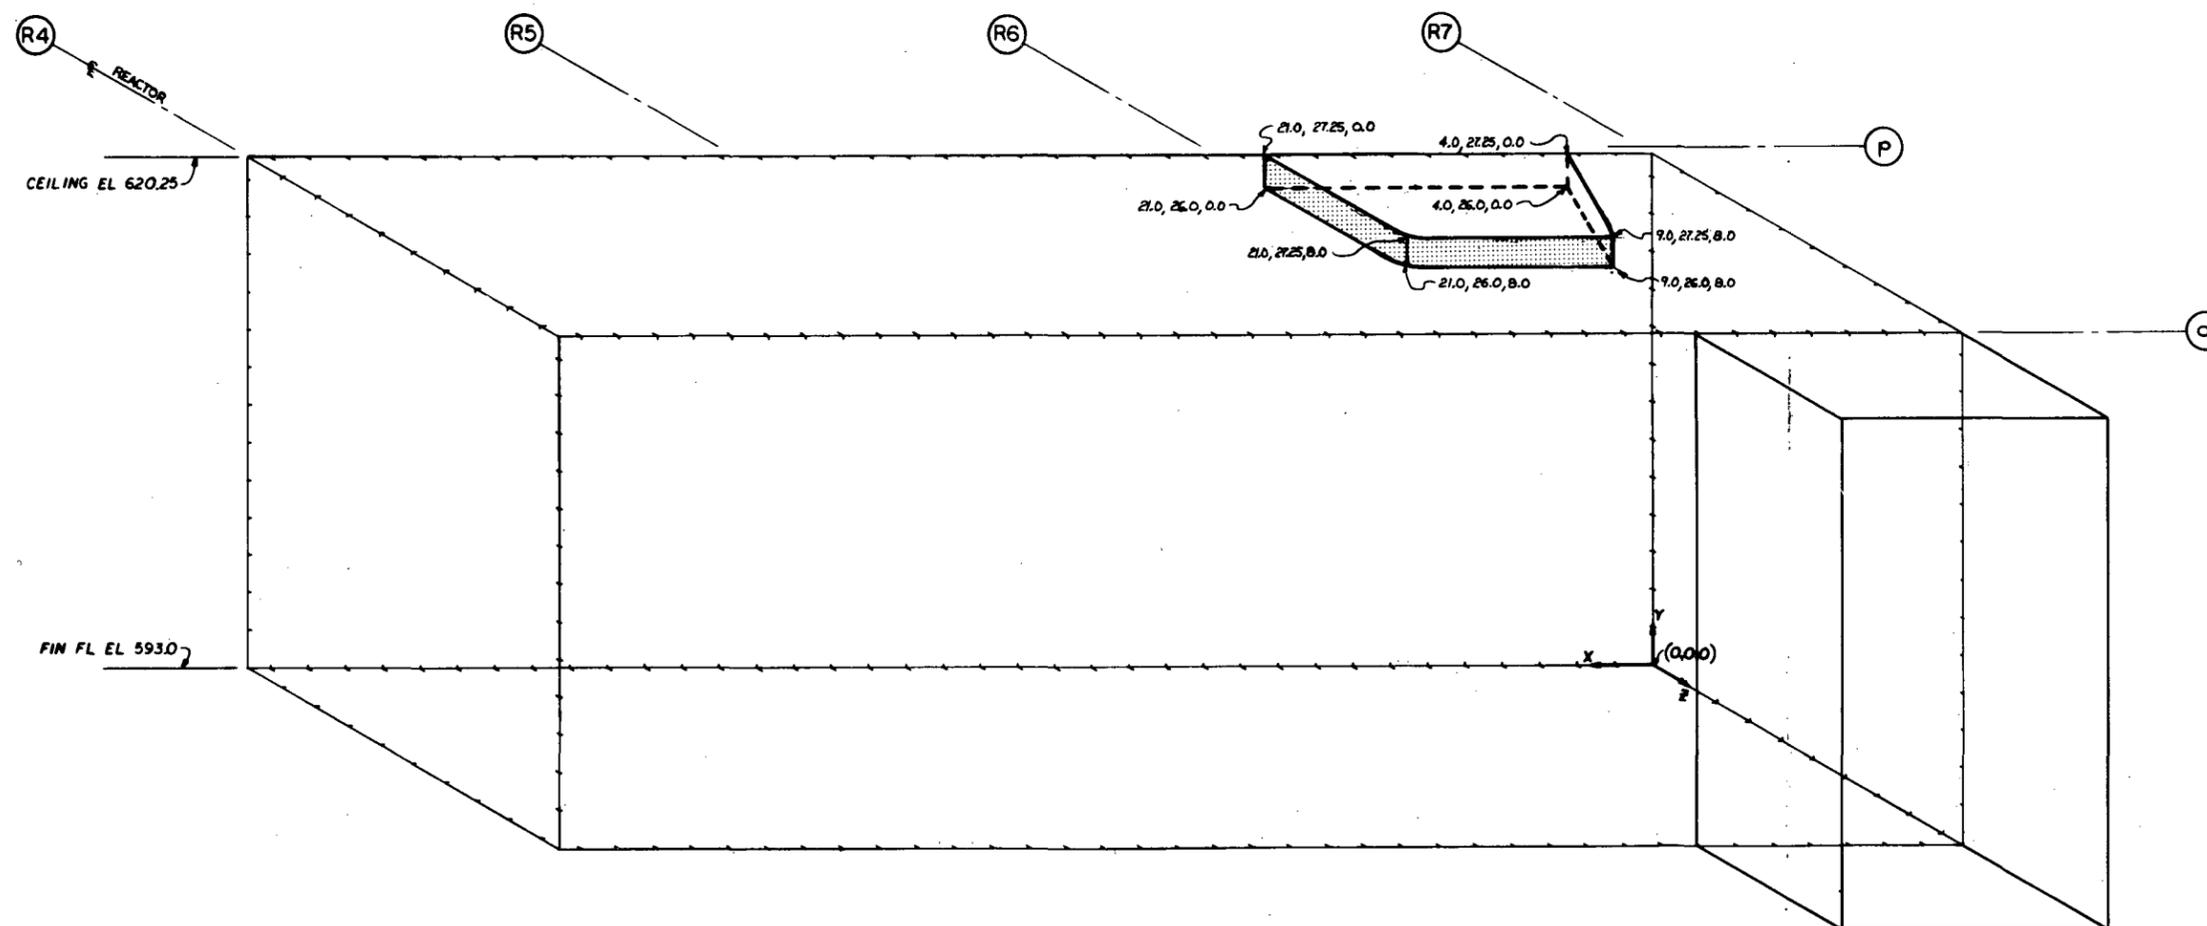
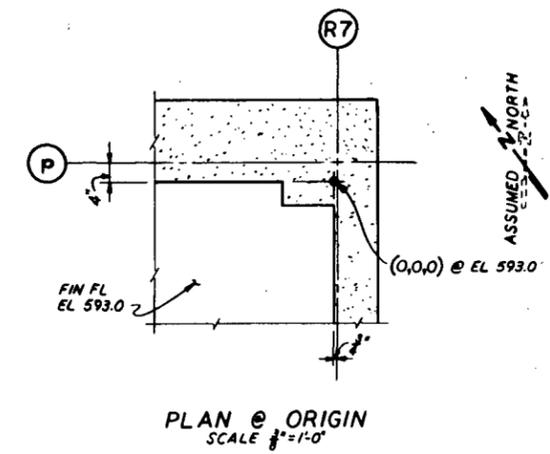
FIGURE 1
ESTIMATED TEMPERATURE ZONES - 1500 F

1500 F - Buff colored concrete.

1500 F zone - This zone is characterized by buff colored concrete on the ceiling and is located as shown in figure 1. The color interpretation was a judgment type decision but was substantiated by other observations also. One such observation was that within a distance of approximately 1 foot a considerable amount of aluminum conduit had melted (figure 7). The melting point of aluminum is known to be approximately 1220 F. Also the 1500 F zone is located approximately above both the greatest concentration of consumed material and the incoming supply of fresh air. Heat from the burning cables, fanned by the intrushing air to the lower pressure of the reactor building, rose in convection currents.

This rising heat was sufficient to melt the aluminum 1 foot from the ceiling. The melting of the aluminum conduit and subsequent burning of the insulated cables contained therein is considered to account for the 1500 F temperature of figure 1.

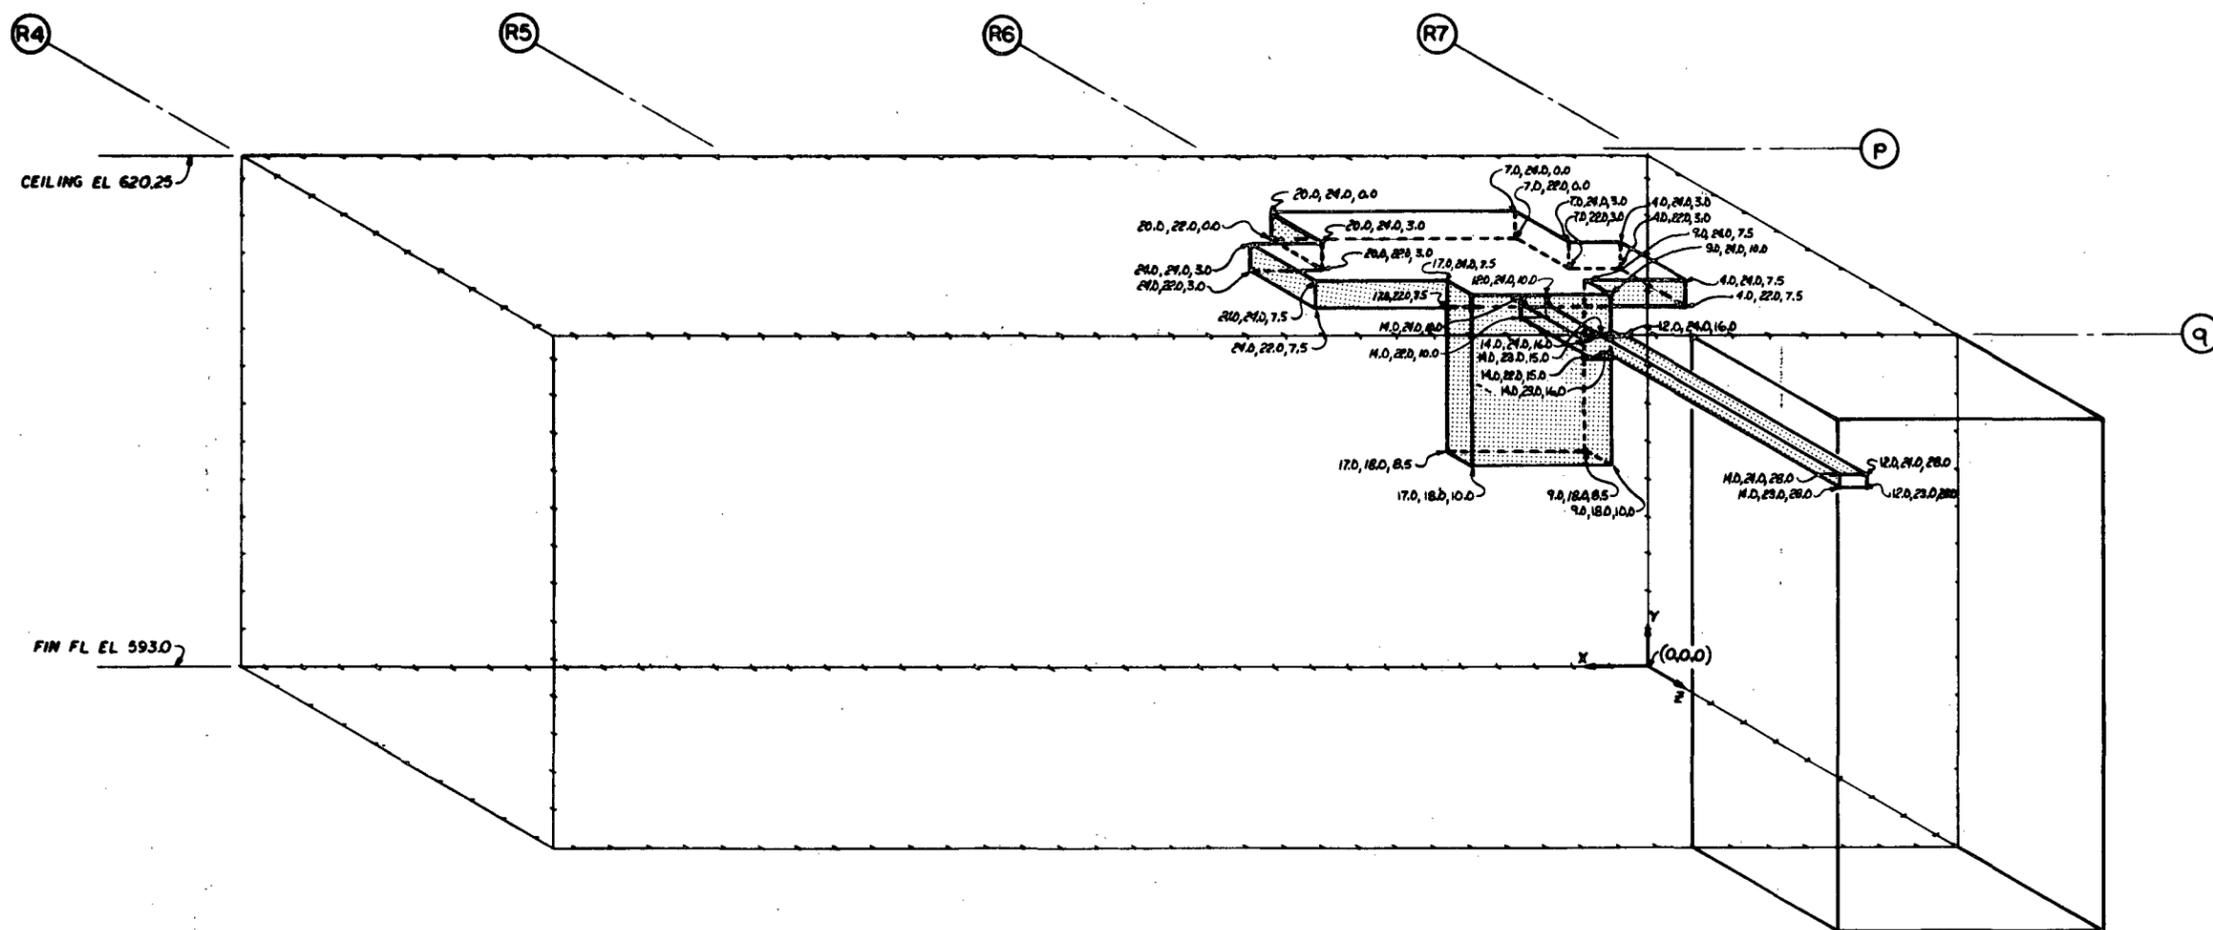
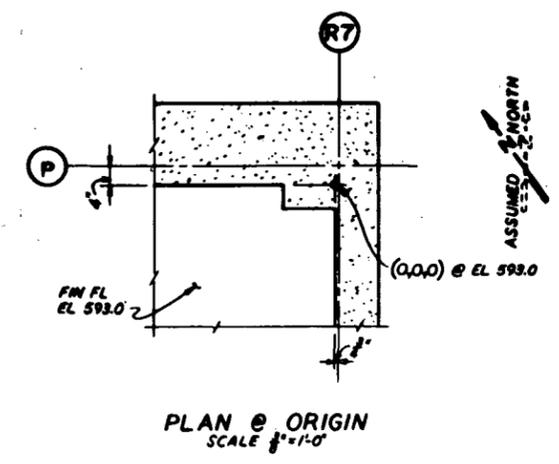
FIGURE 2
ESTIMATED TEMPERATURE ZONES - 1220 F

1220 F - Melted aluminum conduit and insulation lagging.

1220 F zone (figure 2) - ^{This} The zone envelops all melted aluminum observed in the burn region. Except for highly congested regions containing large amounts of consumable insulating material, this zone is formed by a vertical projection of the burned cable trays and extends from the top tray to an elevation enveloping the uppermost signs of melted aluminum (figures 7, 8, and 9).

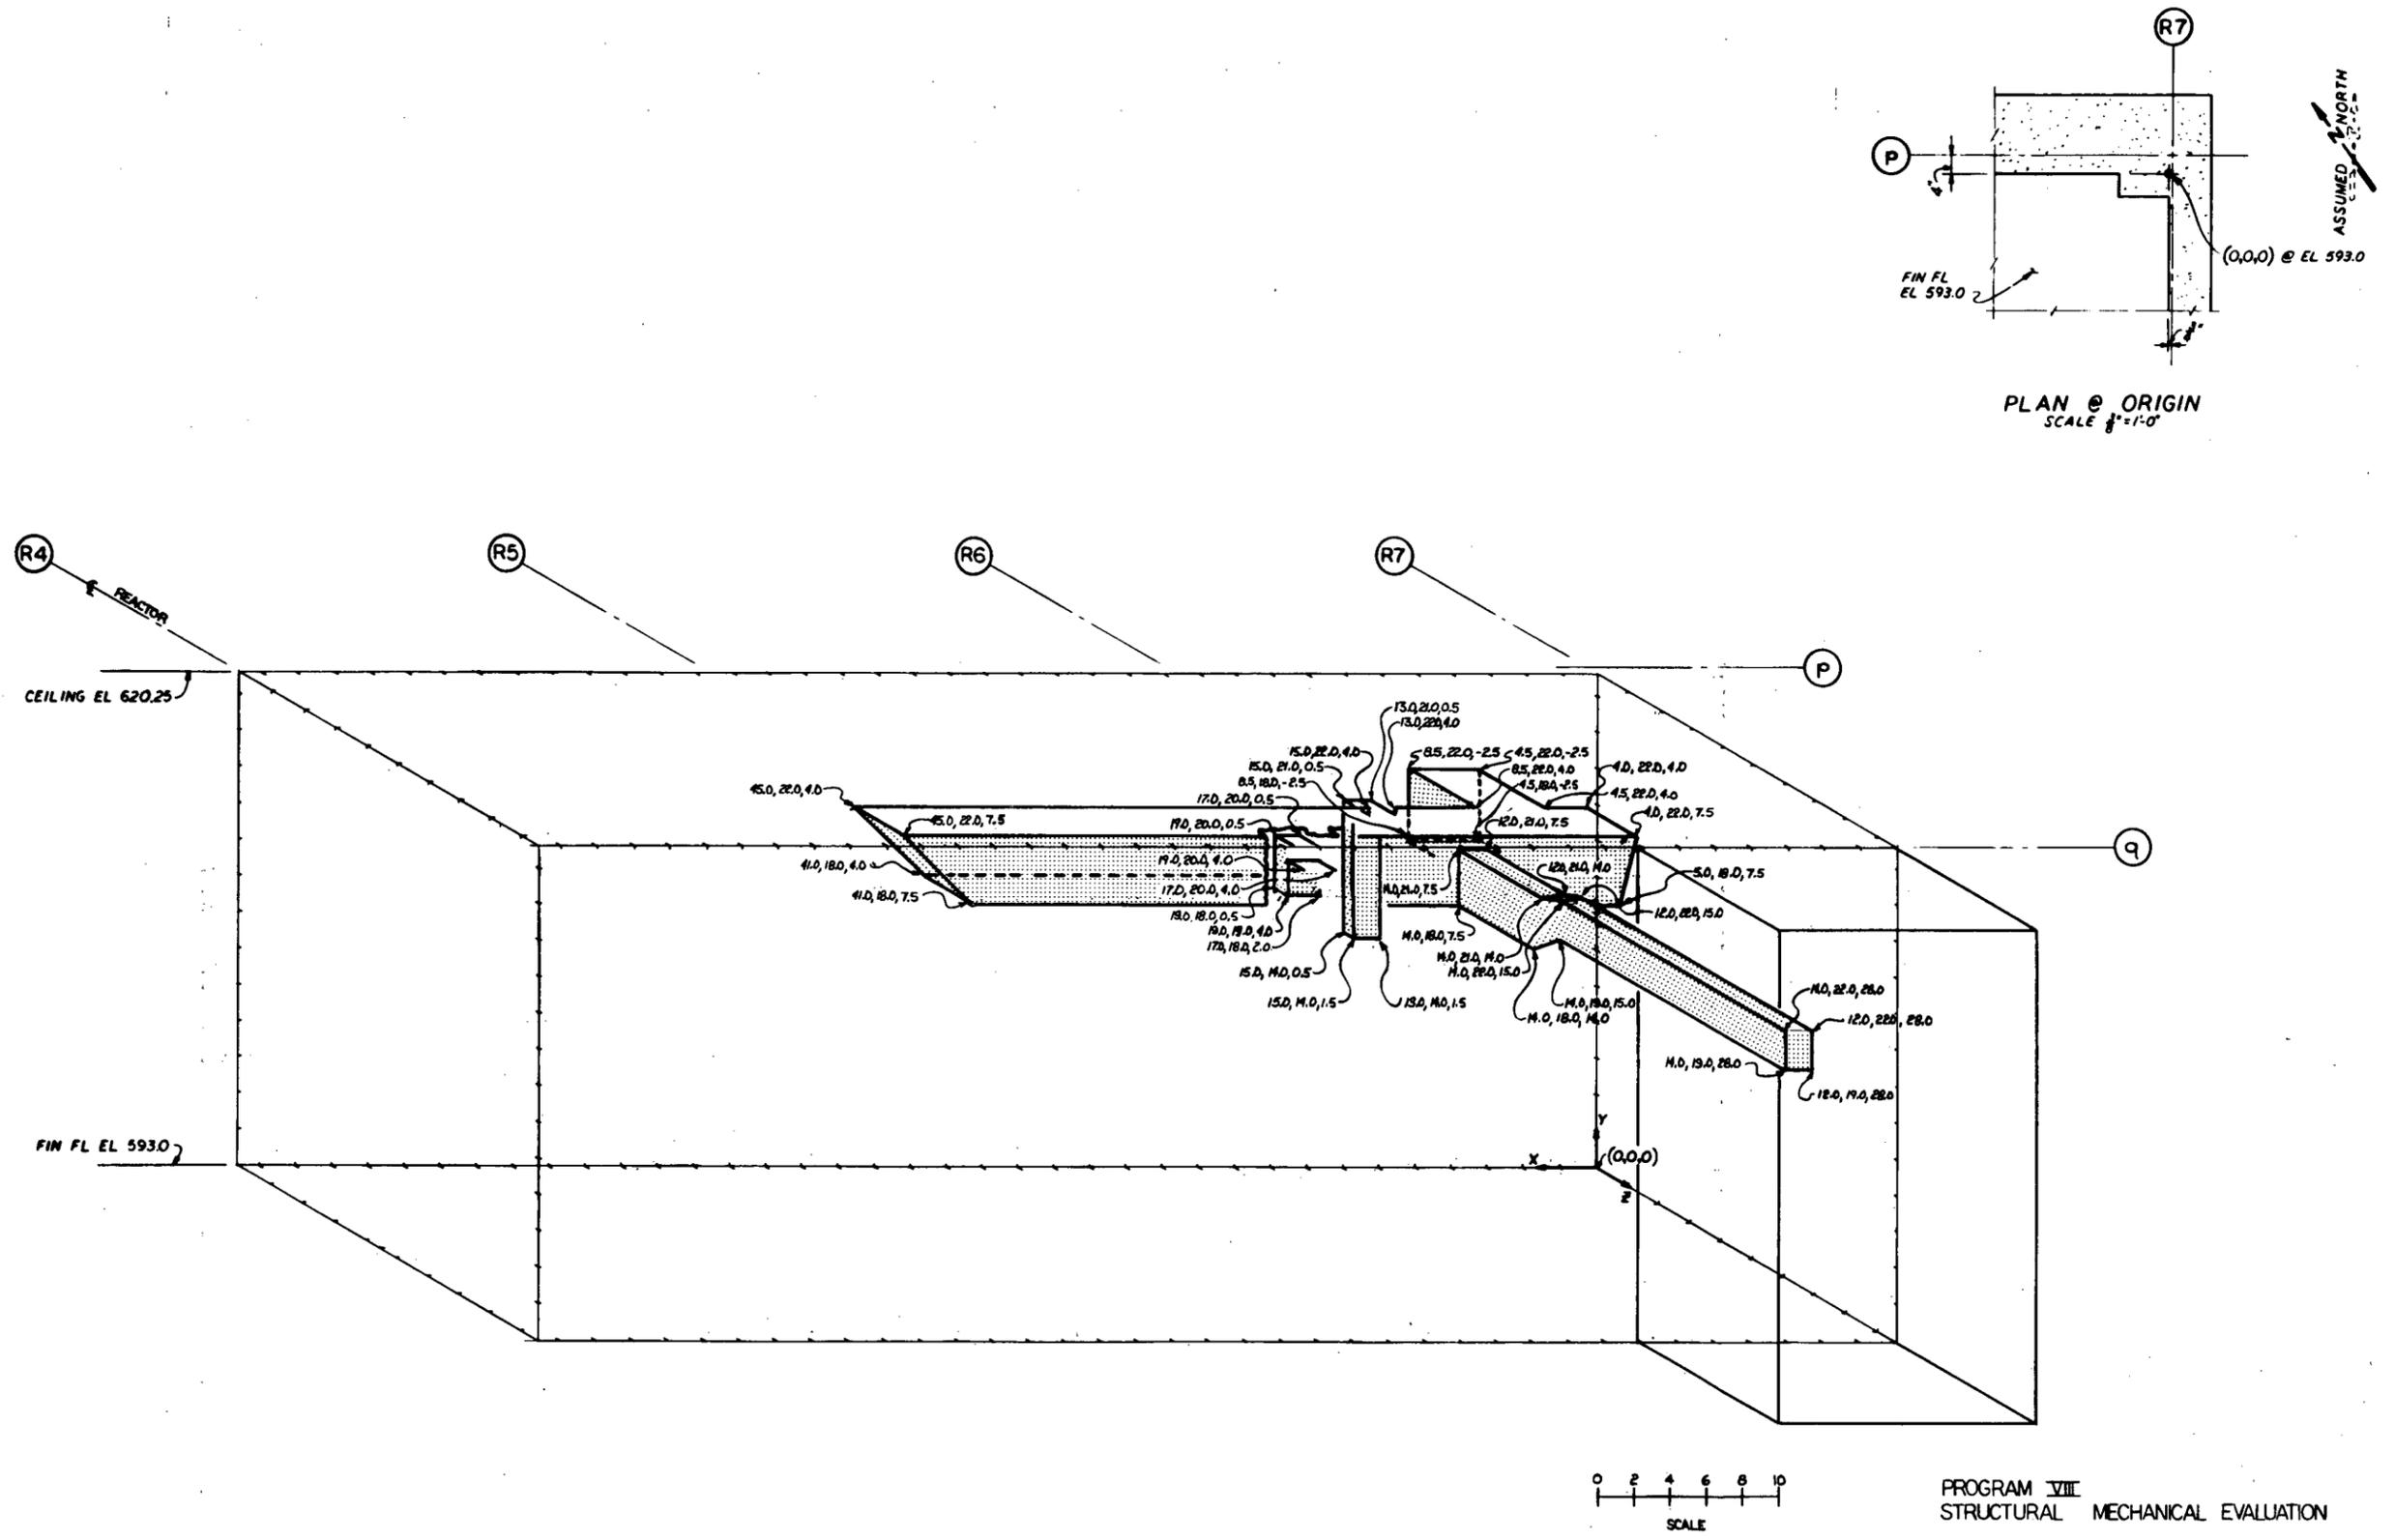
FIGURE 3
ESTIMATED TEMPERATURE ZONES - 787 F

787 F - Melted galvanizing (exterior surfaces of burned cable trays).

787 F zone (figure 3) - Essentially all cable trays containing burned cables showed signs of melted galvanizing (figures 7 through 11). This zone is assumed to be the volume containing all of the burned-out cable trays. Temperatures within the trays were probably much higher (figures 8 and 11) but this is of no interest since nothing within the trays is salvageable (references 4.4 and 4.5). In some areas the surfaces of the trays were also much higher and the galvanizing temperature greatly exceeded the melting point (figure 11). This too is of no importance since nothing in contact with the burned trays is salvageable either (references 4.4 and 4.5).

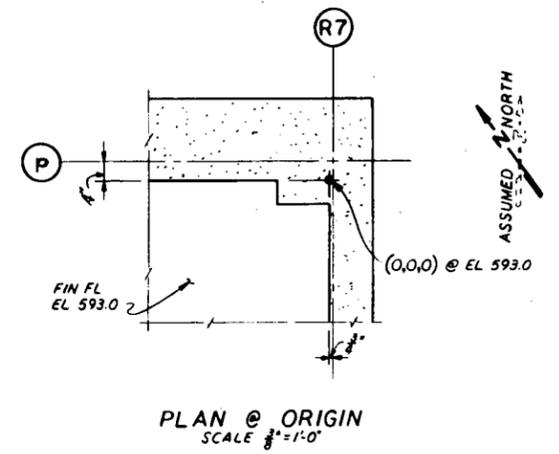
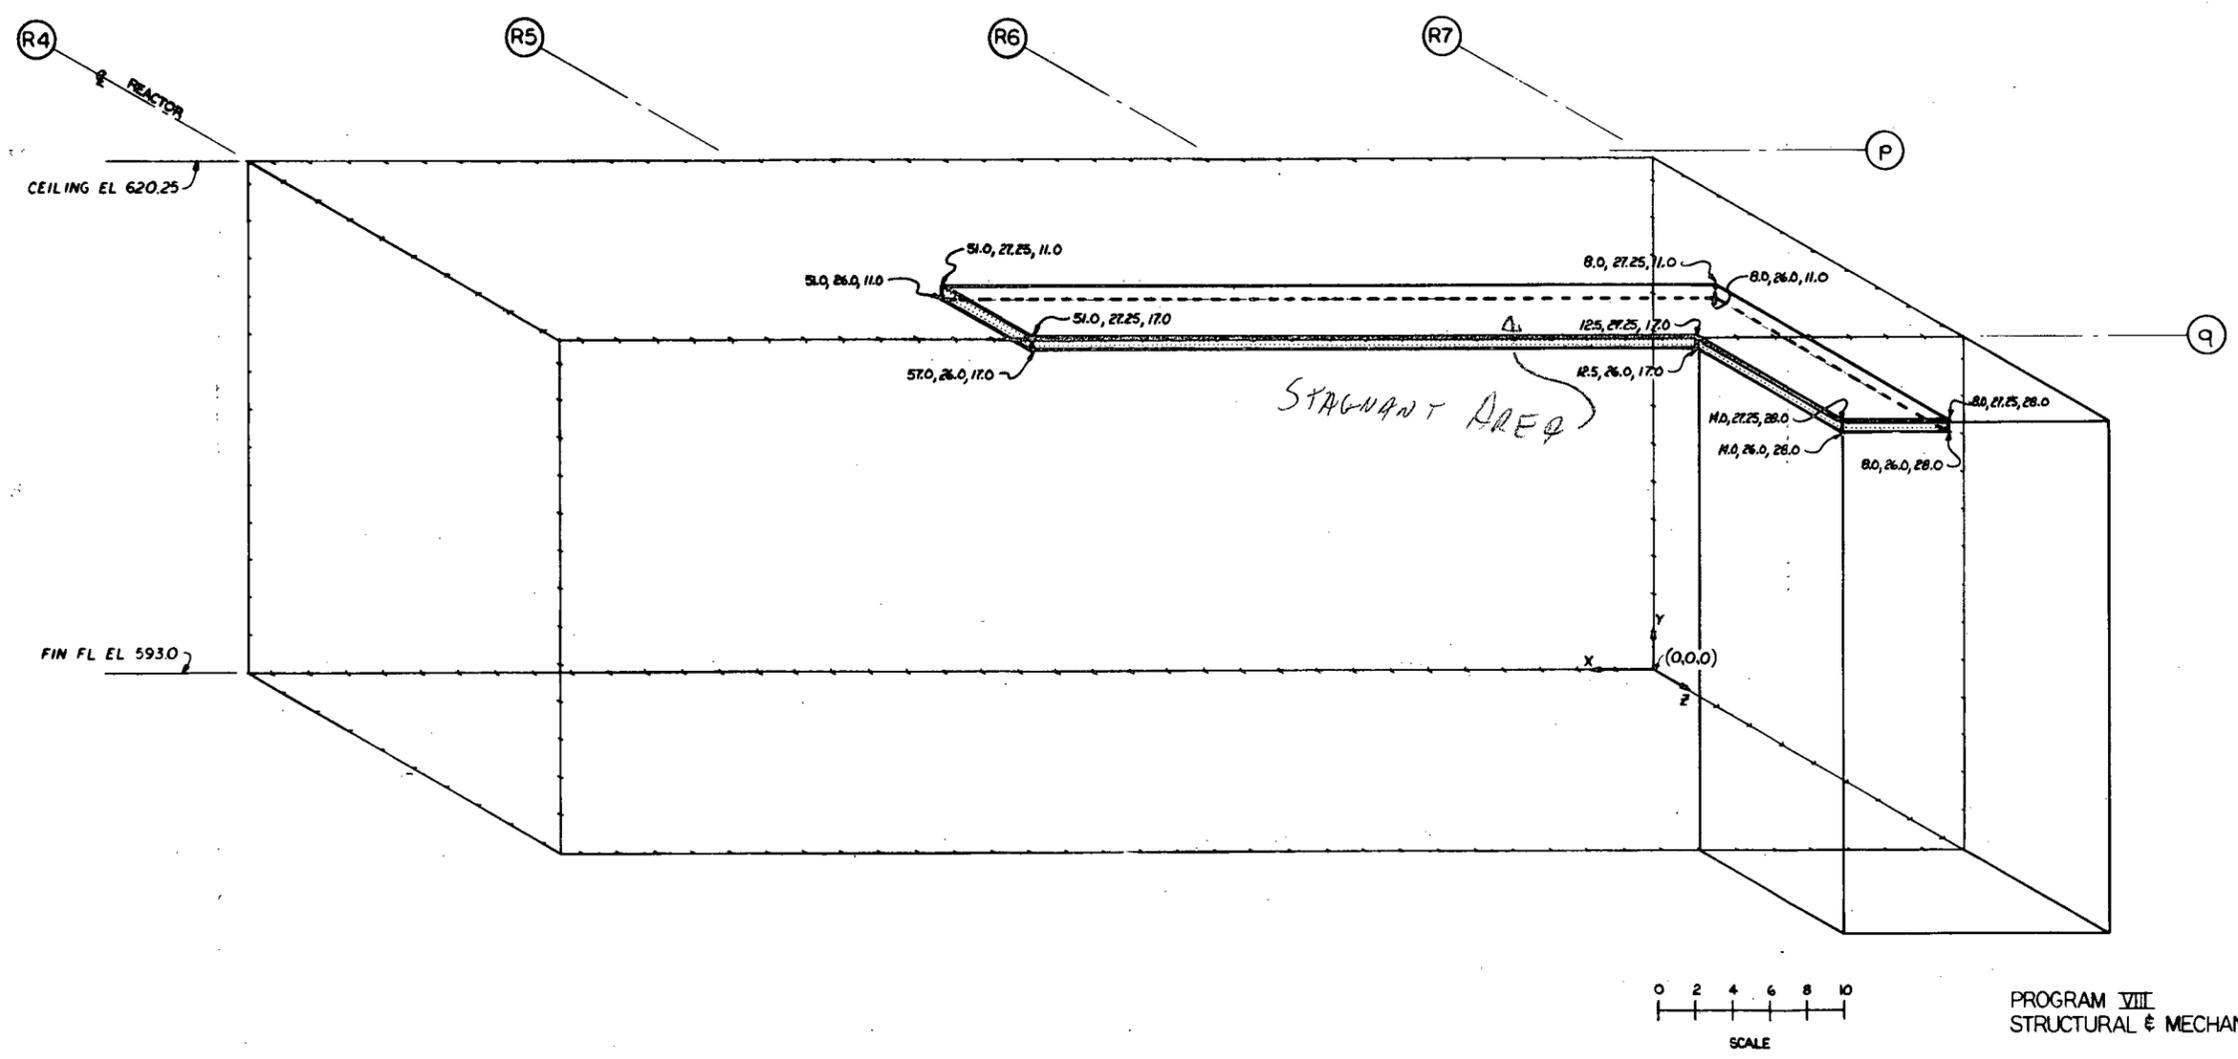
FIGURE 4
ESTIMATED TEMPERATURE ZONES - 500 F

500 F - This zone was estimated based upon proximity to other identifiable zones.

500 F zone (figure 4) - This zone appeared to be a somewhat stagnant pool of heat which was not directly over the burned trays. It is directly above a zone found to contain small amounts of blistered

and peeled paint, representing the 340 F zone described below. Some other unidentified and completely burned materials (probably rags) were found in this region which completely disintegrated upon touching them. The stagnation of this region was evidenced by these burned materials (one piece shown in figure 12) and by the total covering of everything in this region by a thick uniform layer of very fine soot. It was obvious that there had been very little or no lateral movement of air in this region since one could disturb a considerable quantity of soot with one's breath.

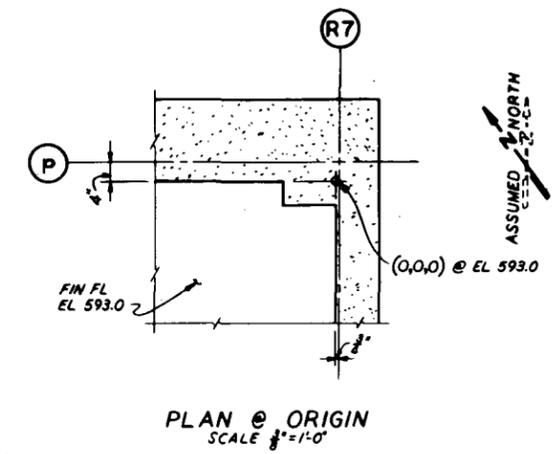
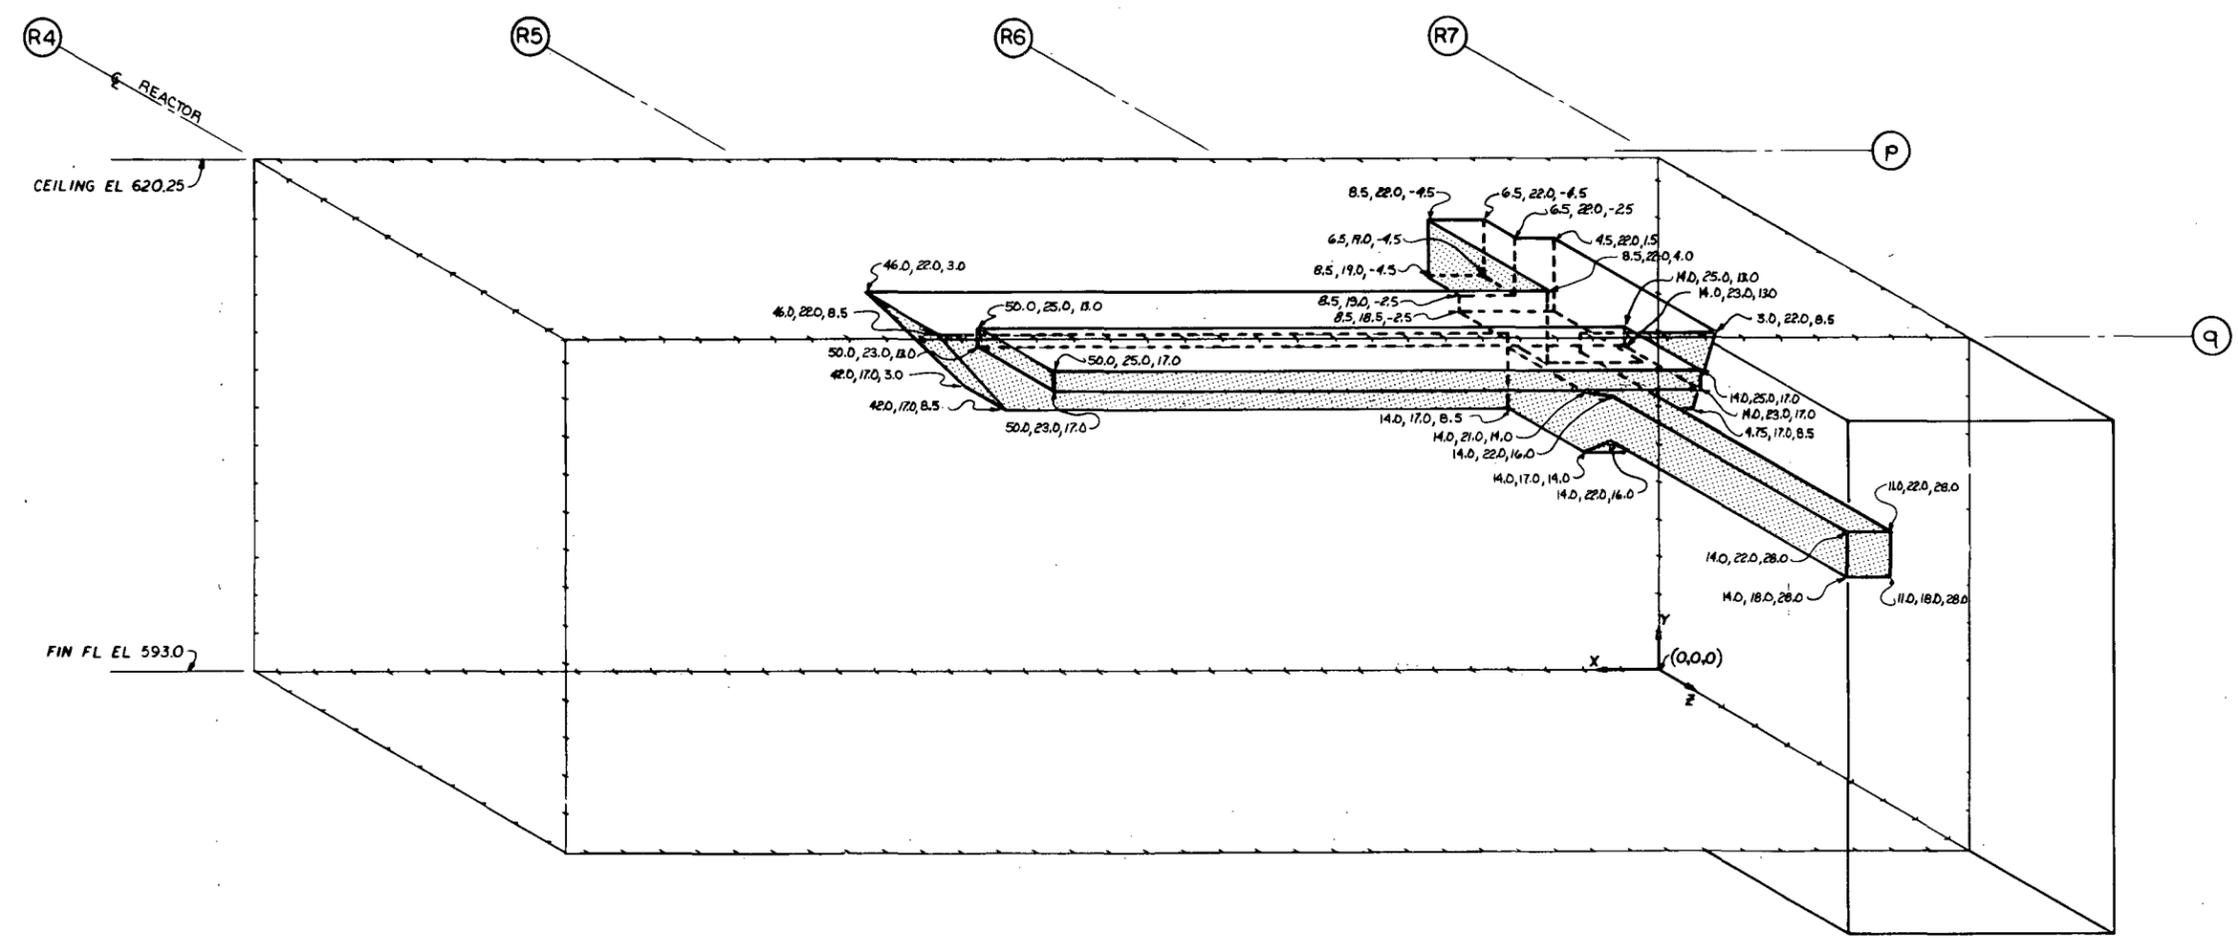
FIGURE 5
ESTIMATED TEMPERATURE ZONES - 340 F

340 F - Blistered and peeled paint.

340 F zone (figure 5) - The predominant characteristic of this zone is blistered and peeled paint (figures 8, 9, and 10) which has not been included in a higher temperature zone. It essentially formed a buffer zone around the cable trays, outward and downward, a distance of 3 to 12 inches. One other zone was found, however, both of which are shown in figure 5. This zone appeared somewhat stagnant as did the 500 F zone which was directly above it.

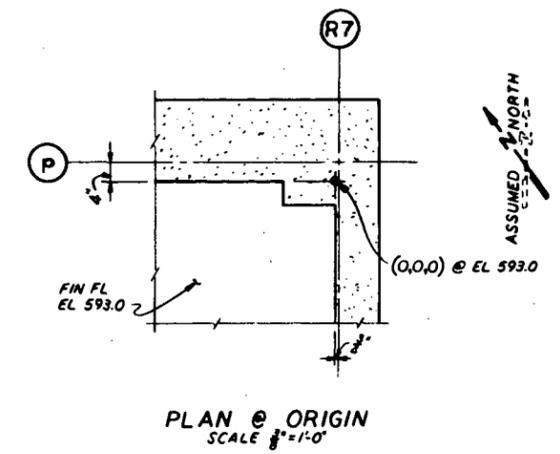
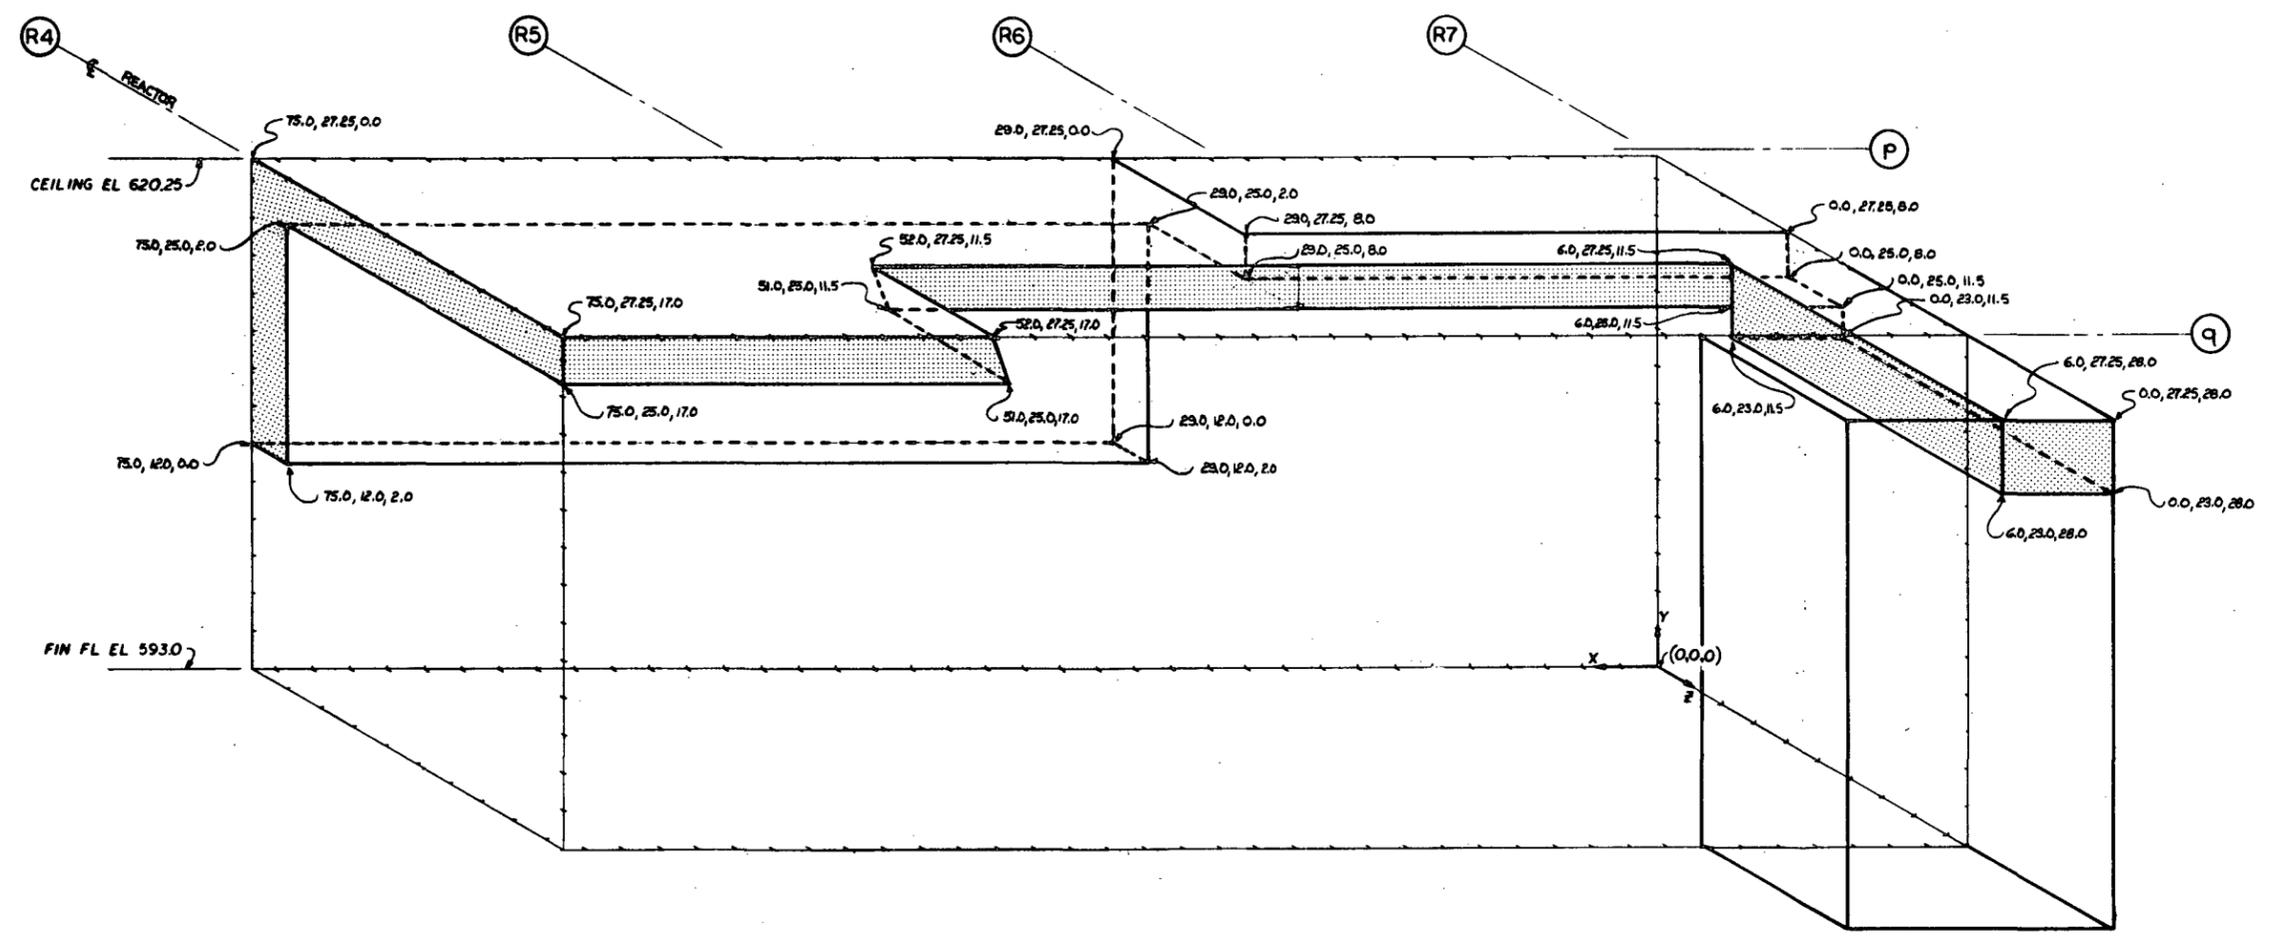
FIGURE 6
ESTIMATED TEMPERATURE ZONES - 300 F

300 F - Paint softened, not blistered, sufficiently to allow soot to become embedded in the paint (approximated).

300 F (figure 6) - Much of this zone is outside the temporary wall constructed of polyethylene film. It does not have well defined boundaries and the temperature was judged to be just under that for blistered paint. The primary characteristic indicator outside the temporary wall was paint which at some time during the fire had attained a temperature sufficient to soften it. The paint had then been exposed to a layer of soot which became entrapped to the extent that wire brushing could not separate the paint from the soot.

For other areas, indicators for this temperature were not readily determined and the boundaries were approximated based upon proximity to other better defined zones.

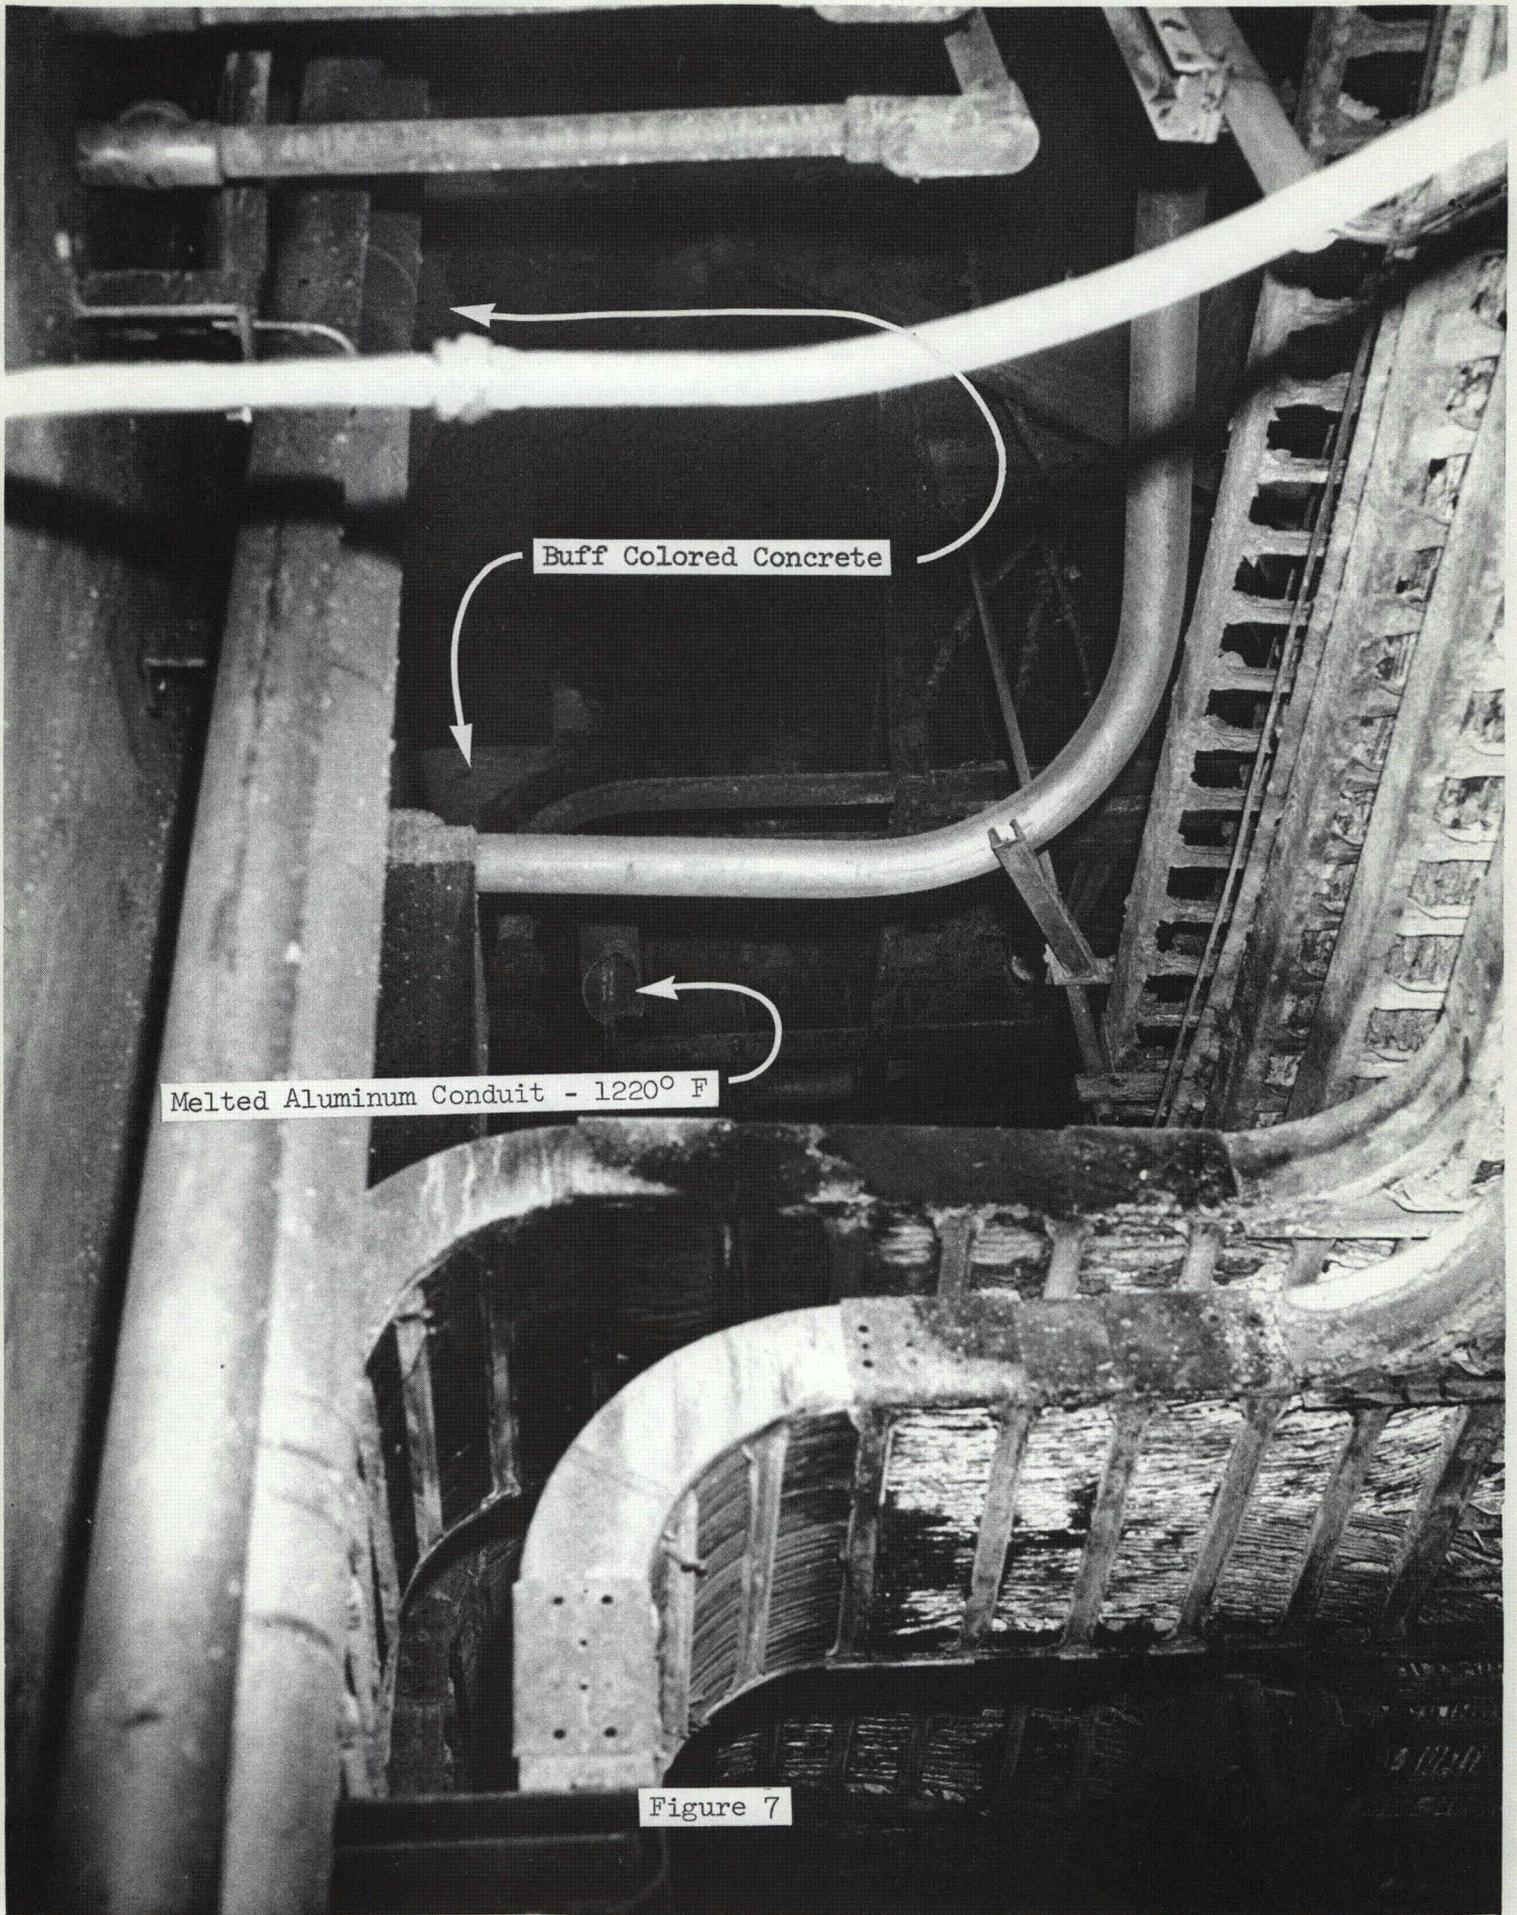
Figure 7

Buff Colored Concrete

Melted Aluminum Conduit - 1220° F

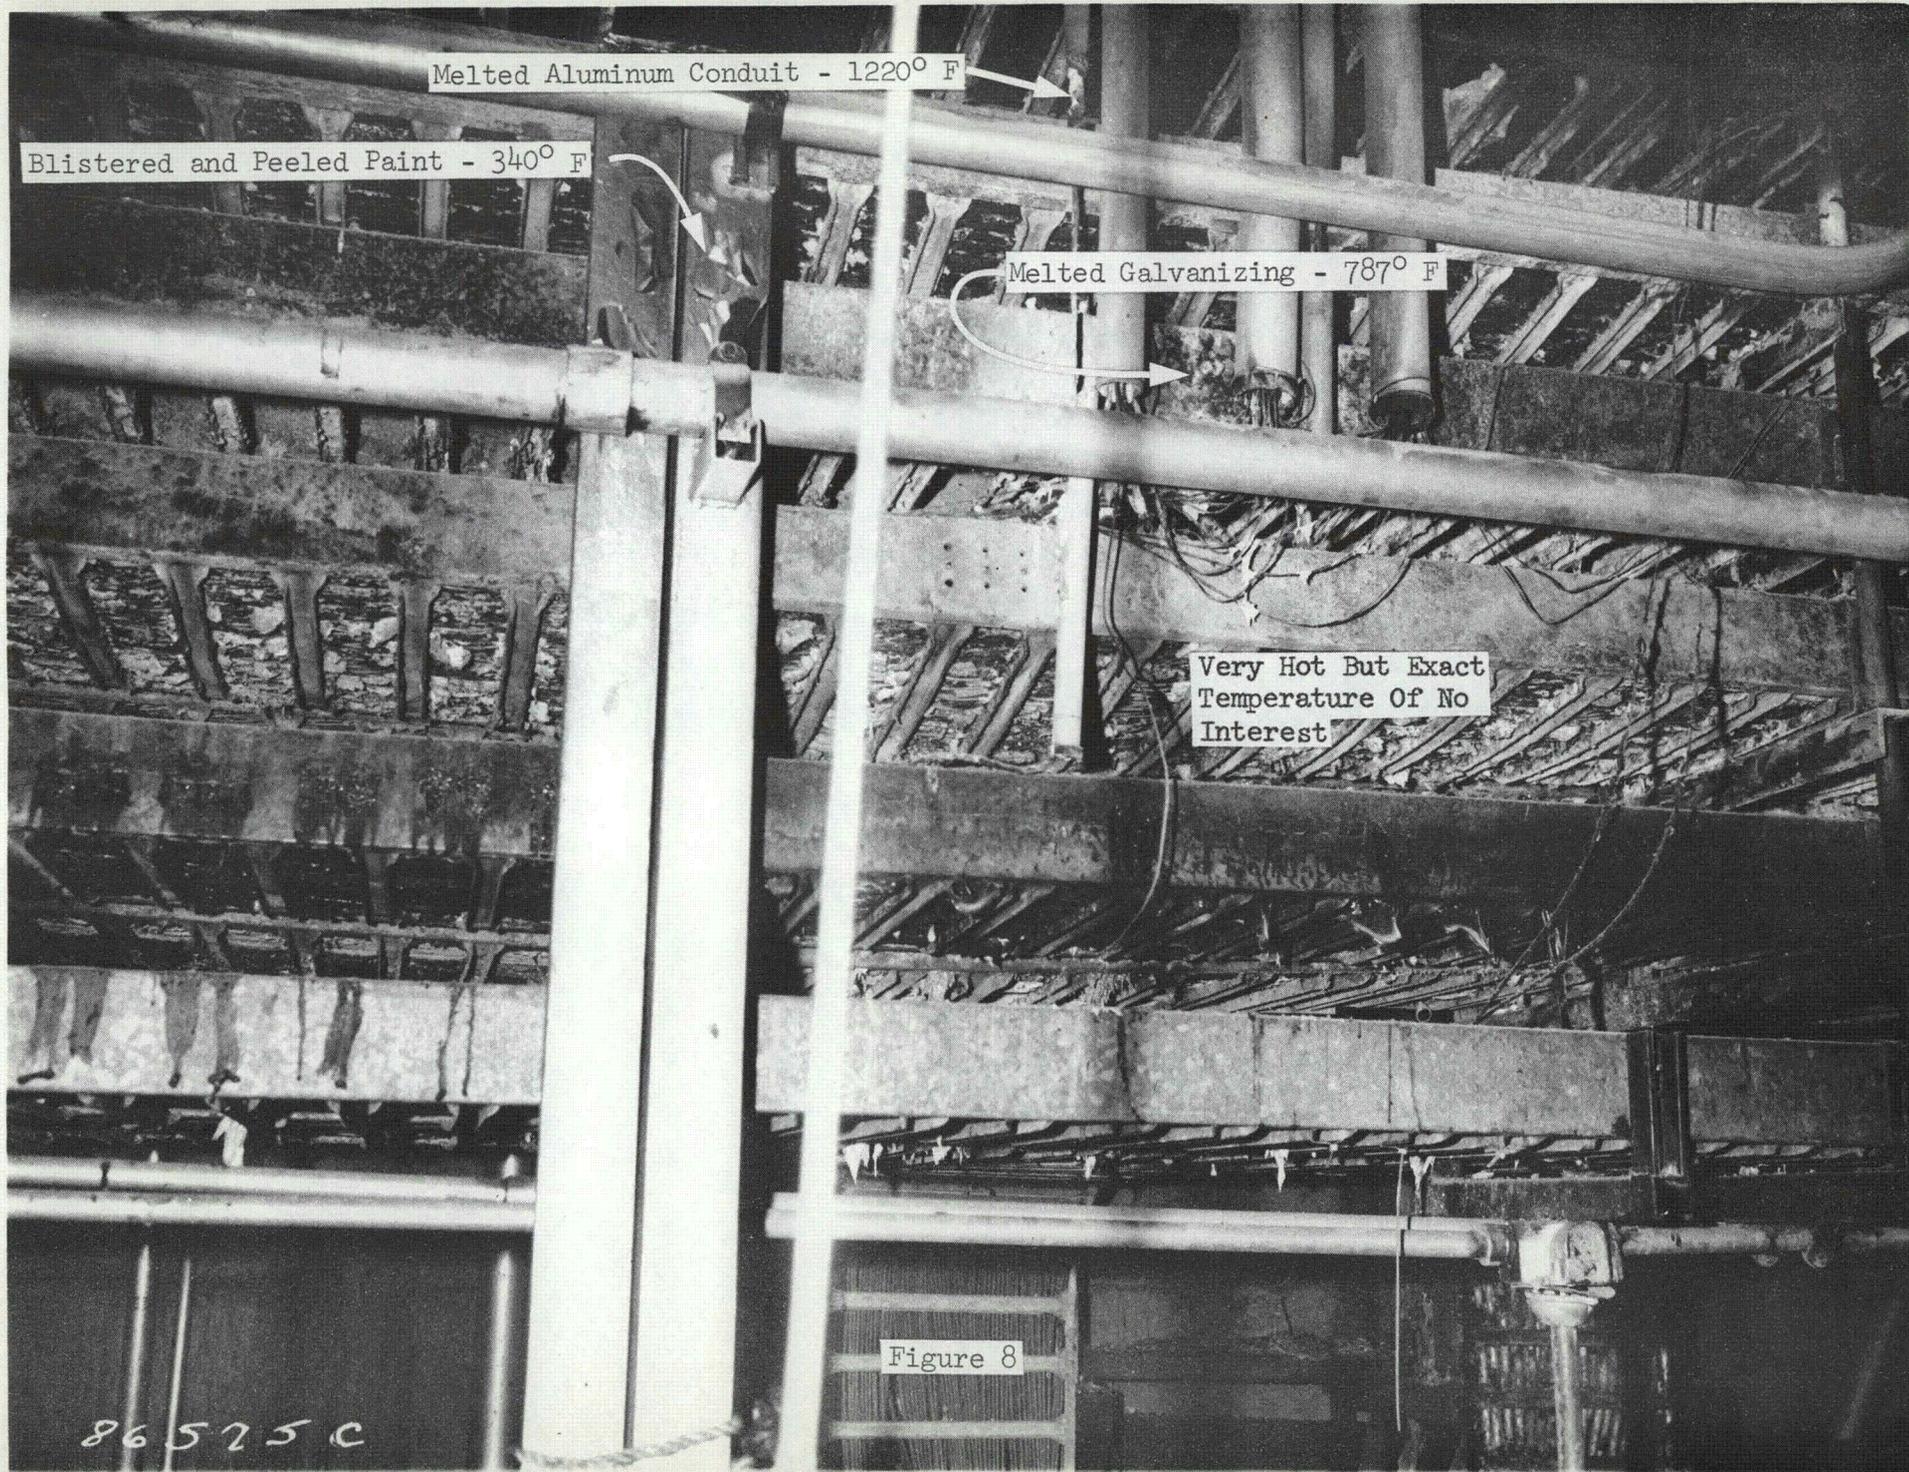
Figure 8

Melted Aluminum Conduit - 1220° F

Blistered and Peeled Paint - 340° F

Melted Galvanizing - 787° F

Very Hot But Exact
Temperature Of No
Interest
