BROWNS FERRY NUCLEAR PLANT

UNITS 1 AND 2

APPROXIMATE TEMPERATURE ZONES

CEB-75-12

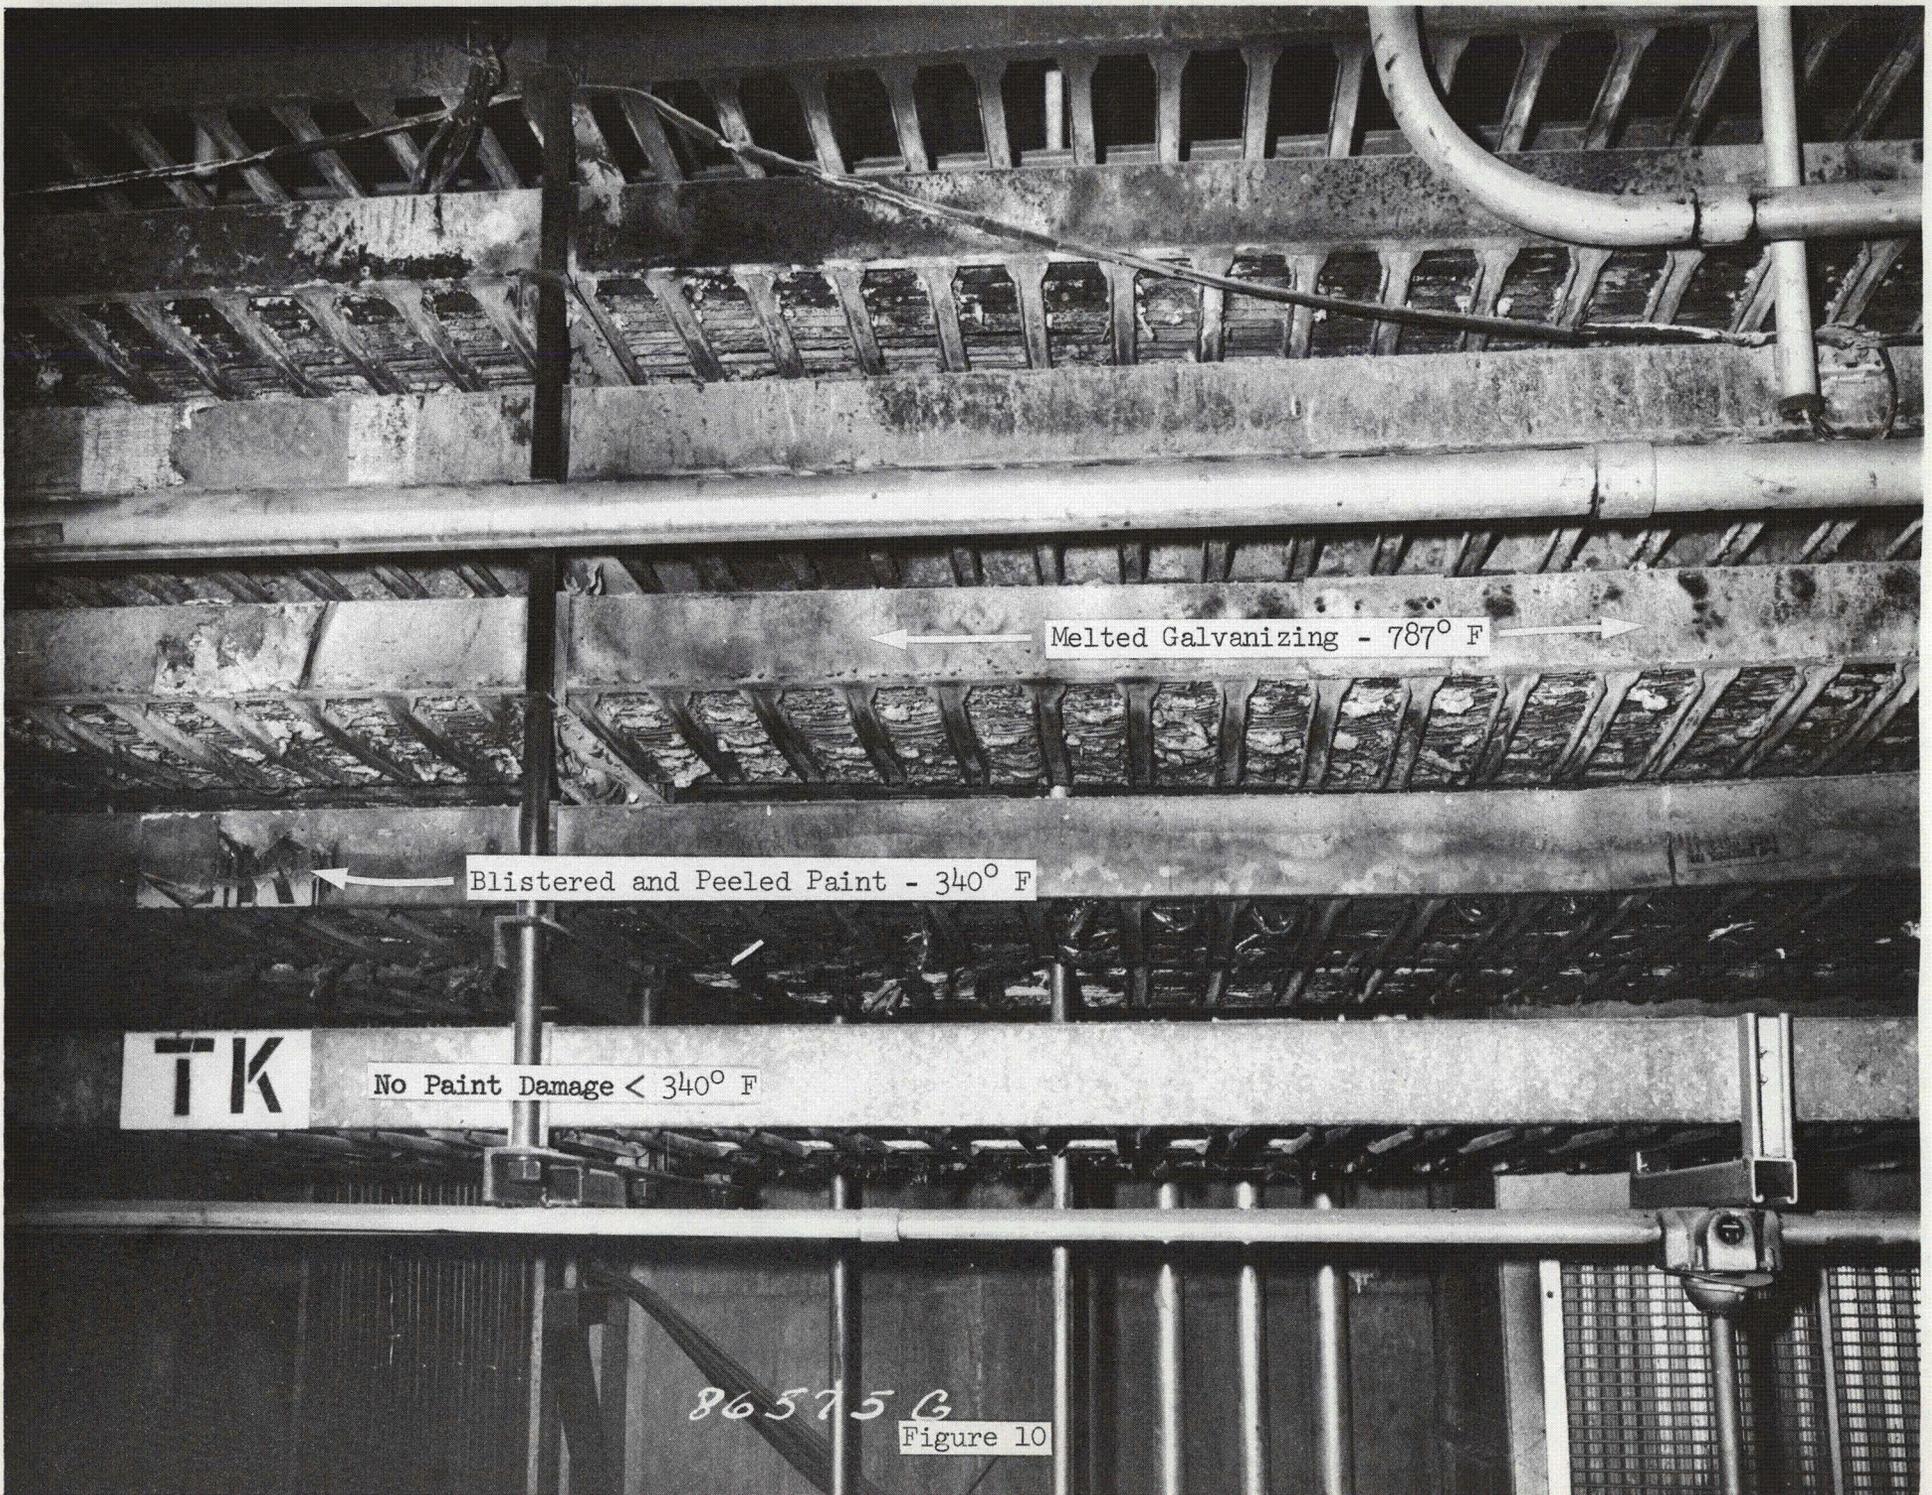
Figure 10

No Paint Damage < 340° F

Blistered and Peeled Paint - 340° F

Melted Galvanizing - 787° F

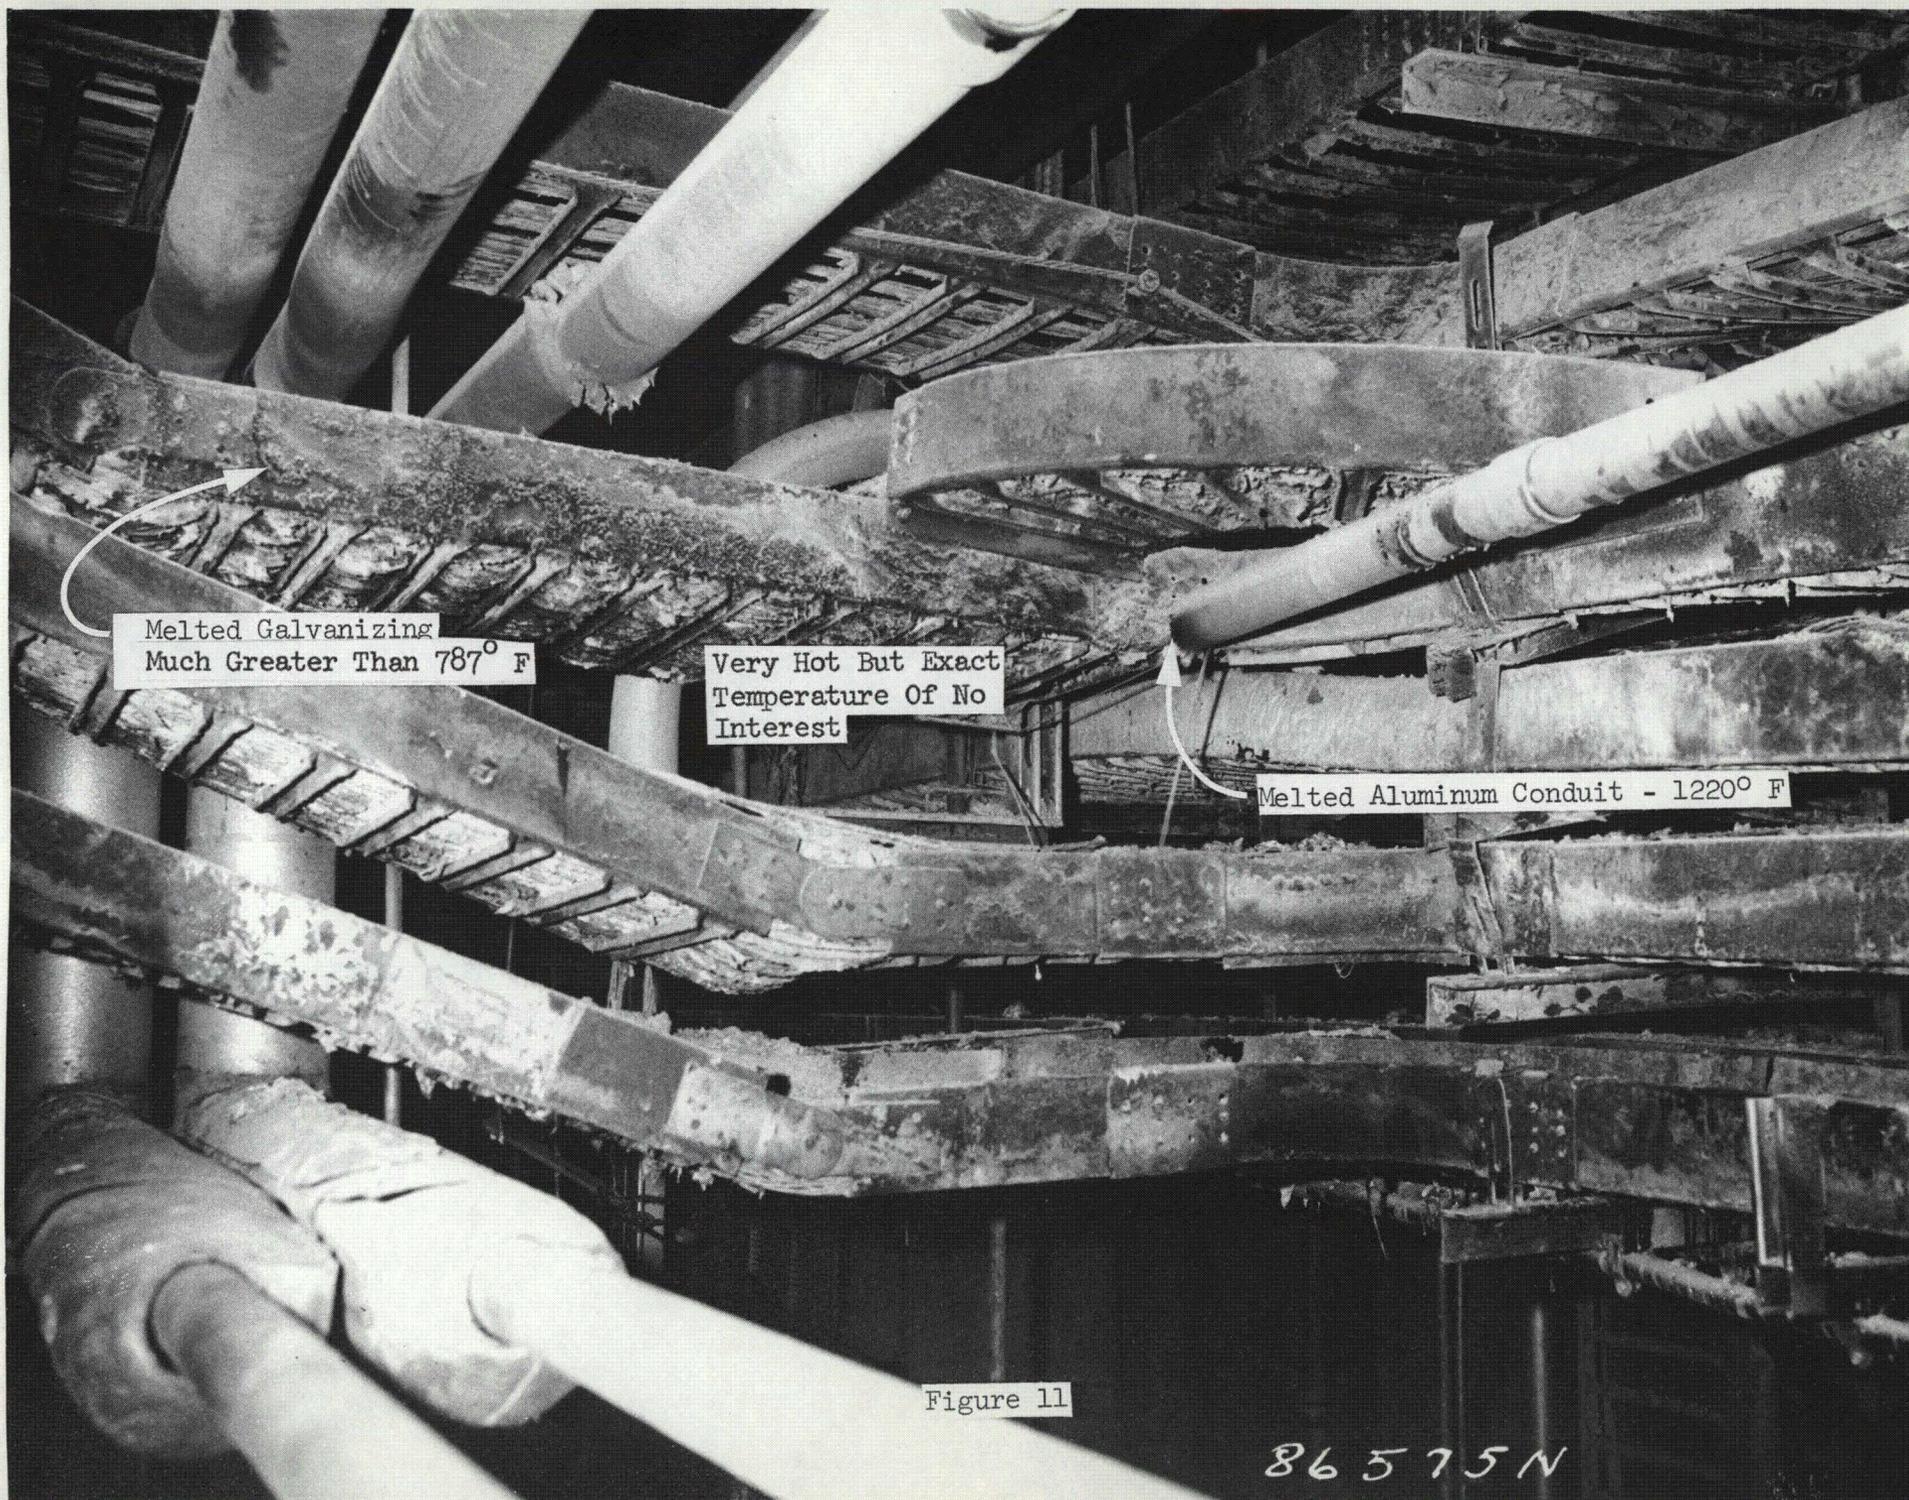
Figure 11

Melted Galvanizing
Much Greater Than 787° F

Very Hot But Exact
Temperature Of No
Interest

Melted Aluminum Conduit - 1220° F
