BROWNS FERRY NUCLEAR PLANT FIRE

HEARINGS

JOINT COMMITTEE ON ATOMIC ENERGY

SEPTEMBER 16, 1975

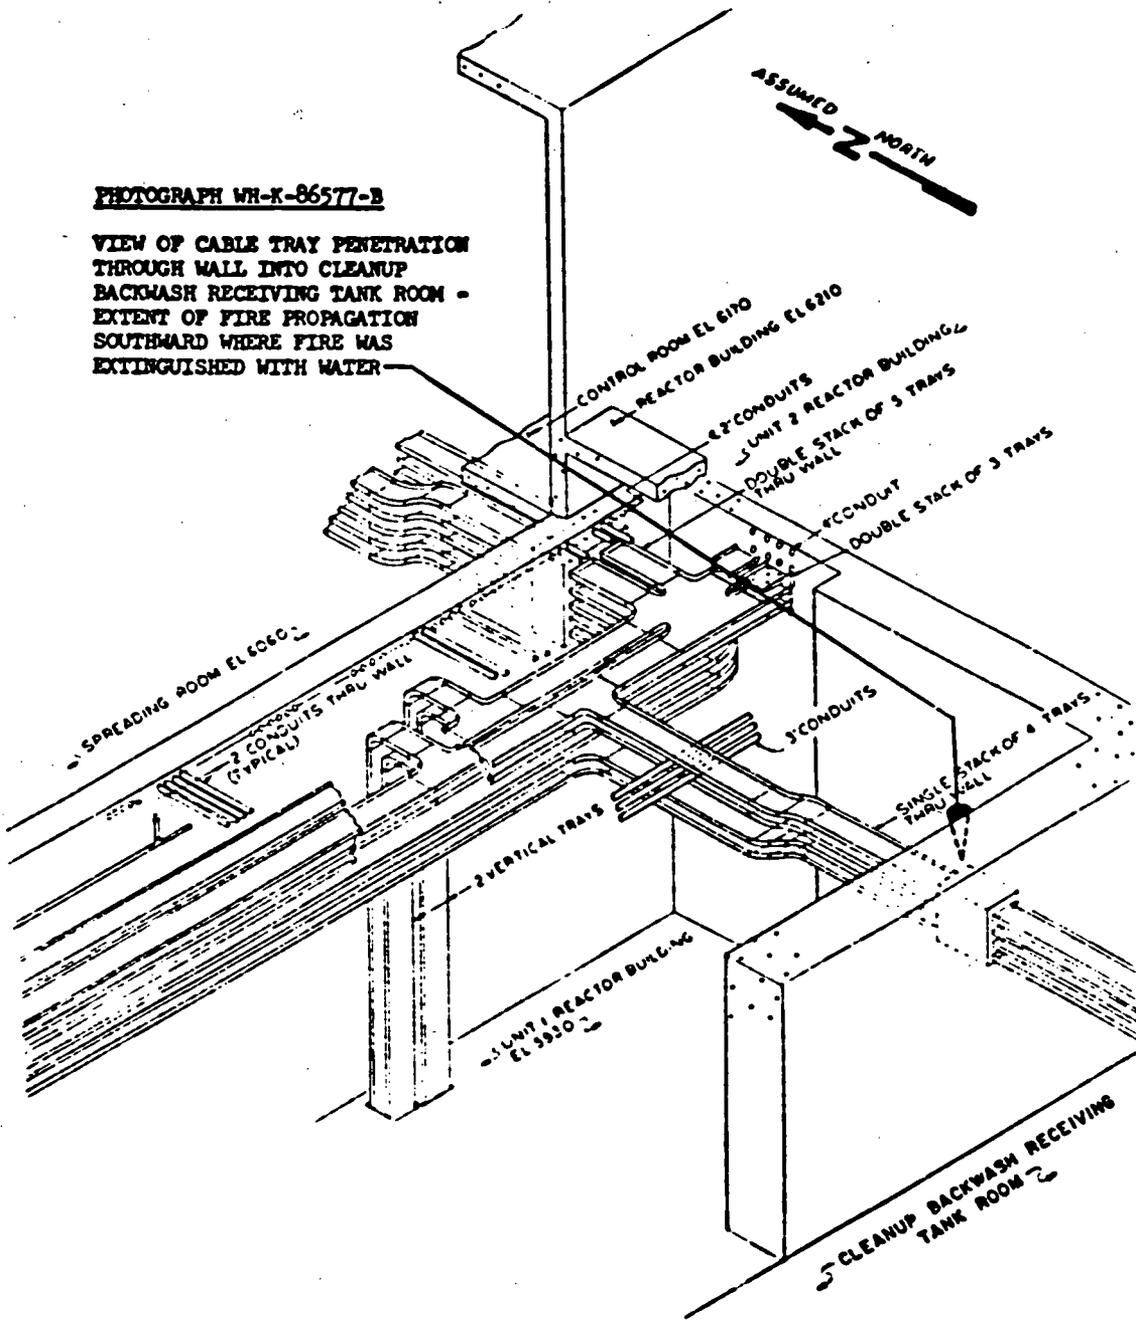
VIEW OF CABLE TRAY PENETRATION THROUGH WALL INTO CLEANUP BACKWASH RECEIVING TANK ROOM - EXTENT OF FIRE PROPAGATION SOUTHWARD WHERE FIRE WAS EXTINGUISHED WITH WATER

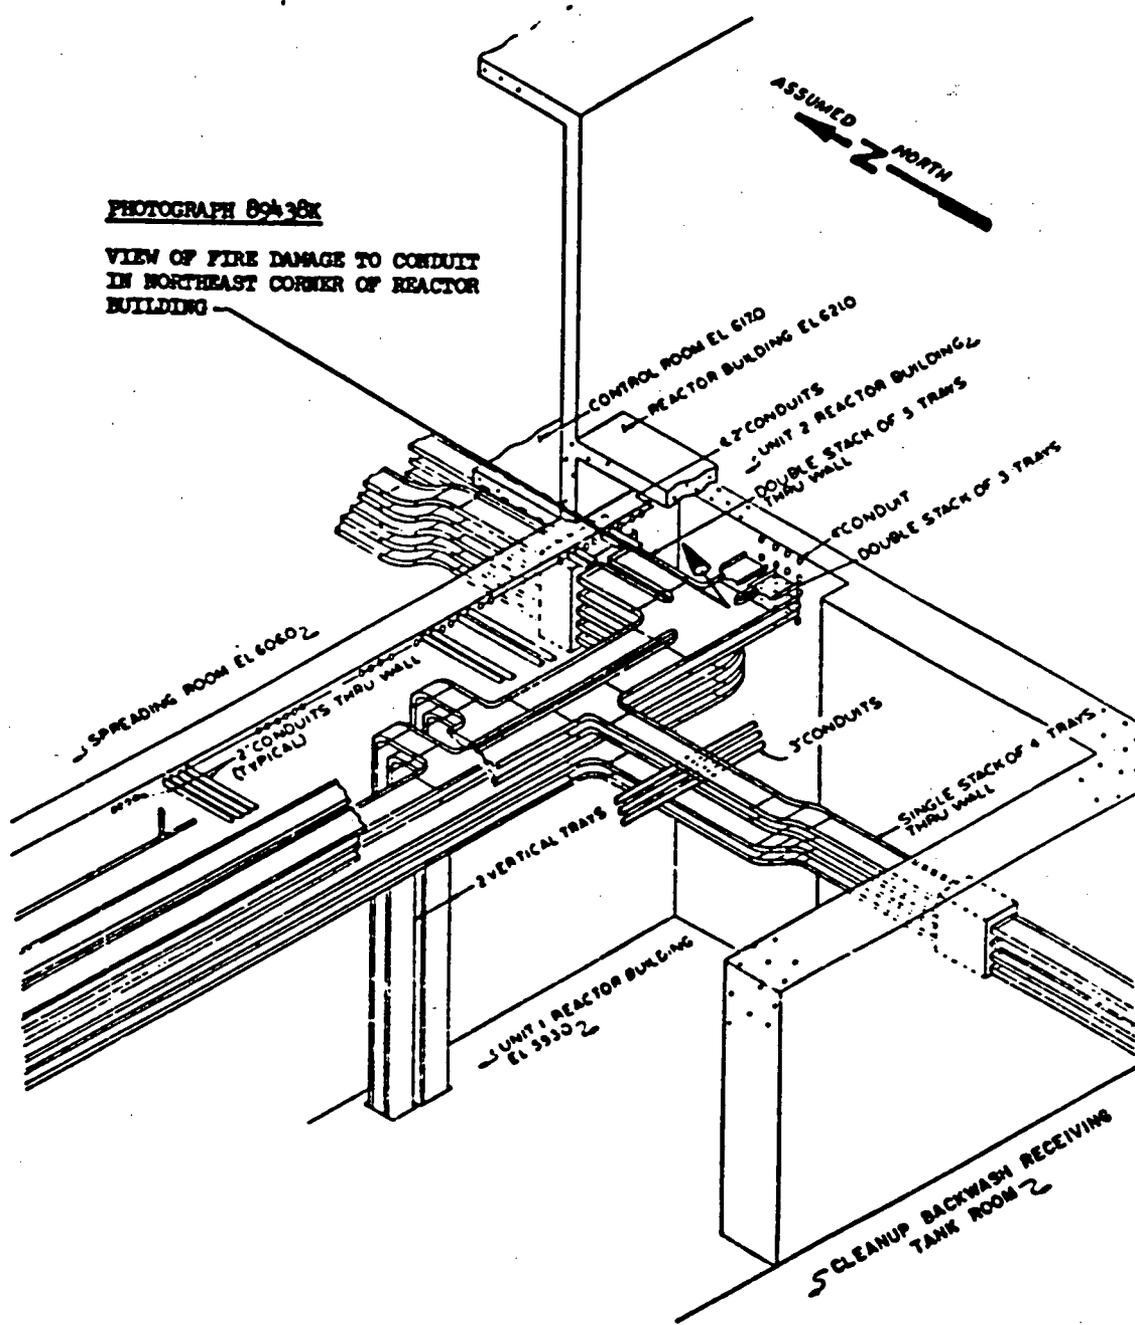
PHOTOGRAPH 89A38X
VIEW OF FIRE DAMAGE TO CONDUIT
IN NORTHEAST CORNER OF REACTOR
BUILDING
