BROWNS FERRY NUCLEAR PLANT FIRE

HEARINGS

JOINT COMMITTEE ON ATOMIC ENERGY

SEPTEMBER 16, 1975

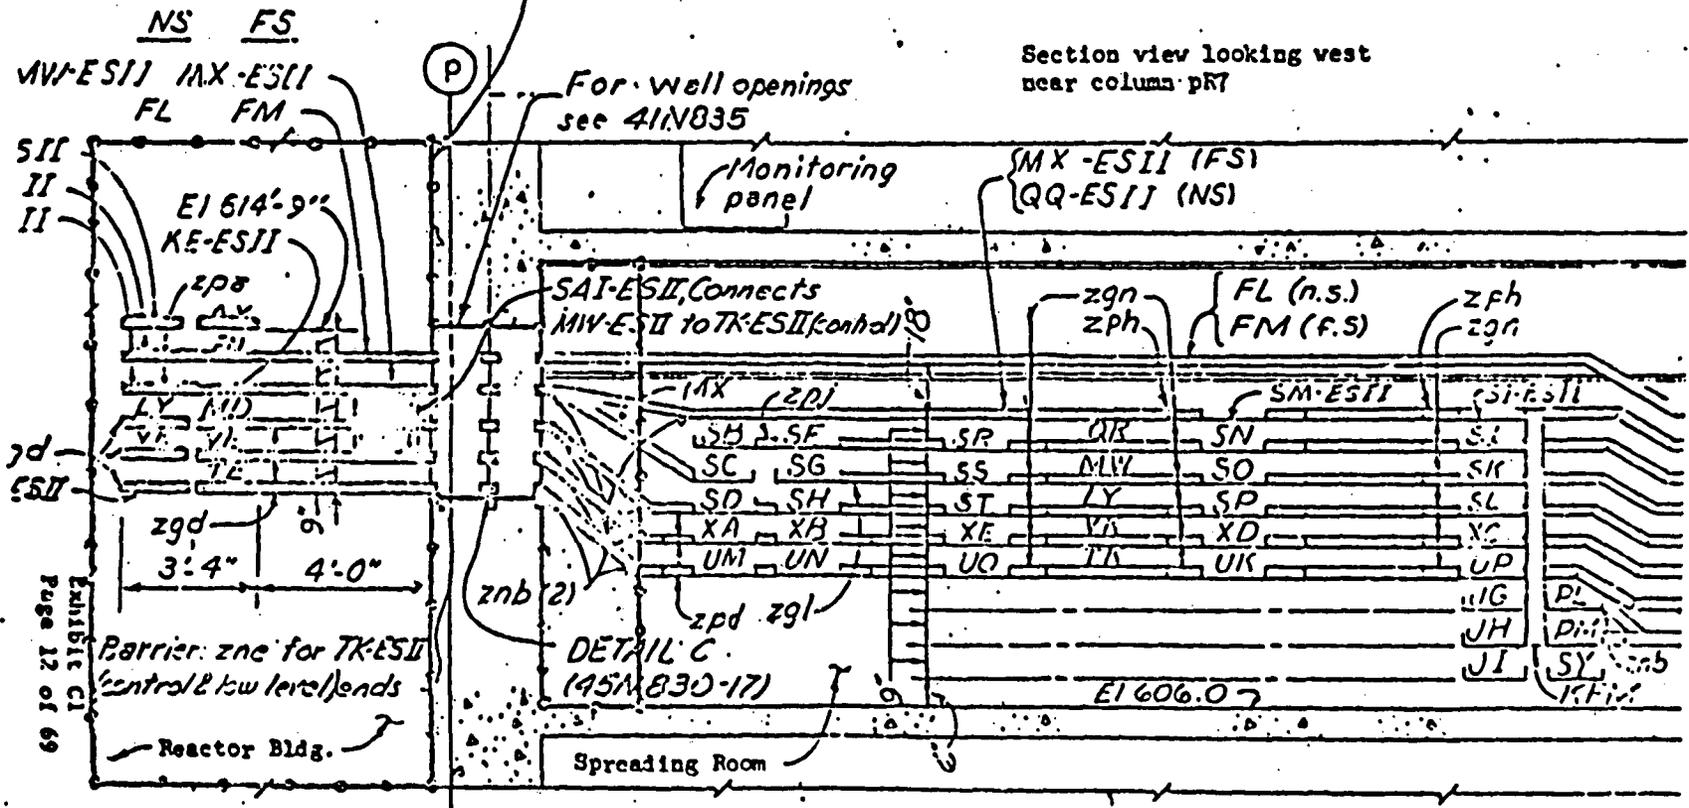
AF - AF

Shaded areas indicate damaged trays

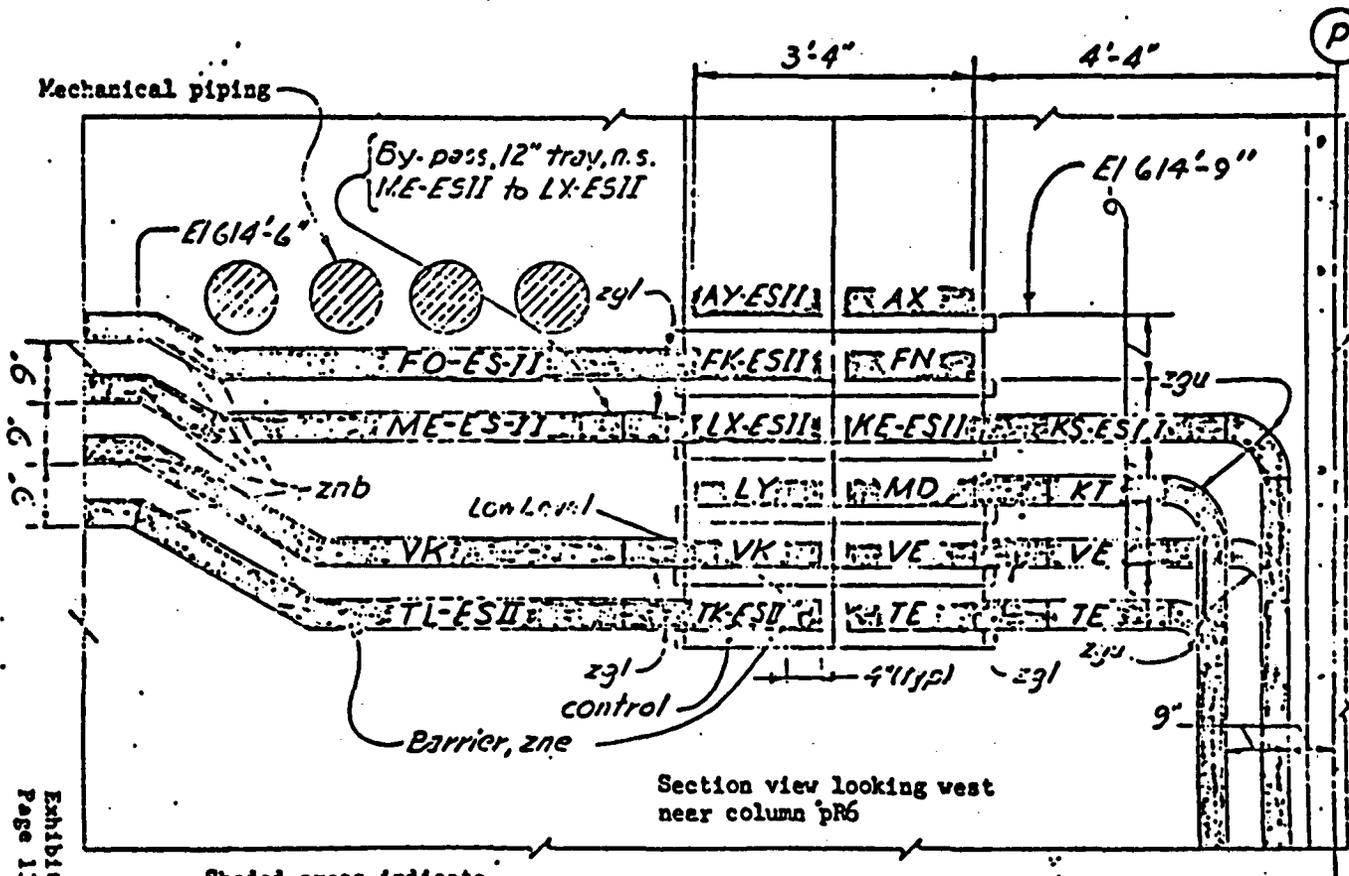
AY-AY
(5N830-6)

Shaded areas indicate
damaged trays

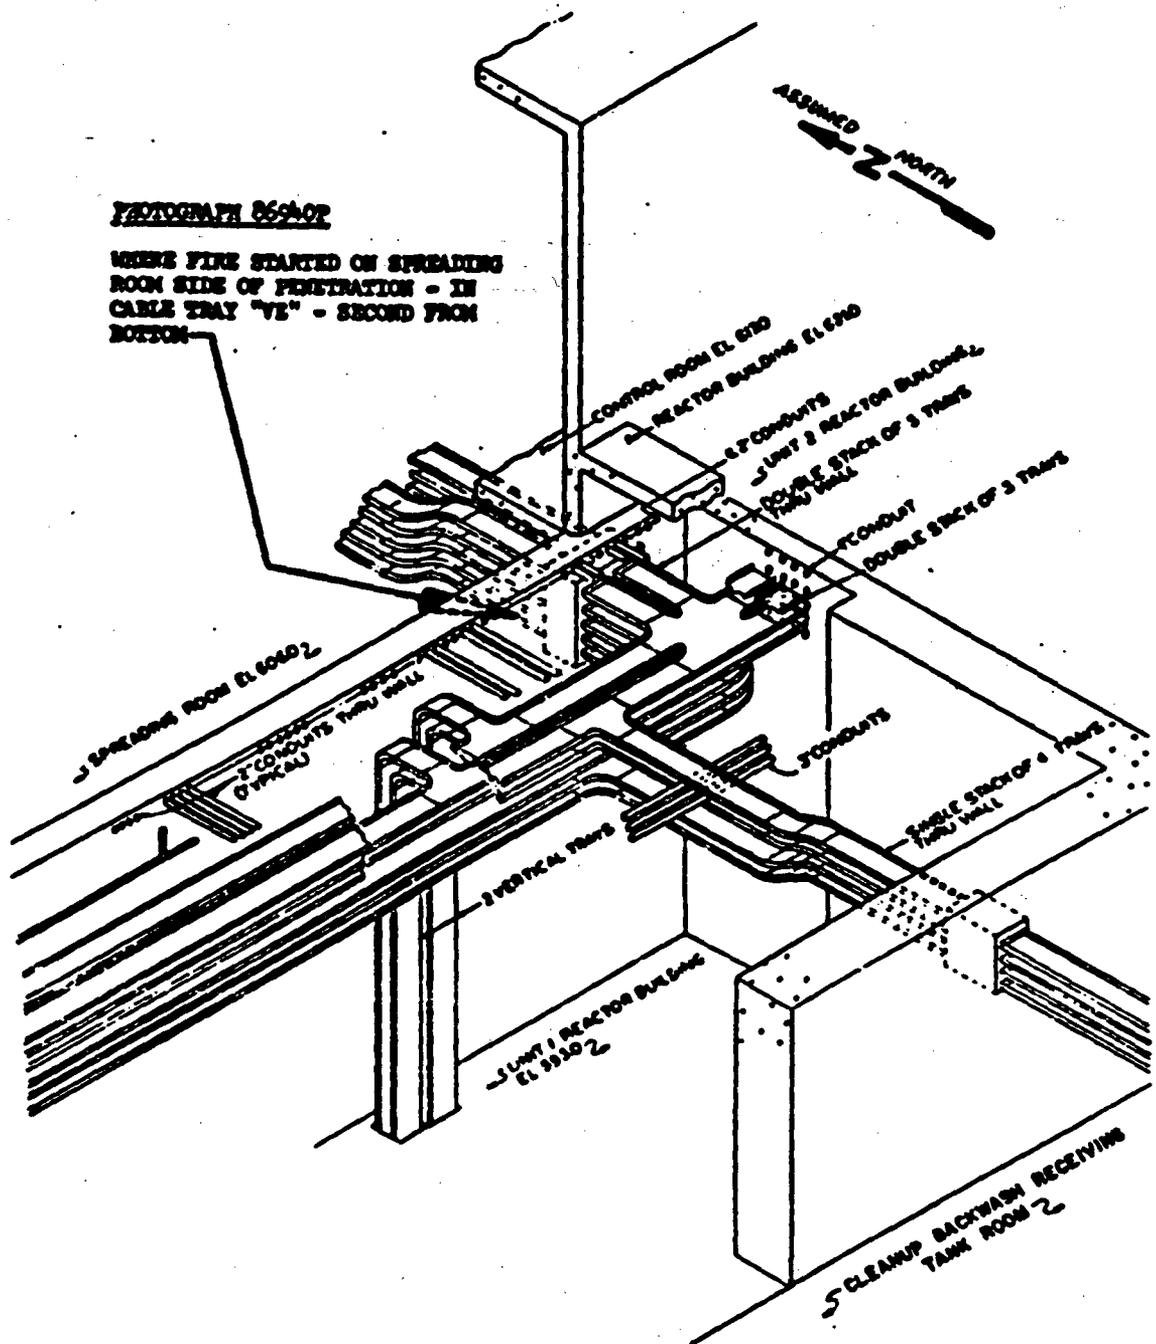
PHOTOGRAPH 8690P

WHERE FIRE STARTED ON SPREADING ROOM SIDE OF PENETRATION - IN CABLE TRAY "VE" - SECOND FROM BOTTOM

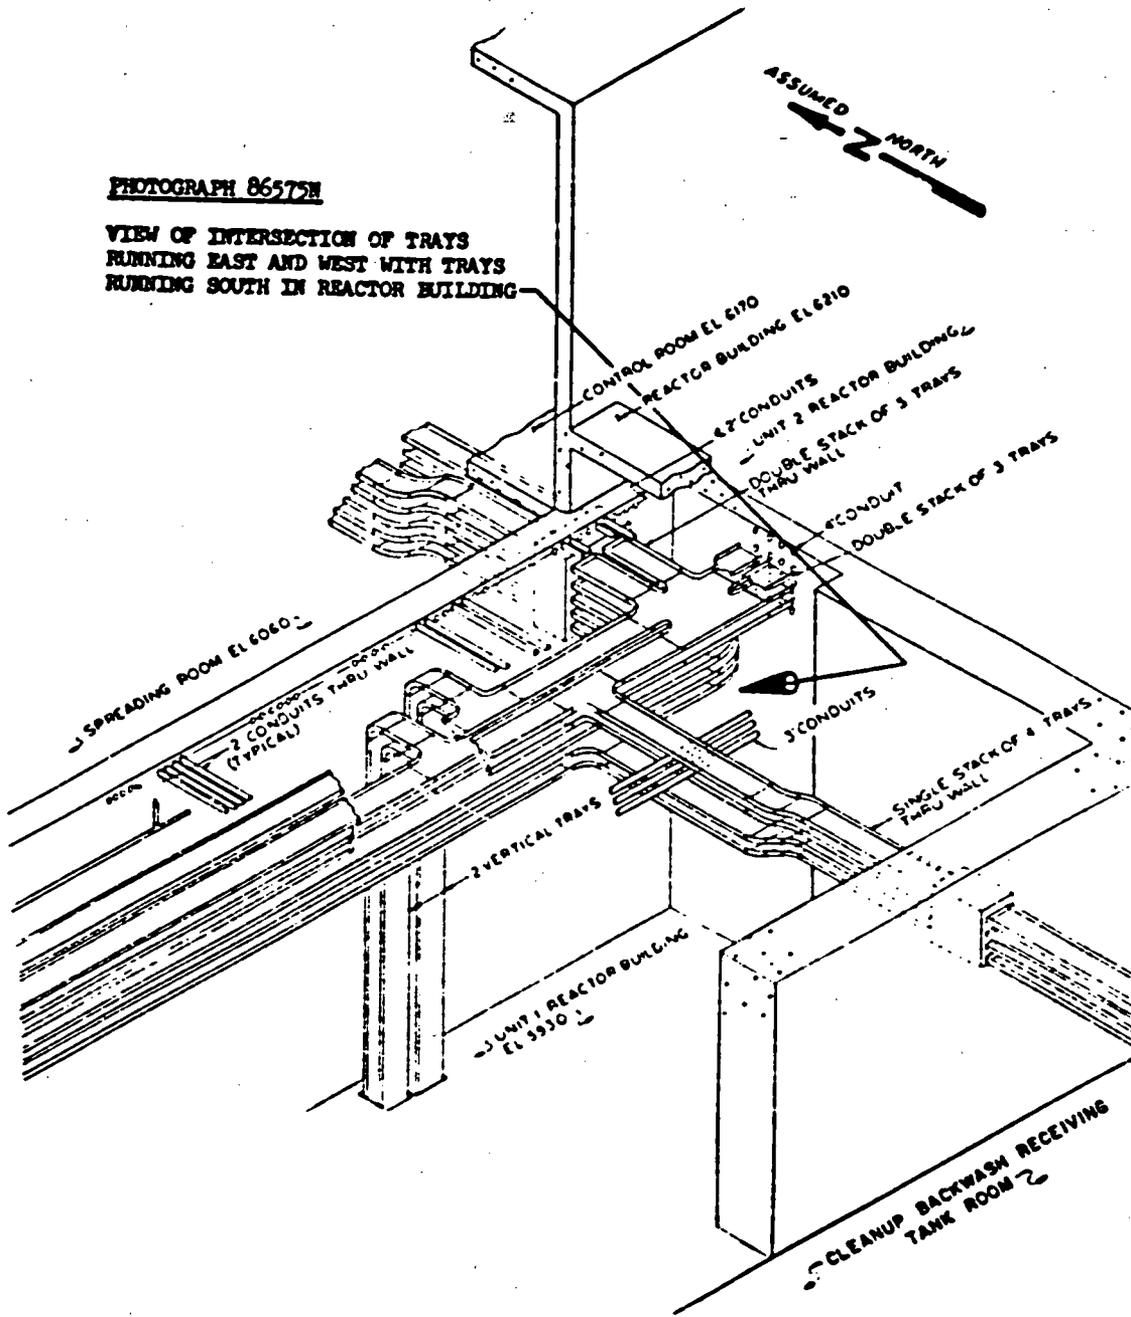
PHOTOGRAPH 86575H

VIEW OF INTERSECTION OF TRAYS
RUNNING EAST AND WEST WITH TRAYS
RUNNING SOUTH IN REACTOR BUILDING

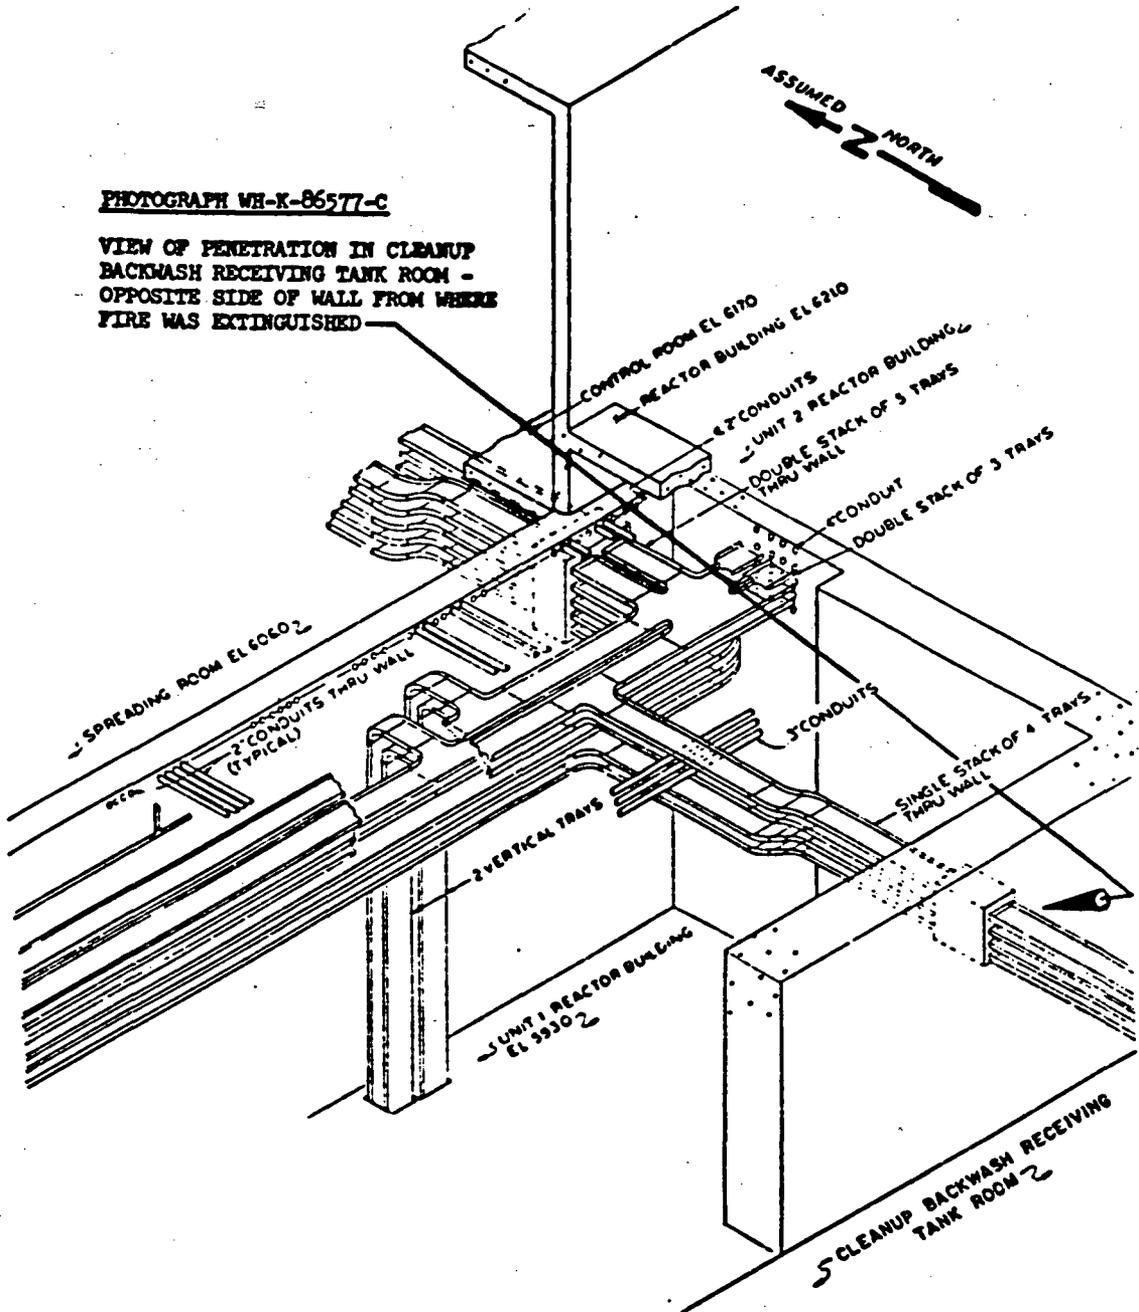
PHOTOGRAPH WH-K-86577-C

VIEW OF PENETRATION IN CLEANUP
BACKWASH RECEIVING TANK ROOM -
OPPOSITE SIDE OF WALL FROM WHERE
FIRE WAS EXTINGUISHED

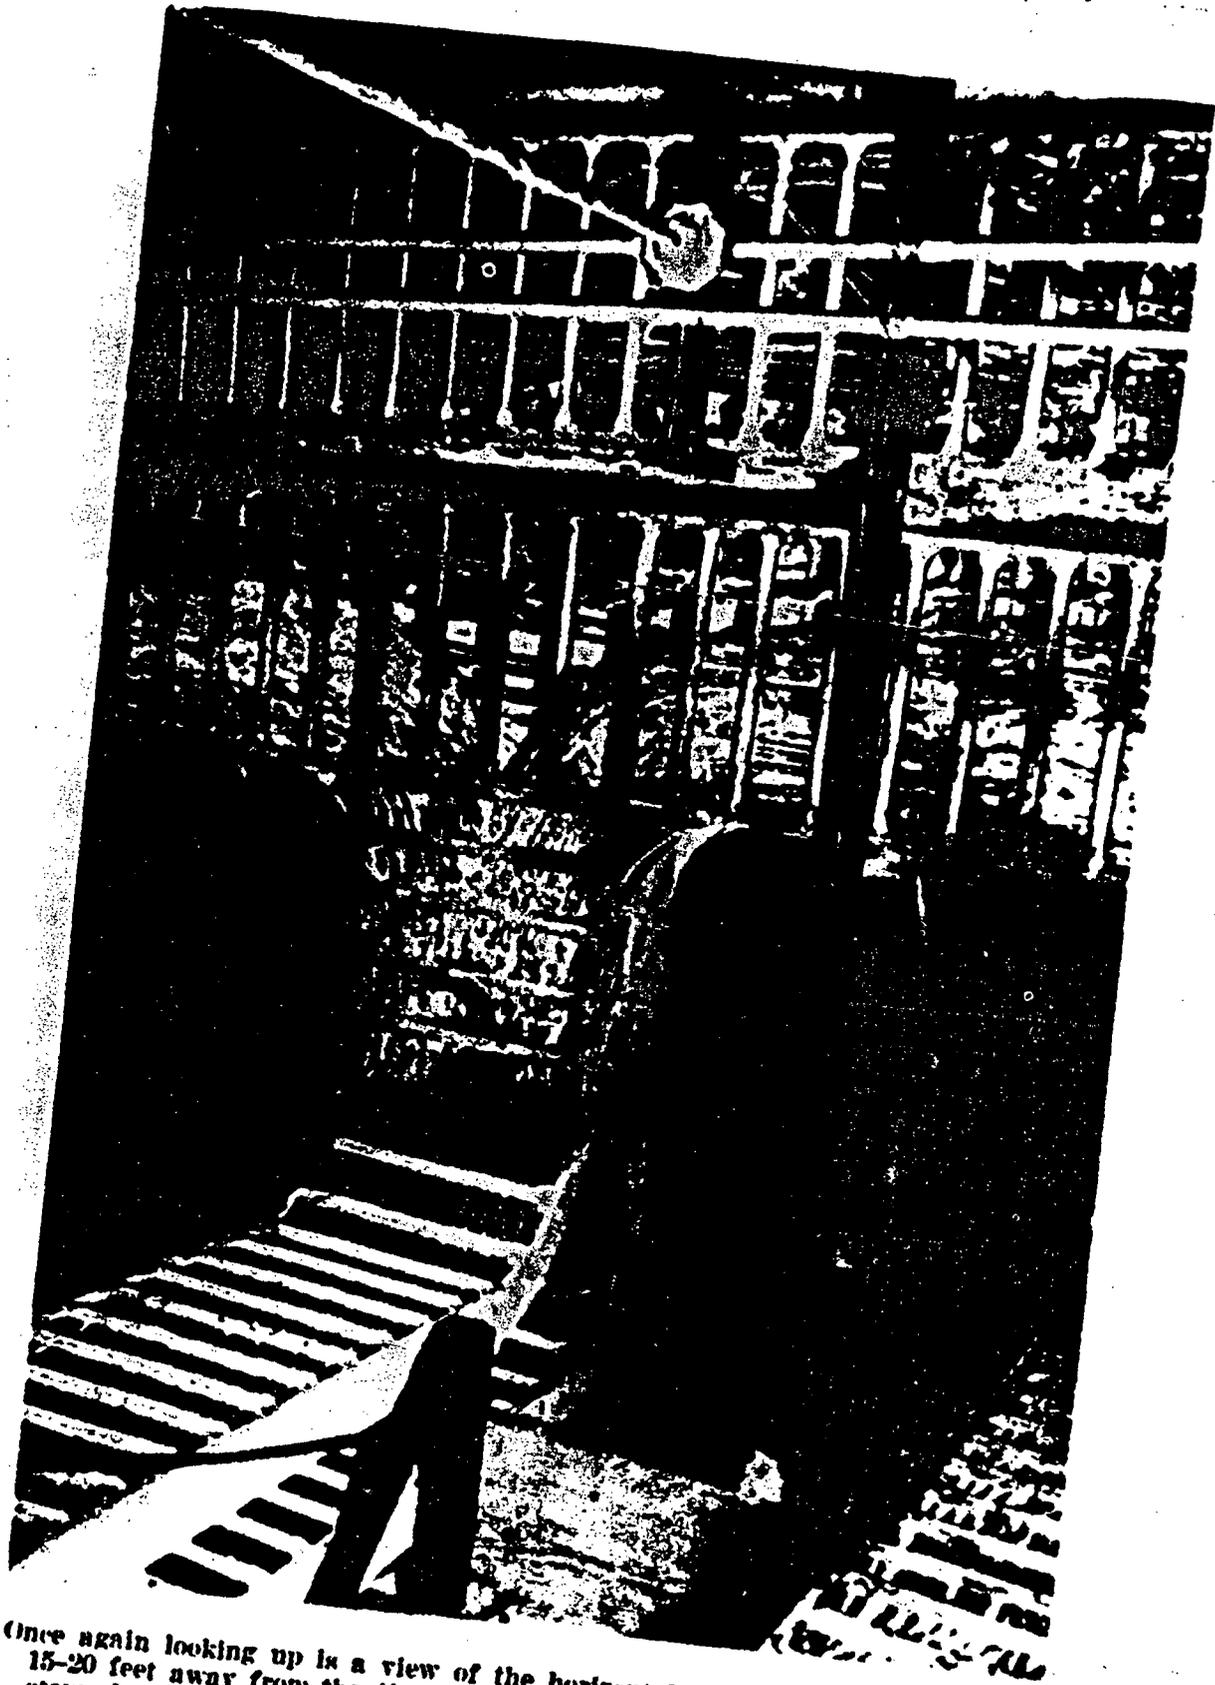
Once again looking up is a view of the horizontal cable trays approximately 15-20 feet away from the 4' x 4' cable tray penetration. Note where the fire stopped in the vertical trays in the center of this photo whereas in the top right corner tray, the fire continued downward 7-8 feet.

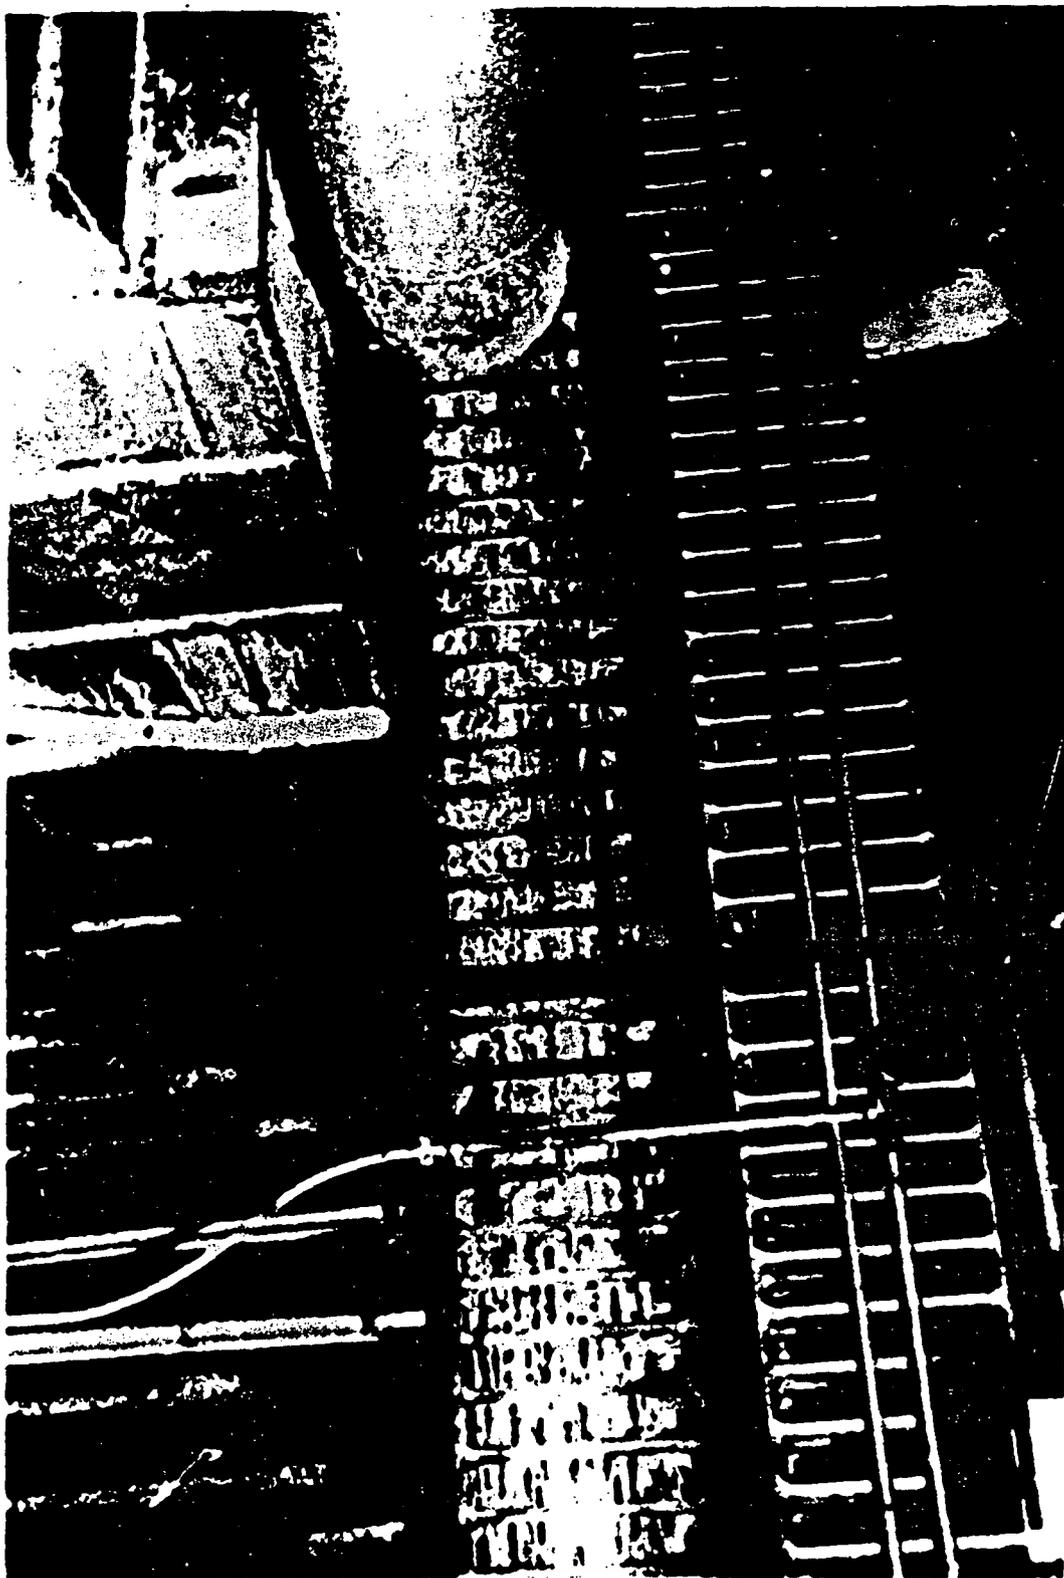
This photo illustrates how far the cable fire spread (35-40') in the direction parallel to the Reactor Building-Cable Spreading Room wall. Note the damage to the cable in the adjacent cable tray (upper), the dry chemical powders in the bottom tray, the acid markings on the conduit and the carbon deposits on the ceiling.

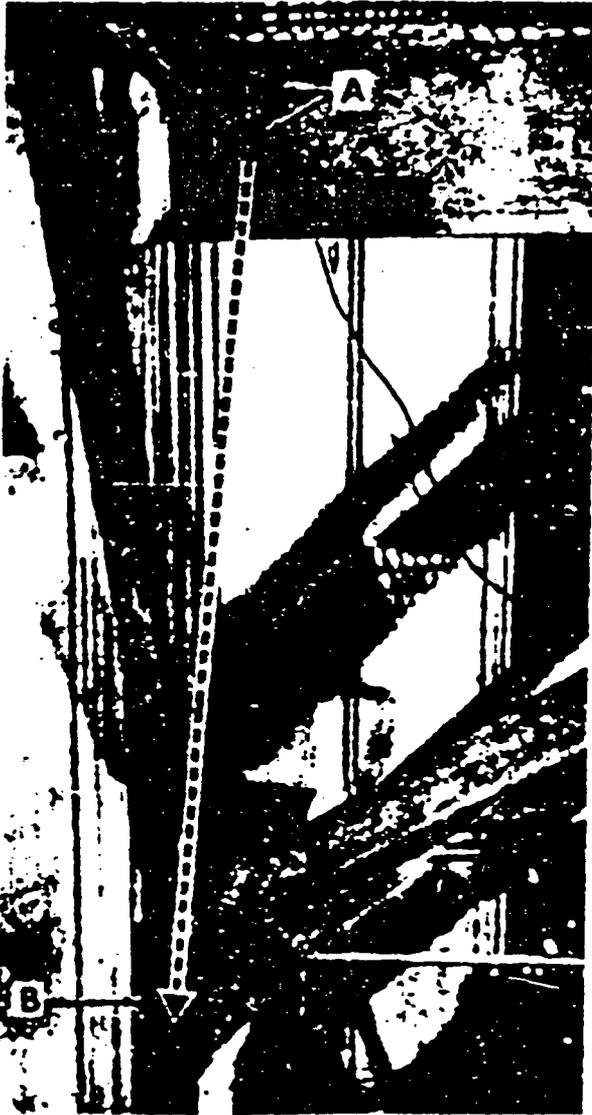
- Illustration 1 -

Location "A" indicates the position of the two one-inch carbon steel bolts which were burned off the support walkway.

Location "B" indicates the point of penetration into the tower.
