Nebraska Public Power District

Subject: Revised Root Cause Investigation – Diesel Generator Amphenol Connector
Cooper Nuclear Station, Docket No. 50-298, DPR-46

Root Cause Investigation (Rev. 1)
Unexpected DG-2 Shutdown
CR-CNS-2008-00304
Dated 7/11/2008

UNEXPECTED DG-2 SHUTDOWN CR-CNS-2008-00304

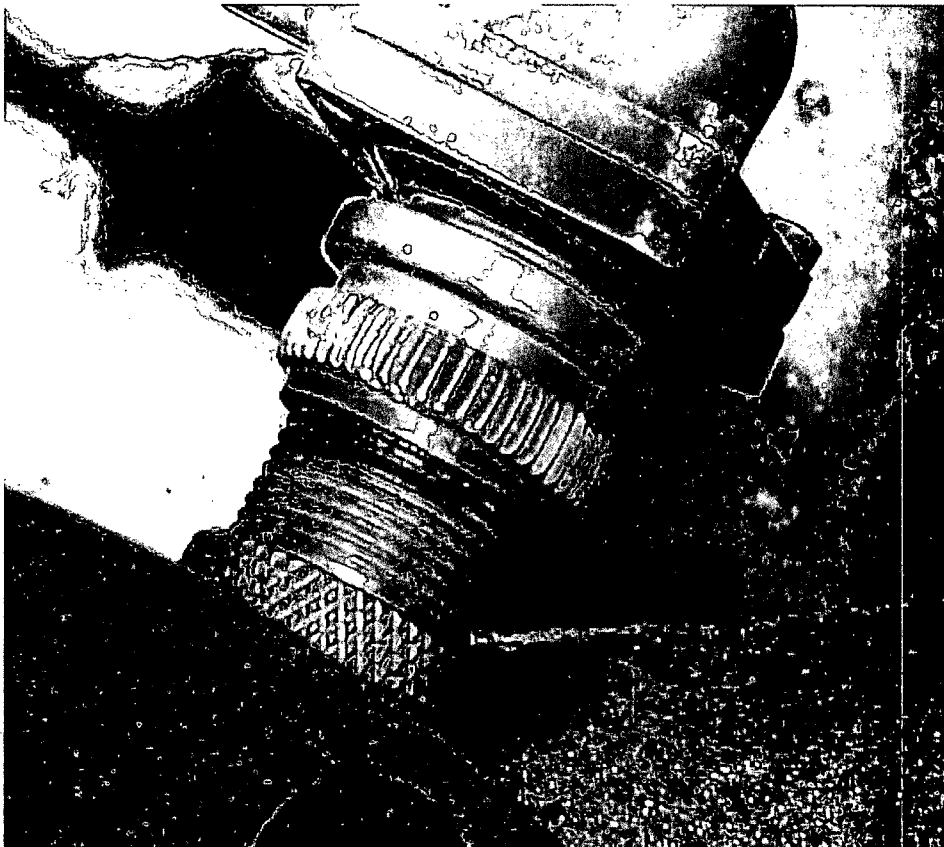
- The coupling nut was observed to be engaged $\sim\frac{1}{4}$ turn (compared to an additional ~ 5 turns to full engagement/tight). Note that there were differing recollections of the as-found connector ring engagement from the technicians that were present. No measurement was taken.
- The connection was felt to be loose when manually manipulated
- Resistance measurements showed instability when the connector was moved

The loose relay tachometer speed sensor connection is deemed to be the failure mode that resulted in the unexpected DG2 shutdown based on the following:

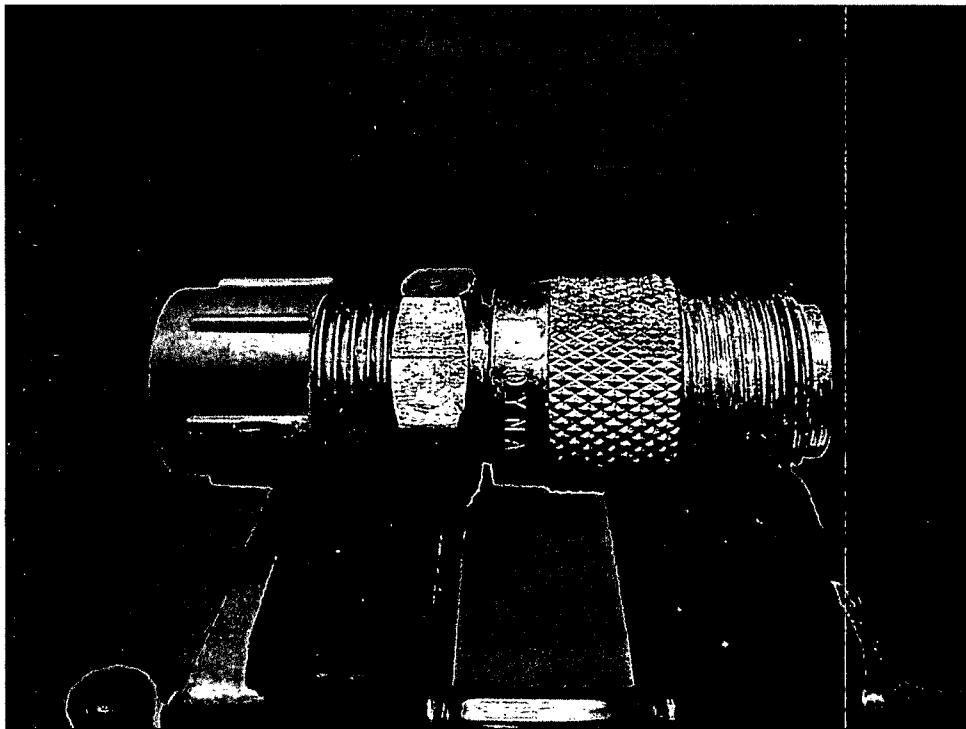
Figure 1. M101 MPU Removed from DG #2

A visual inspection of the connector threads of the relay tachometer MPU removed from DG #2 was performed. The threads showed no noticeable signs of damage or significant wear. The threads were coated with a black material presumed to be Loctite which was wiped off prior to inspection. Figures 1 and 2 below show the M101 MPU and a close up of the connector threads.

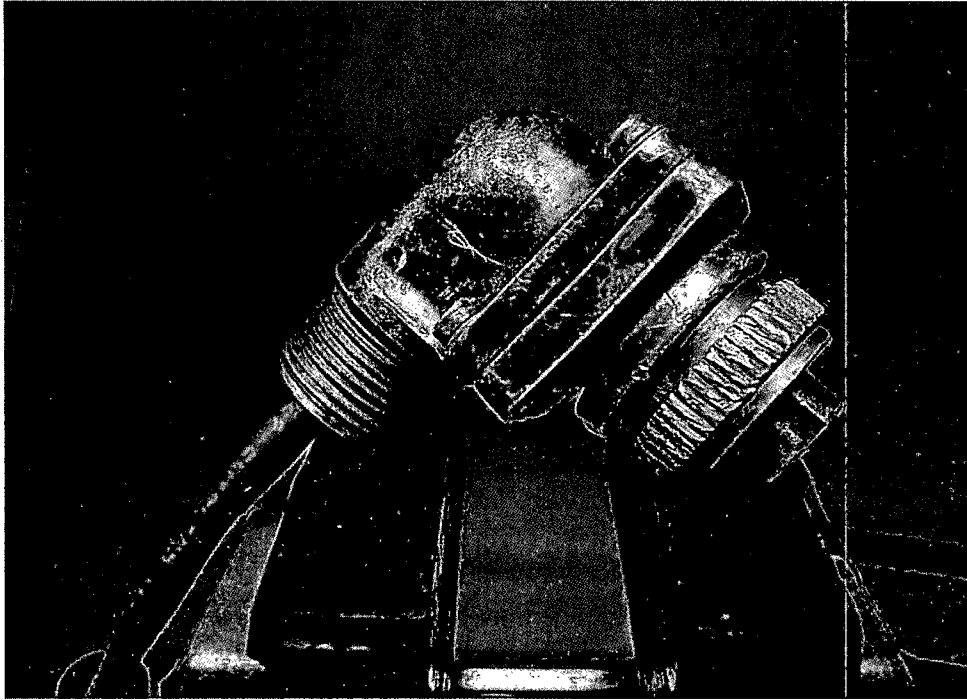
Figure 3. MS 3108A-10SL-4S Connector Removed from DG #2 (A cable was attached prior to taking this picture)

A visual inspection of the MS 3108A-10SL-4S connector removed from DG #2 was performed. The exterior of the connector shows obvious tool marks on the connector collar as well as other scratches. Some signs of wear are also evident on the socket sleeve which attaches to the MPU. None of the damage appeared significant enough to affect the electrical function of the connector. However, the signs of wear on the socket could contribute to making the connector attach less tightly to the MPU. The connector was plugged in and removed from the M101 MPU several times to gauge the tightness of this connection and it was found to be rather tight. That is to say, it seems very unlikely that the connector would fall off the MPU under its own weight. Inspection of the threads in the interior of the connector collar showed no signs of damage of significant wear. Figures 3 and 4 below show close up views of the MS 3108A-10SL-4S connector.

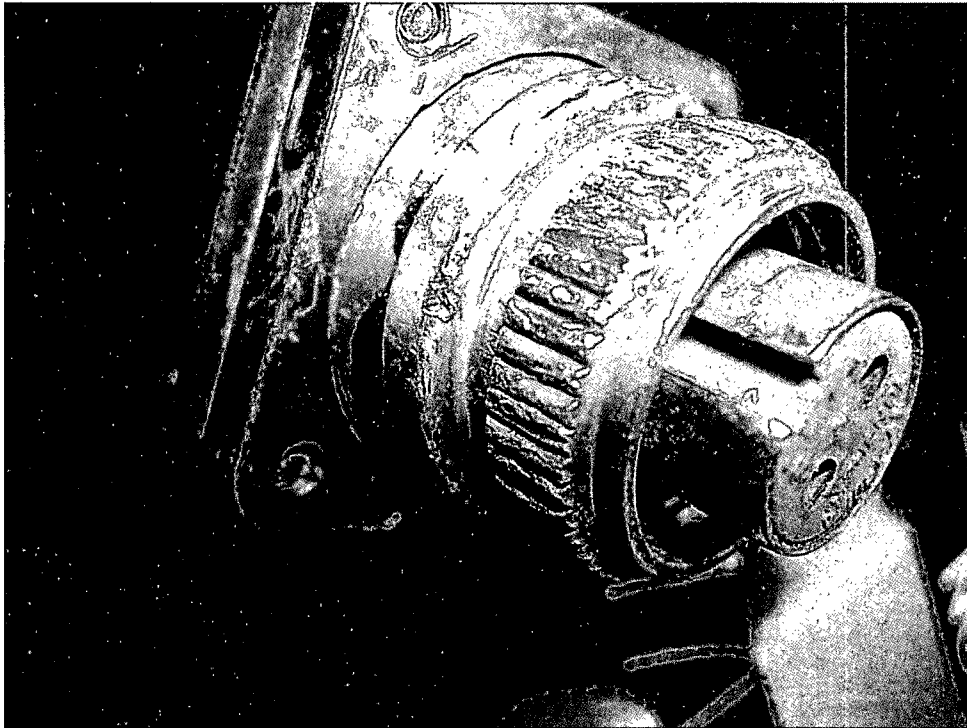
Figure 4. MS 3108A-10SL-4S Connector Removed from DG #2 (Close up of collar and socket showing tool marks and wear)
