WATTS BAR NUCLEAR PLANT UNITS 1 AND 2 - FAULTY ANCHOR PLATES AND BOLTS -
WHD-50-390/81-51, WHD-50-391/81-49 - FIRST INTERIM REPORT

**UNITS BAR NUCLEAR PLANT UNITS 1 AND 2
FAULTY ANCHOR PLATES AND BOLTS
NEDD-50-390/81-51, NEDD-50-391/81-49
10 CFR 50.55(e)
FIRST INTERIM REPORT**

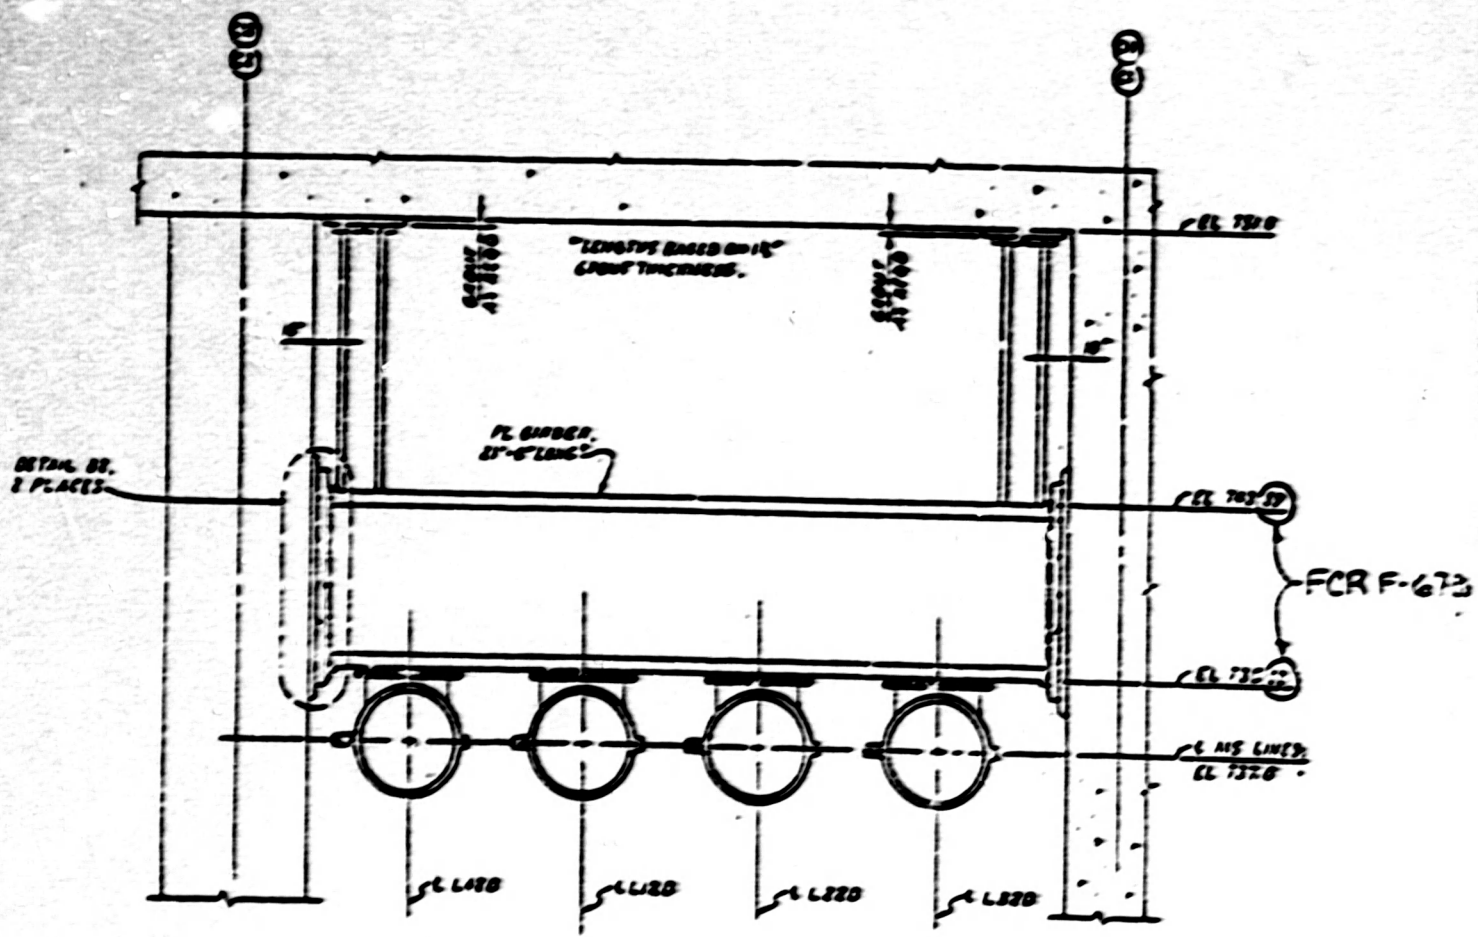
ELEVATION A2-A2
UNIT 1 AS SHOWN
UNIT 2 OPP HAND

The pipe rupture protection structures for main steam lines are shown on the attached drawings. The top part of each wall anchor plate has been bowing away from the walls, and therefore, the top two anchor bolts have been partially pulled out. The exact cause has not been determined, but it probably has to do with the welding sequence during fabrication.
