FIRE AT BROWNS FERRY NUCLEAR PLANT

TENNESSEE VALLEY AUTHORITY

MARCH 22, 1975

PRELIMINARY INVESTIGATING COMMITTEE

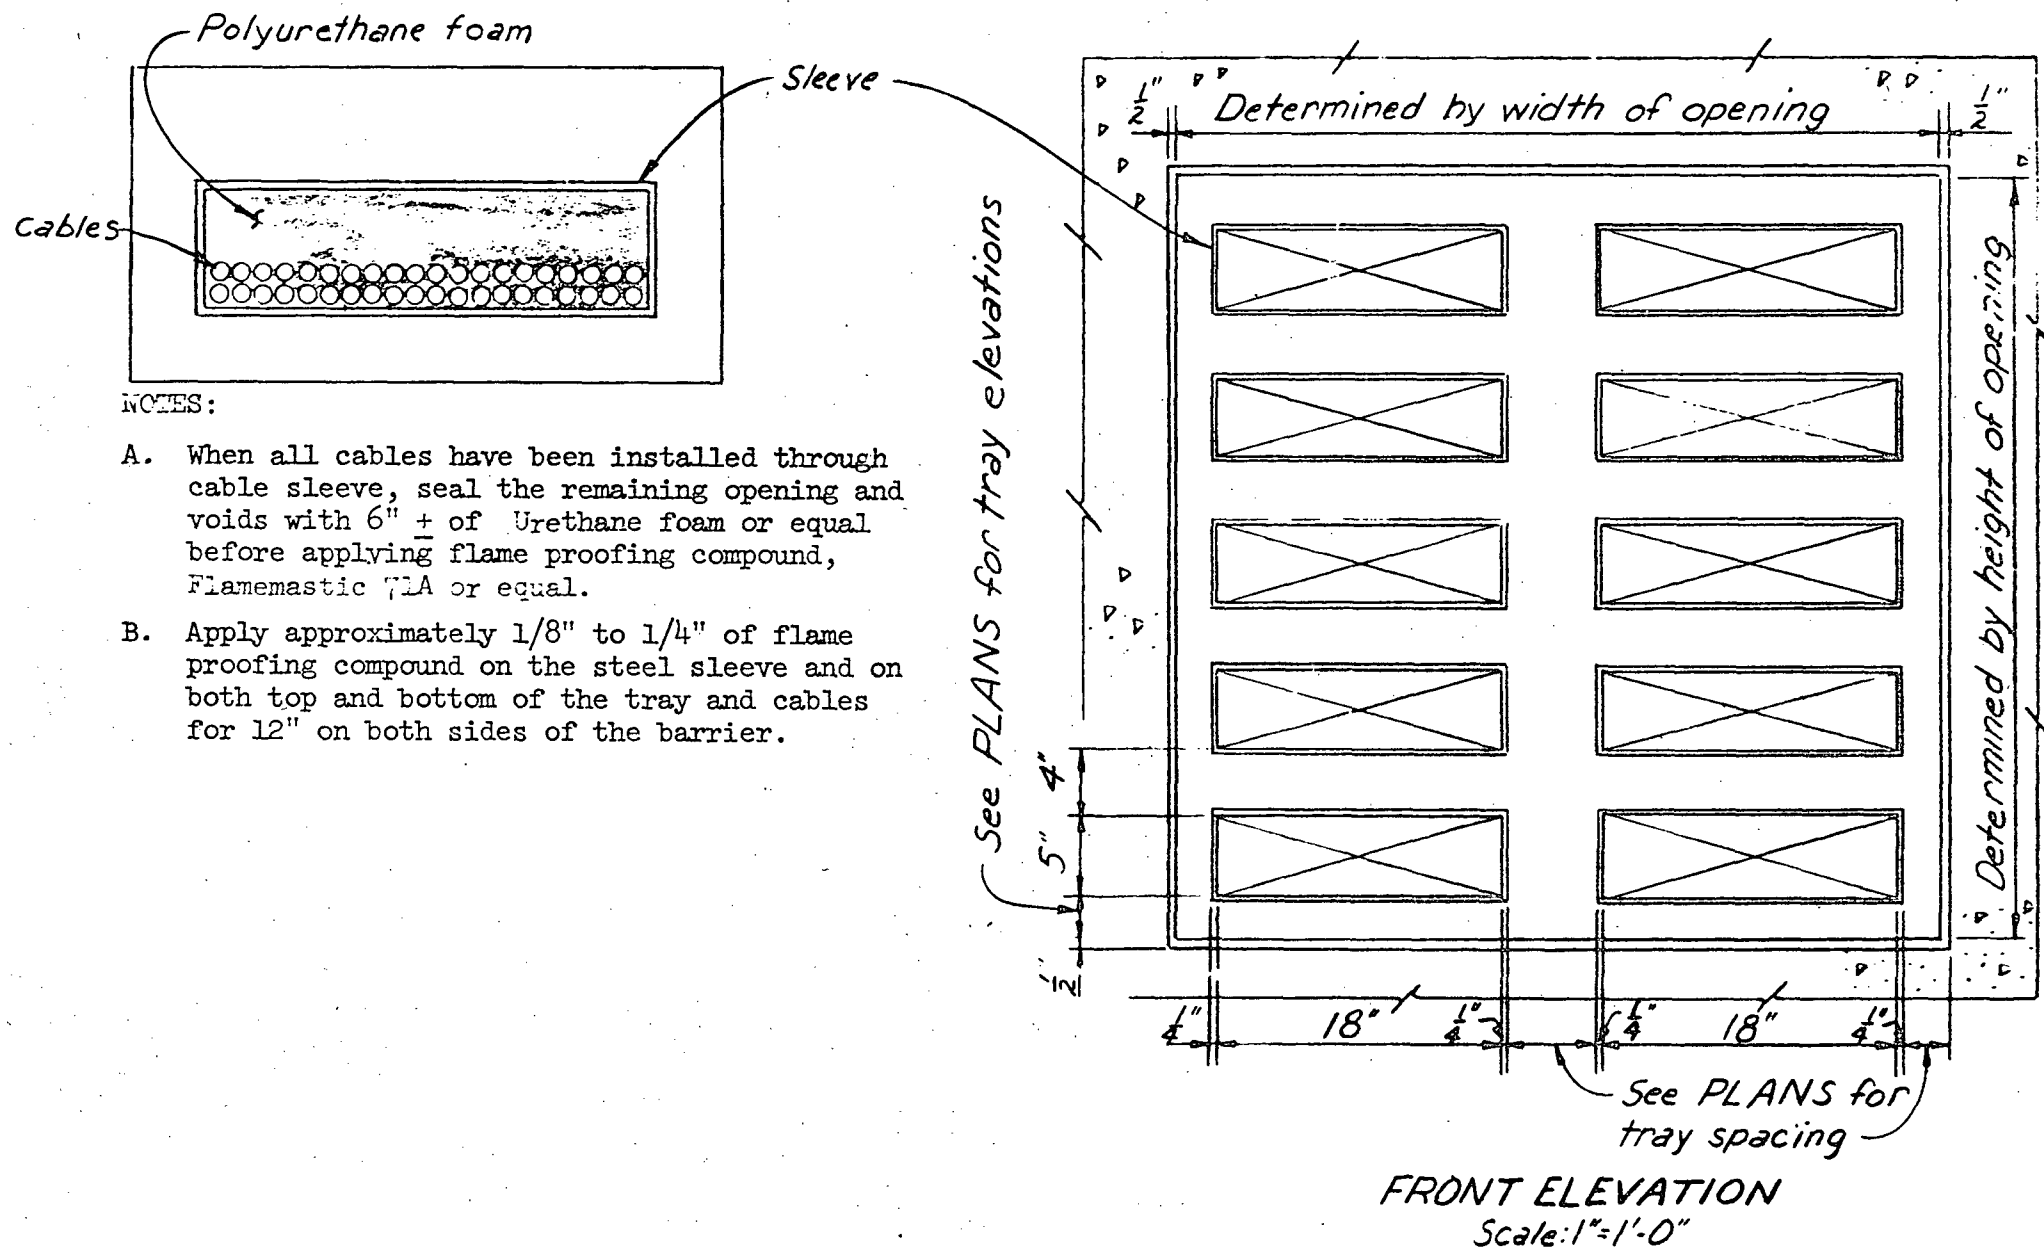
FIGURE 3
TYPICAL WALL PENETRATION

The aide detected a strong air leak in the penetration for the second tray from the bottom on the west row.

The leak was caused when additional cables were pulled through the penetration, which resulted in breaching the originally installed air pressure seal and fire stop.

NOTE: FIRE STARTED IN SECOND
PENETRATION FROM BOTTOM-TRAY VE

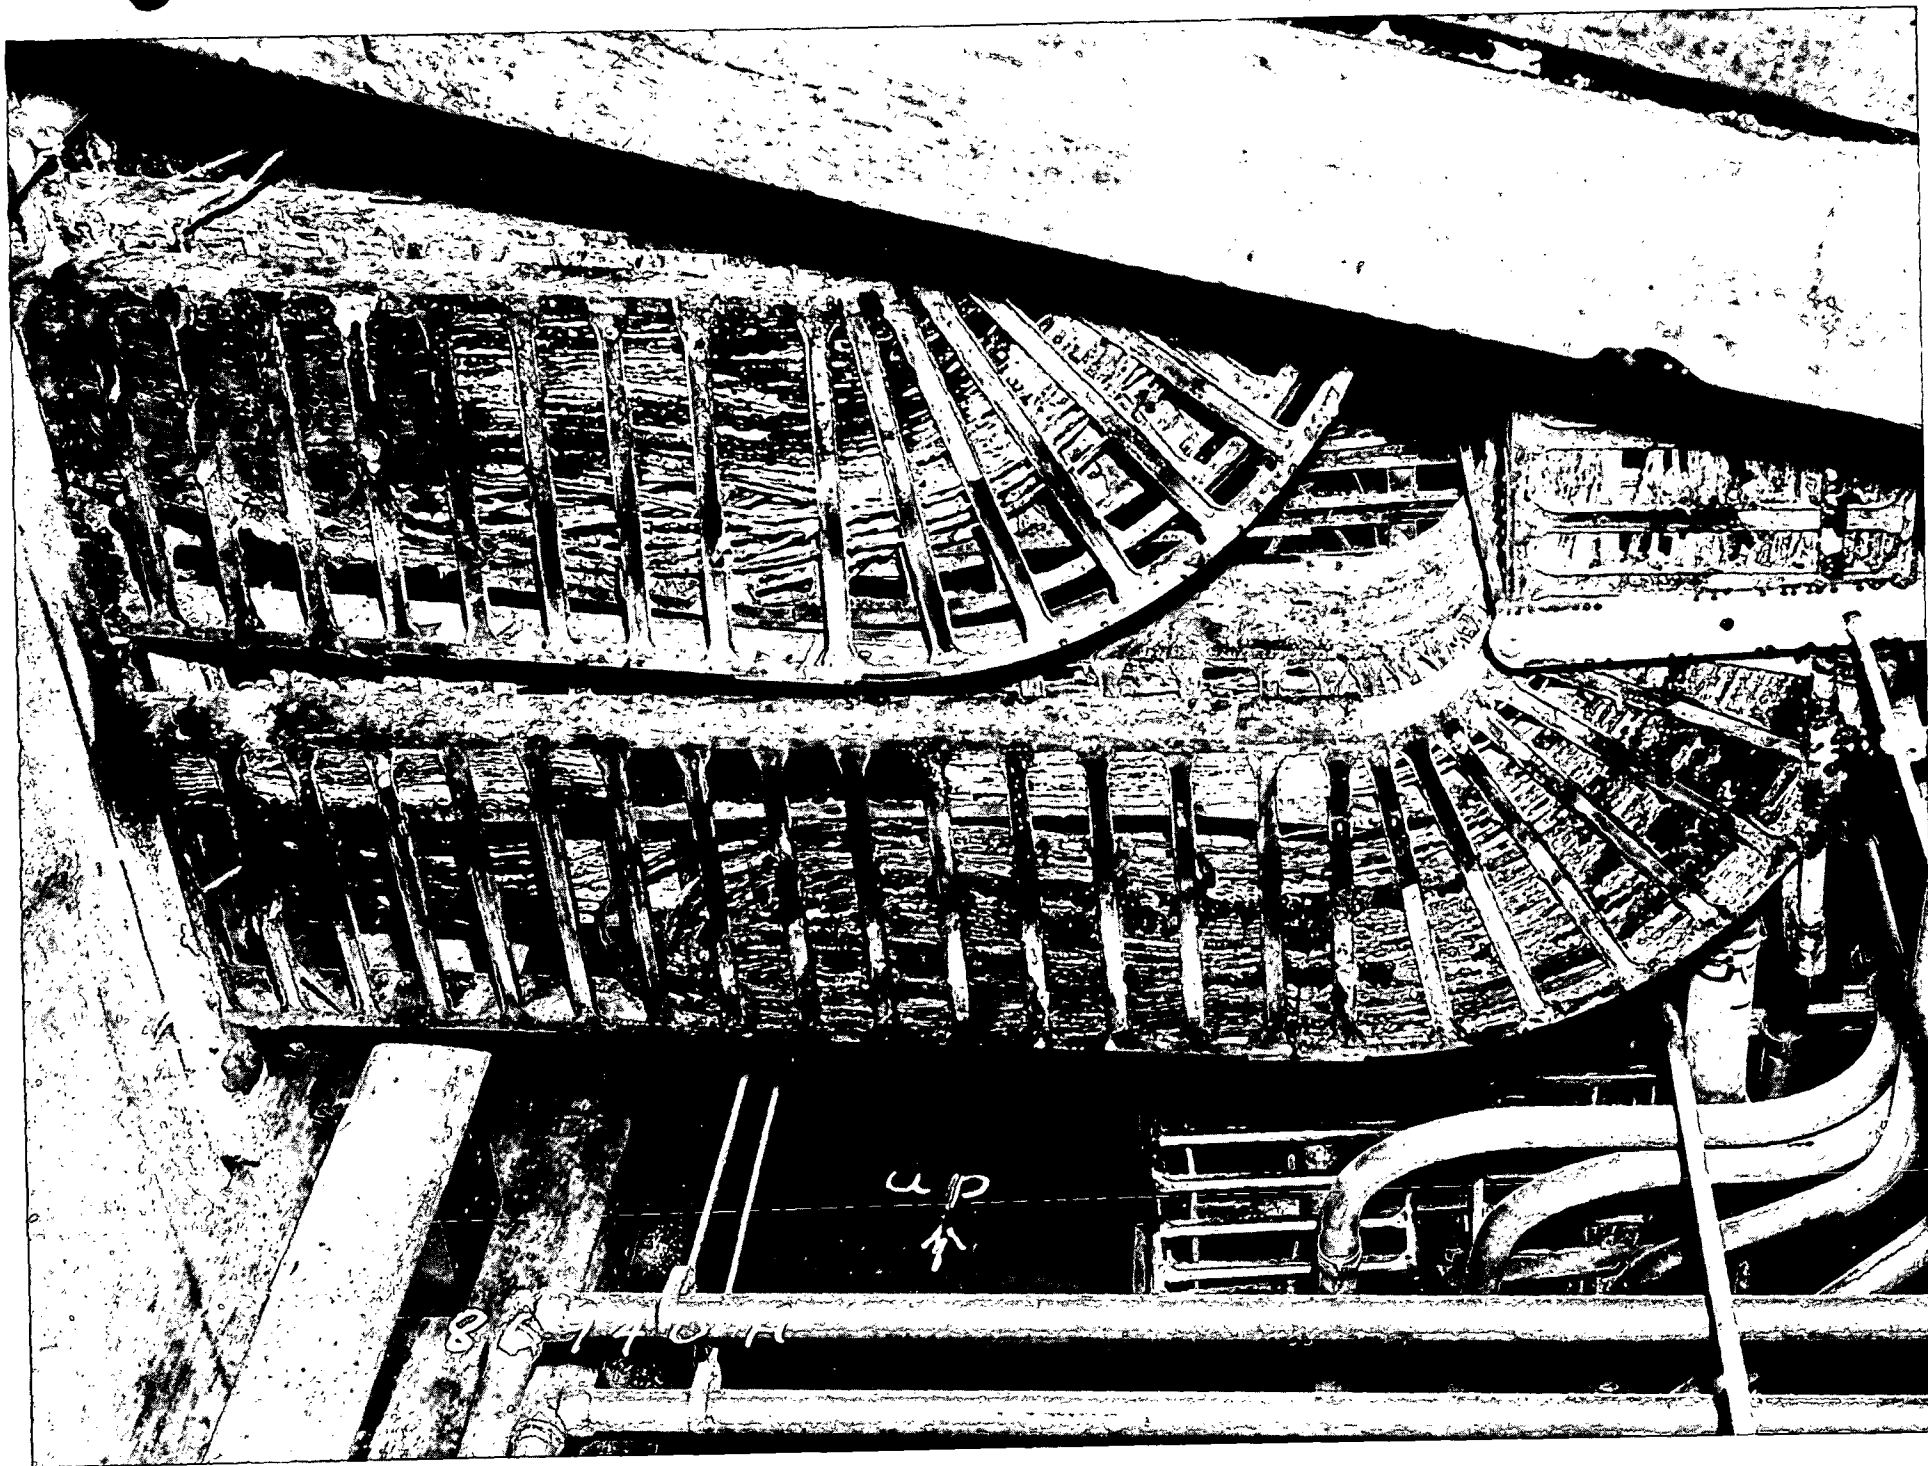
WHERE FIRE BURNED THROUGH
PENETRATION FROM SPREADING ROOM
INTO LOWER CABLE TRAYS IN UNIT 1
REACTOR BUILDING

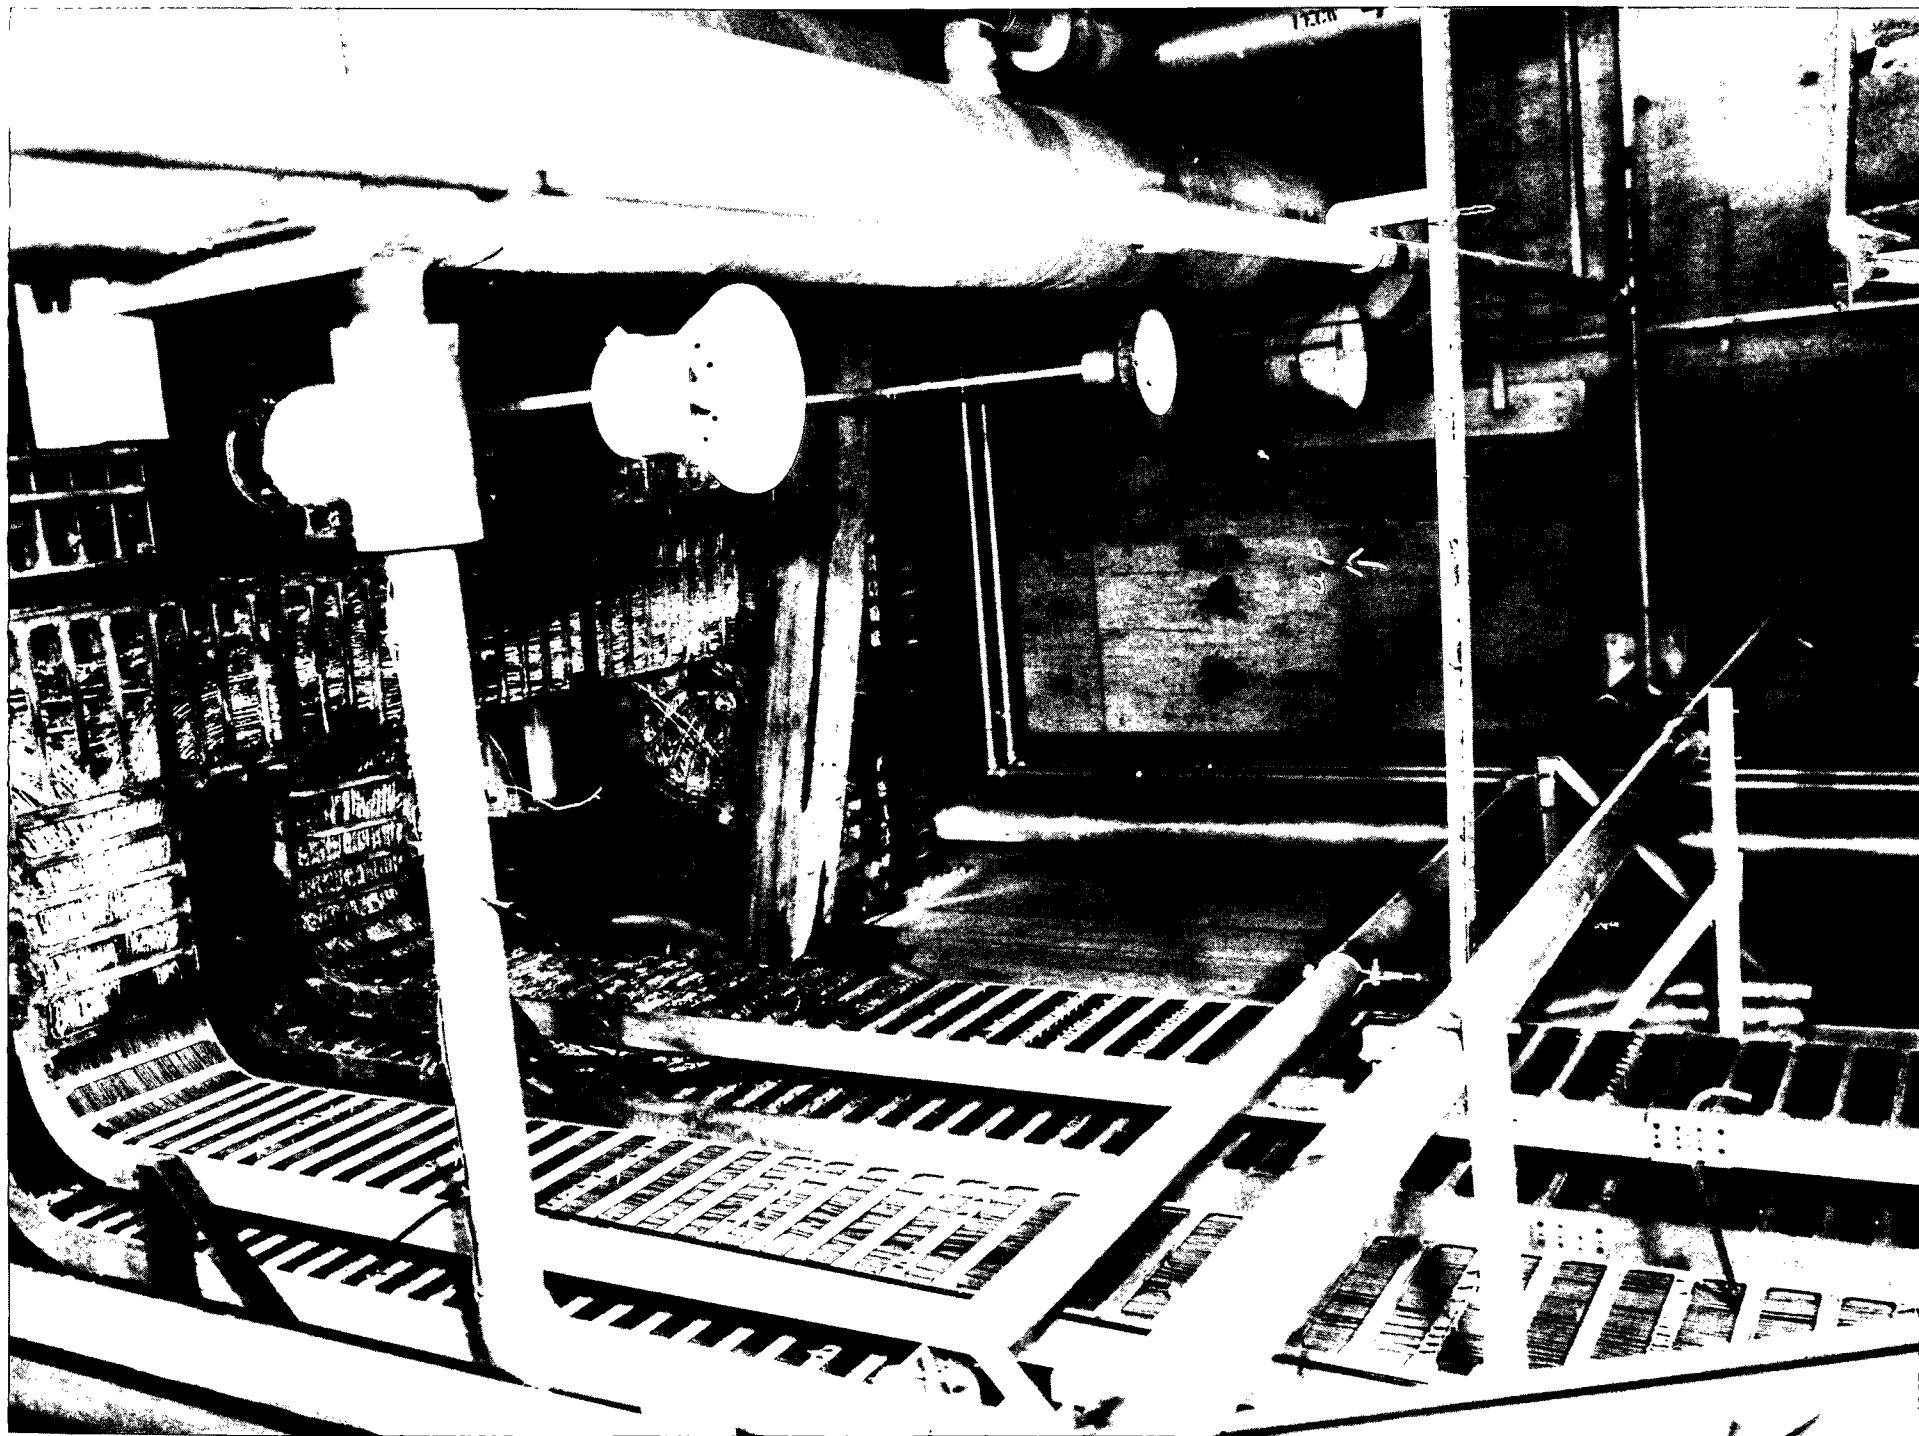
PHOTOGRAPH 67P1991

GENERAL VIEW OF FIRE DAMAGE IN
NORTHEAST CORNER OF REACTOR
BUILDING - SHOWS EXTENT OF FIRE
PROPAGATION DOWNWARD IN VERTICAL
TRAYS

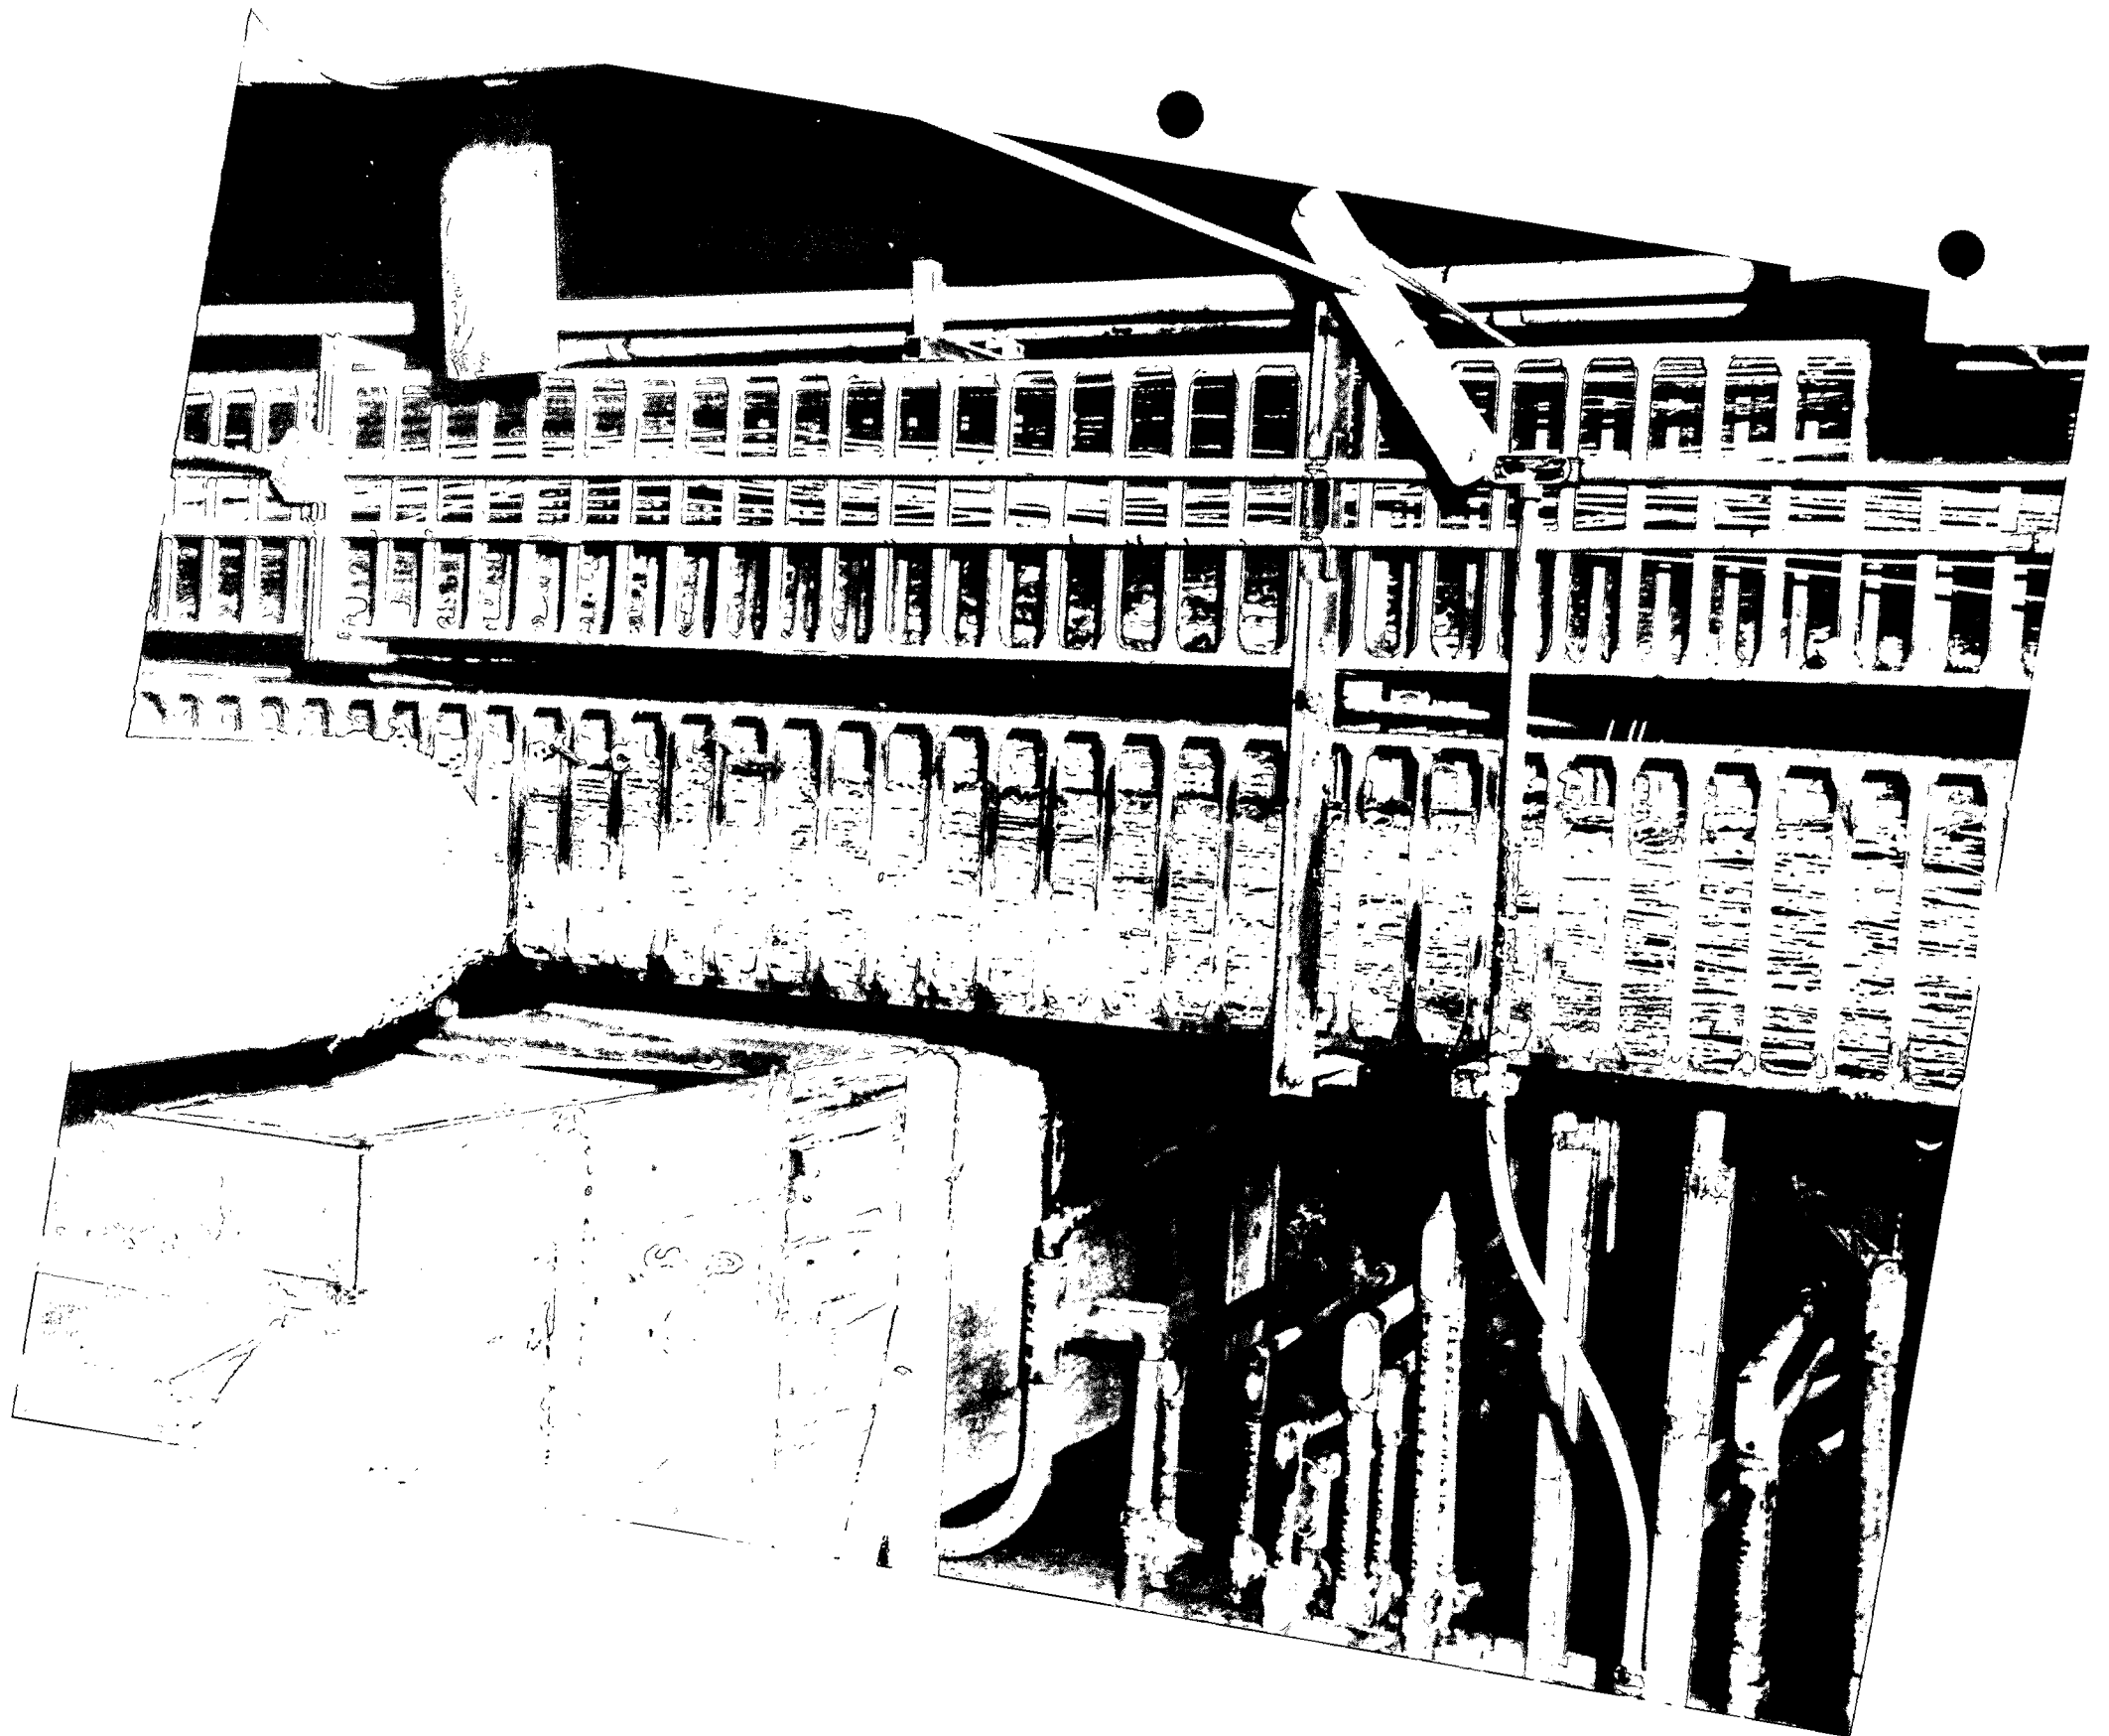
PHOTOGRAPH 86940H

VIEW OF FIRE DAMAGE TO HORIZONTAL
TRAYS IN REACTOR BUILDING ALONG
NORTH WALL - SHOWS APPROXIMATE
EXTENT OF FIRE PROPAGATION
WESTWARD

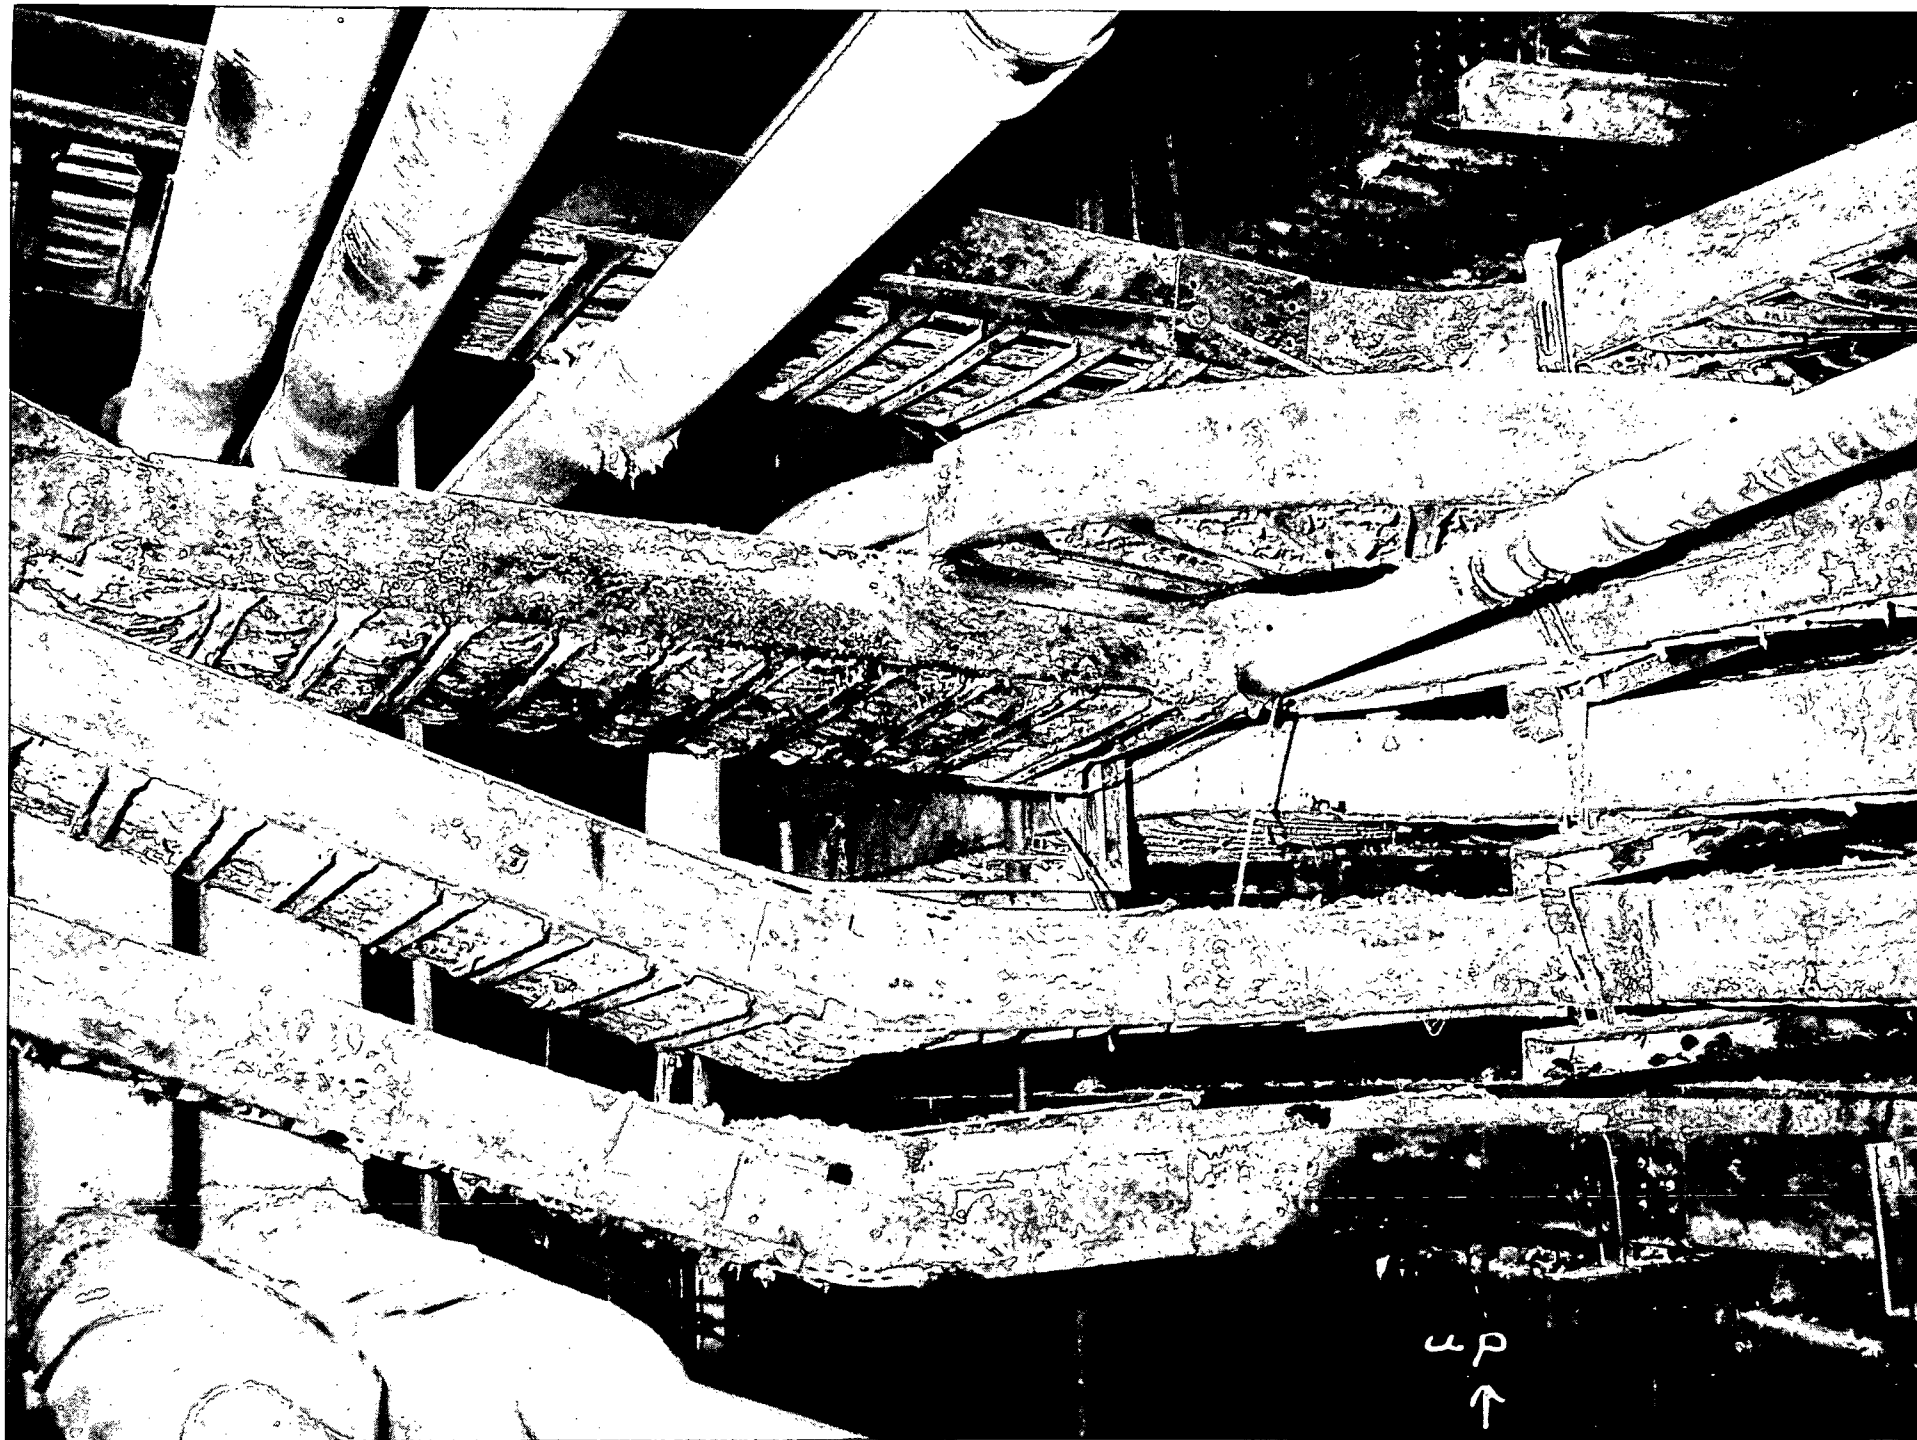
PHOTOGRAPH 86575N

VIEW OF INTERSECTION OF TRAYS
RUNNING EAST AND WEST WITH TRAYS
RUNNING SOUTH IN REACTOR BUILDING

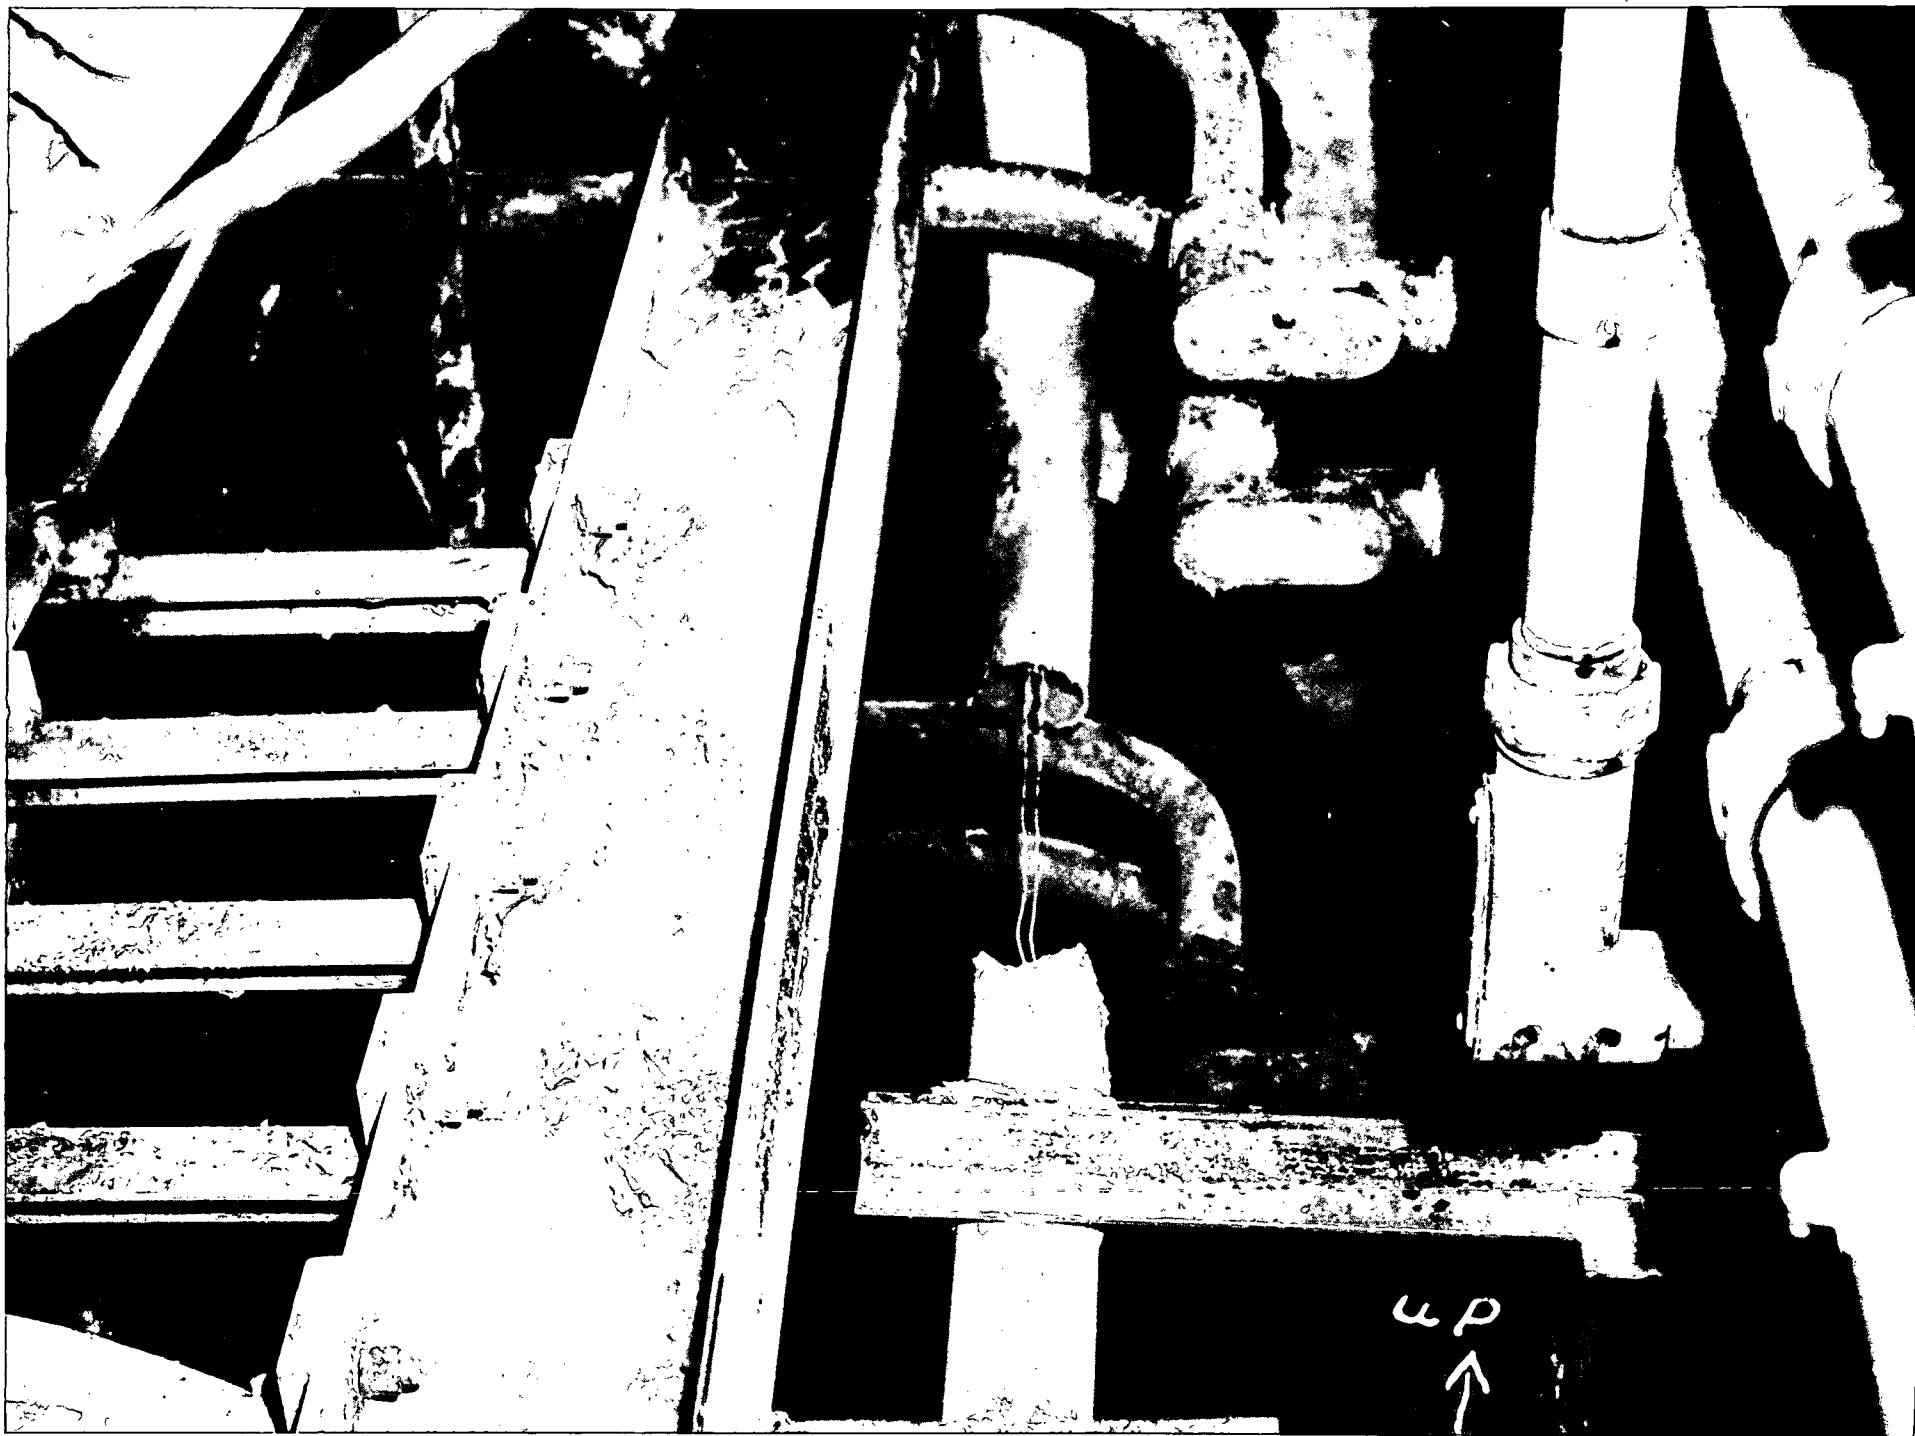
PHOTOGRAPH 89438K

VIEW OF FIRE DAMAGE TO CONDUIT
IN NORTHEAST CORNER OF REACTOR
BUILDING

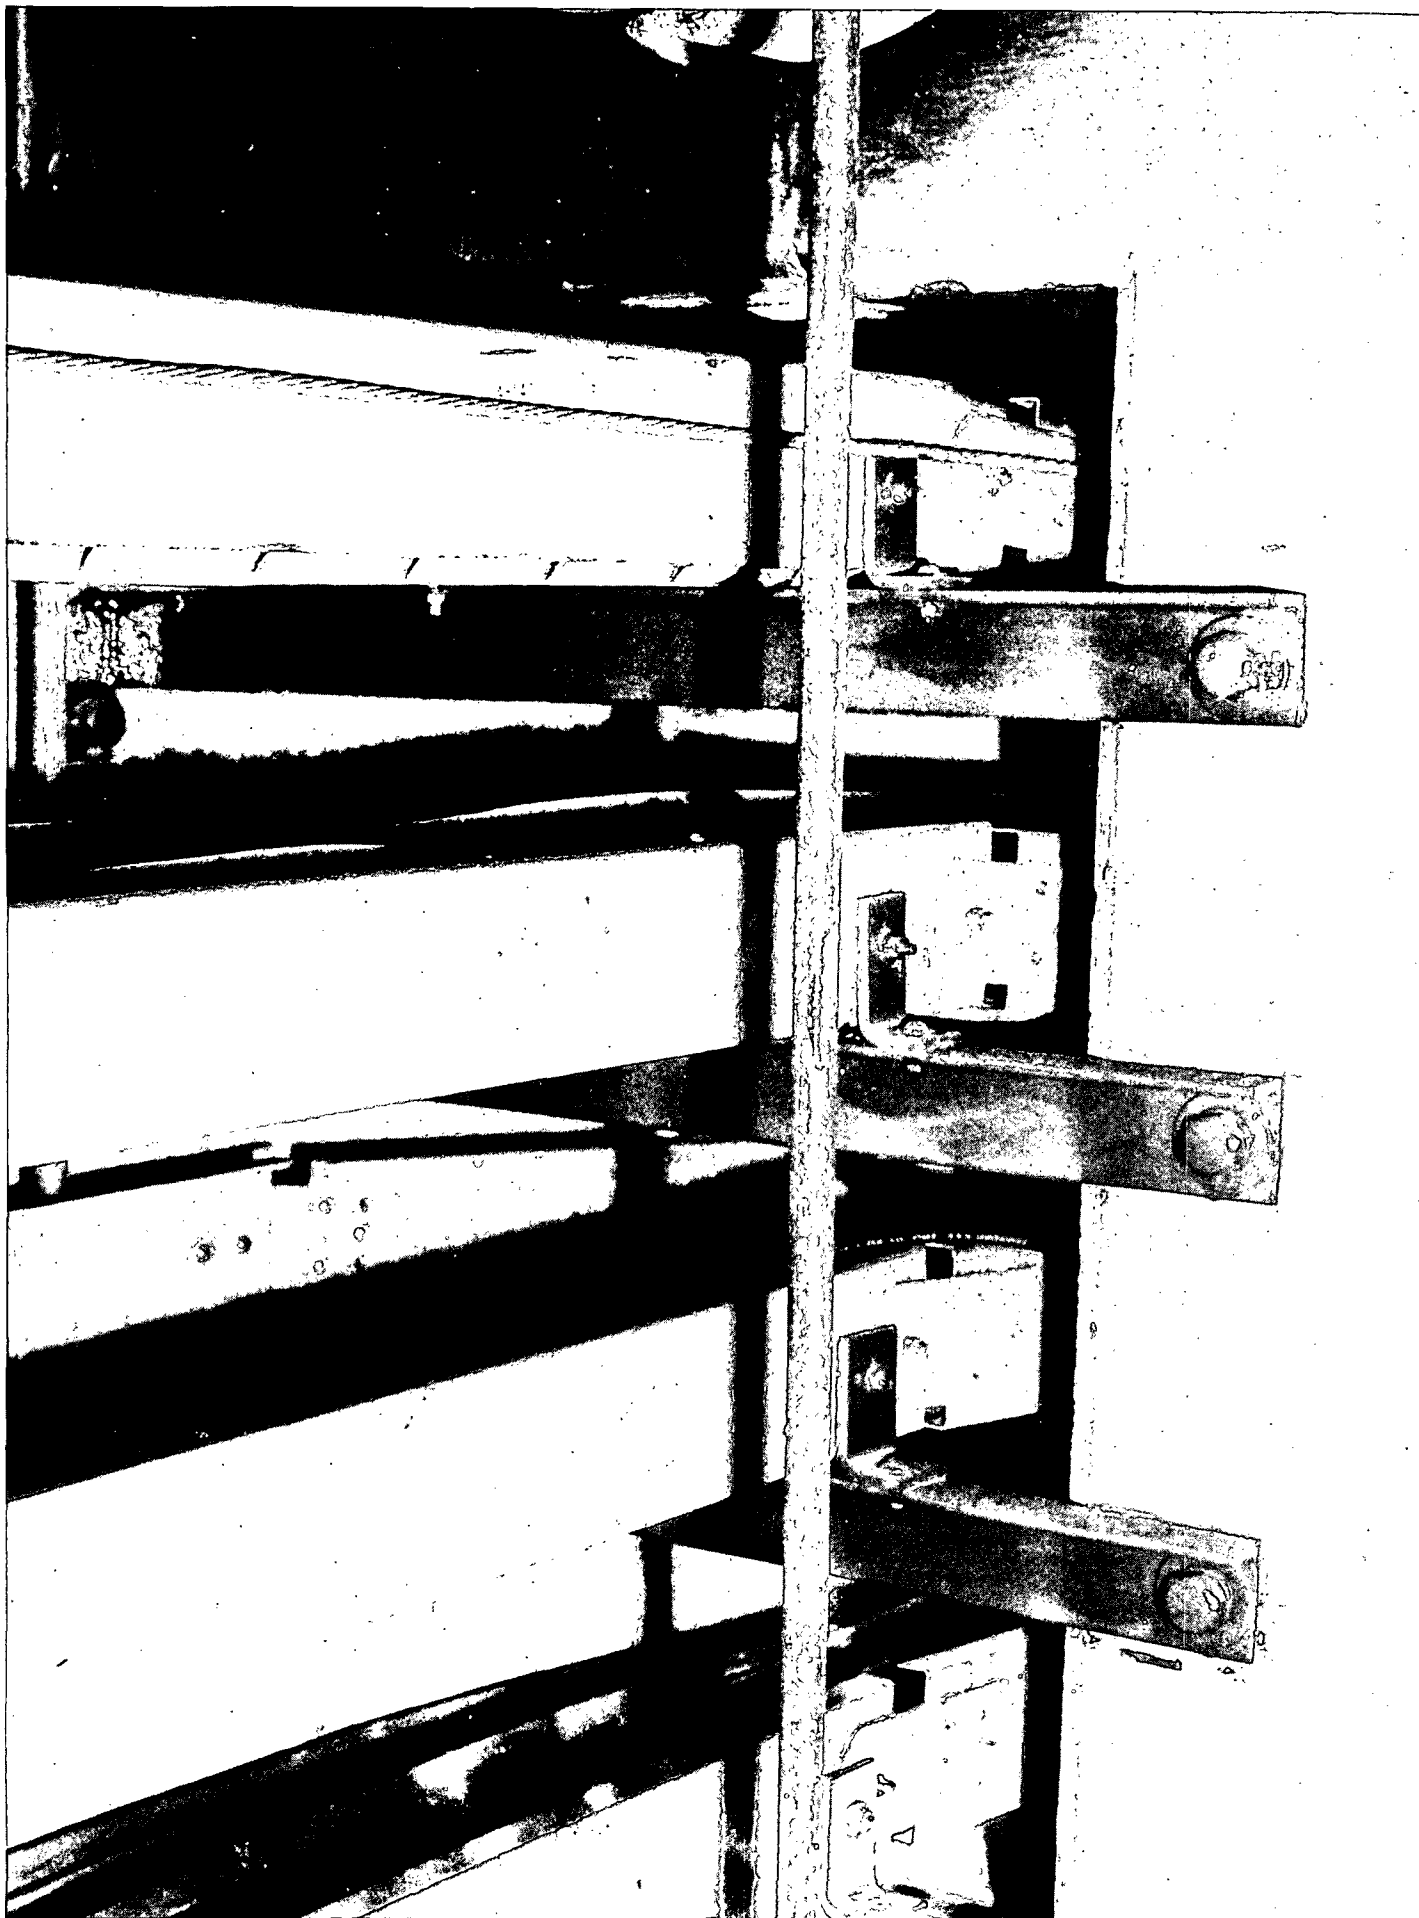
PHOTOGRAPH WH-K-86577-C

VIEW OF PENETRATION IN CLEANUP
BACKWASH RECEIVING TANK ROOM -
OPPOSITE SIDE OF WALL FROM WHERE
FIRE WAS EXTINGUISHED
