RE: Permit to Mine No. 633; Release of Solutions Report

### **Power Resources, Inc Smith Ranch-Highland Uranium Project URANIUM IN SITU FLUID RELEASE REPORT**

#### **Production Fluids**

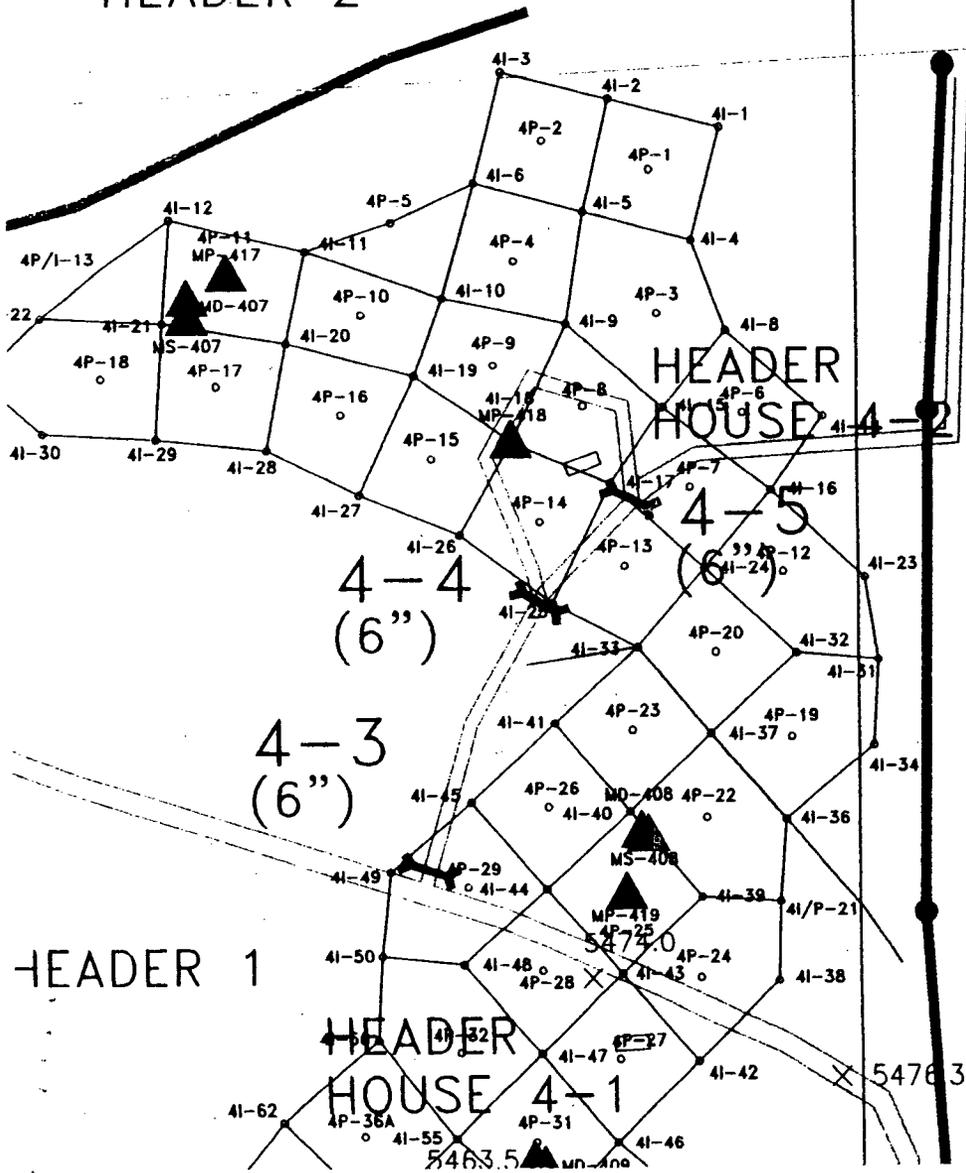
Booster #5

On 18 July 2008 at approximately 12:00 pm, a Satellite Operator reported a release of production fluid at a booster station (#5) northeast of Wellfield 4 (see attached map). Upon discovery of the leak, the wellfield was immediately shut down to control further loss of production solution.

The release occurred adjacent, and east-northeast of Wellfield 4, and affected approximately 0.18 acre.

386' Long

Average 20' wide

7720 sqft
