WATT'S BAR NUCLEAR PLANT UNITS 1 AND 2 - FAULTY ANCHOR PLATES AND BOLTS -
WBRO-50-390/81-51, WBRO-50-391/81-49 - FINAL REPORT

WATTS BAR NUCLEAR PLANT UNITS 1 AND 2
FAULTY ANCHOR PLATES AND BOLTS
WBRD-50-390/81-51, WBRD-50-391/81-49
10 CFR 50.55(e)
FINAL REPORT

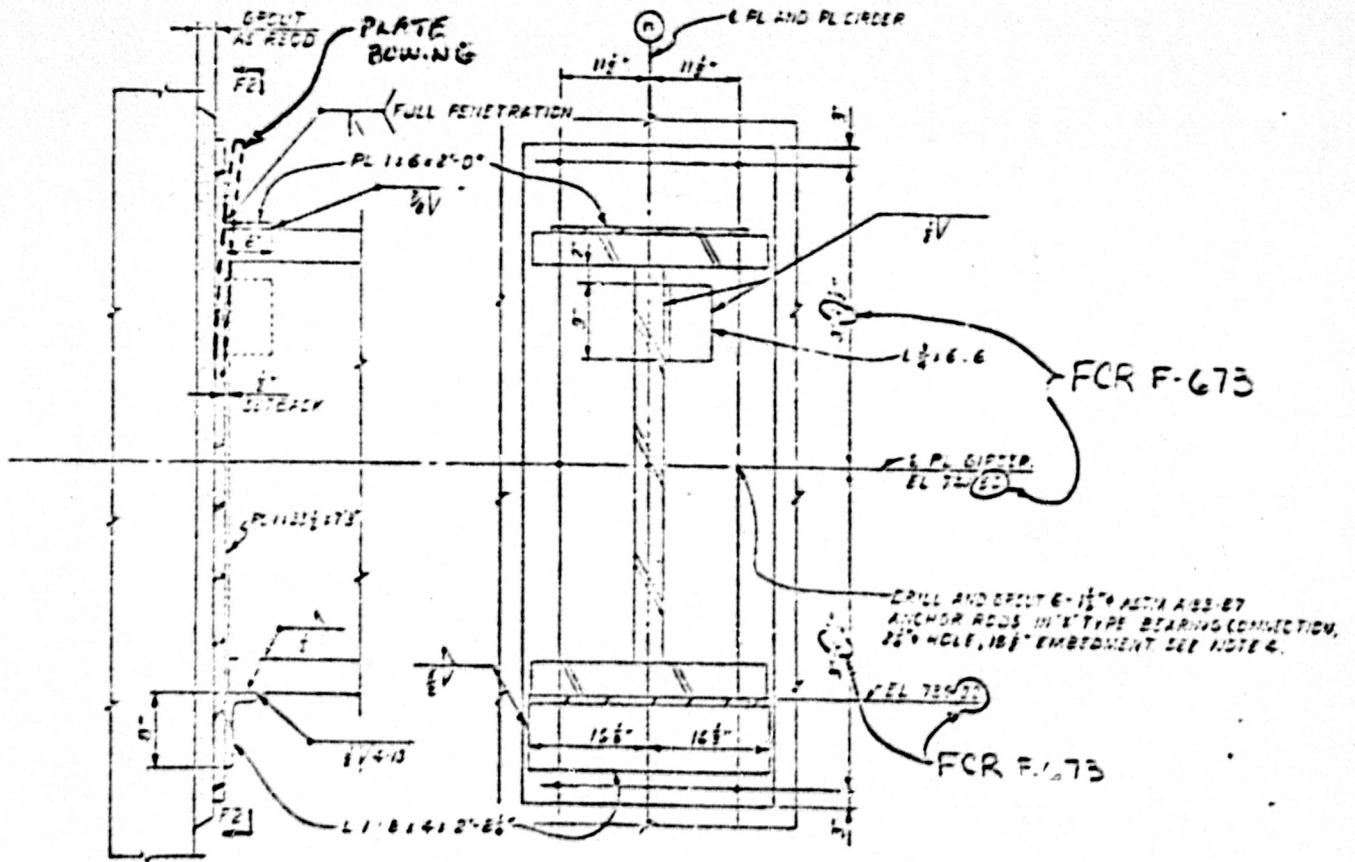
DETAIL B2

The tops of wall plates and the upper two anchors on the main steam line pipe rupture restraints have pulled away from the wall or column (see attached drawings of elevation A2-A2 and detail B2 from drawing 48W1352-2 R3). This has occurred at each end of both the unit 1 and 2 restraints. The main causes of this deficiency were improper grouting of the anchor bolts as verified by pull tests and a design oversight which allowed the girder to be welded at both ends to embedded plates, thereby restricting any thermal movement.

All the anchors will be tested and those that fail will be regouted and retested. The connection at one end of the girder will be redesigned and made a sliding connection so as not to restrict thermal movement. Also, all welds will be reinspected using liquid penetrant examination to assure that they have not been damaged. In order to prevent recurrence of this type of nonconformance, craft personnel and inspectors will be reinstructed in the proper procedures for installations of grouted anchors. Further, it will be emphasized to design engineers to recognize and provide for thermal movements in structural designs. All corrective action will be completed by January 1, 1982.
