Westinghouse
Electric Corporation

NS-TMA-2451

SUBJECT: Volume Control Tank Level Instrumentation

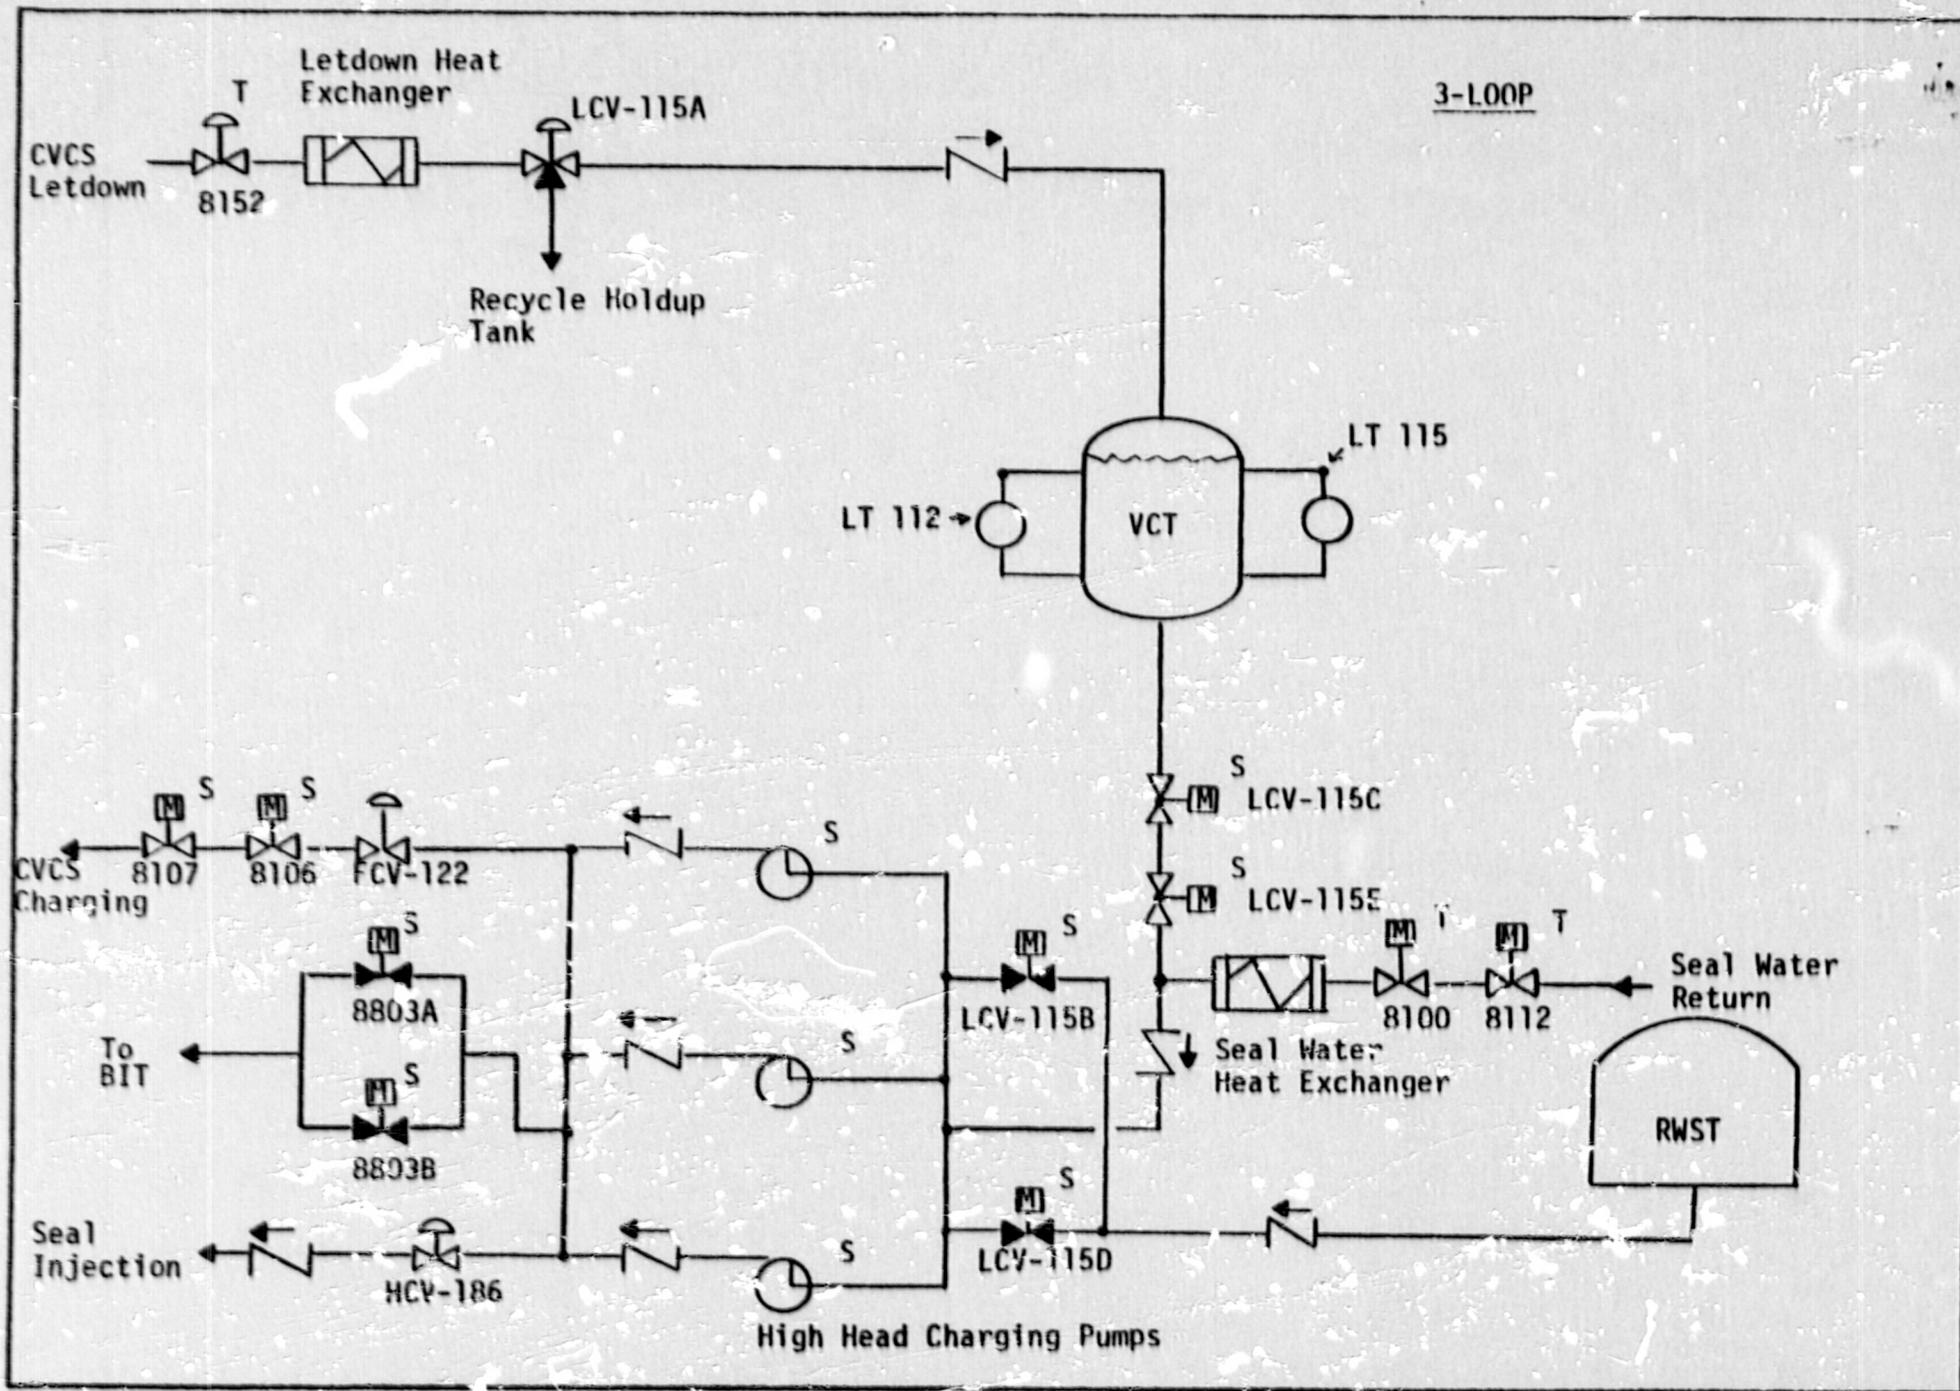
FIGURE 1

Westinghouse has identified a potential control and protection system interaction concern involving the Volume Control Tank (VCT) level control system. Figures 1 and 2 show simplified schematics for 3 and 4 loop plants respectively. The postulated event is as follows:

Assume the plant is operating with a centrifugal charging pump performing the normal charging function. (Normally one of three available charging pumps is running with another as standby.) A failure of the VCT level control system causes the letdown flow to be diverted to the liquid holdup tank. The VCT liquid inventory decreases due to normal charging without any makeup to the VCT via letdown. Without operator intervention the VCT could empty causing the operating centrifugal charging pump to be damaged due to loss of suction fluid. If it is further assumed that one charging pump is out of service, as allowed by the Technical Specifications, there would then be only one remaining undamaged pump available to provide makeup to the reactor coolant system as required by letdown and reactor coolant pump seal leakage. The one remaining pump does not then meet the single failure criterion.

It is recommended that the plant procedures be reviewed to assure that the operator would be properly alerted to this situation and would take the appropriate action necessary to assure an adequate water supply to the charging pumps in the event of a VCT level control system failure.
