WATTS BAR NUCLEAR PLANT UNIT 1 - FAILED MOTOR PINION KEY AND MOTOR SHAFT IN  
LIMITORQUE OPERATOR - WBRD-50-390/86-64, - SECOND INTERIM REPORT

ENCLOSURE  
WATTS BAR NUCLEAR PLANT UNIT 1  
FAILED MOTOR PINION KEYS AND MOTOR  
SHAFT IN LIMITORQUE OPERATOR  
WBRD-50-390/86-64  
NCR W-477-P  
10 CFR 50.55(e)  
SECOND INTERIM REPORT

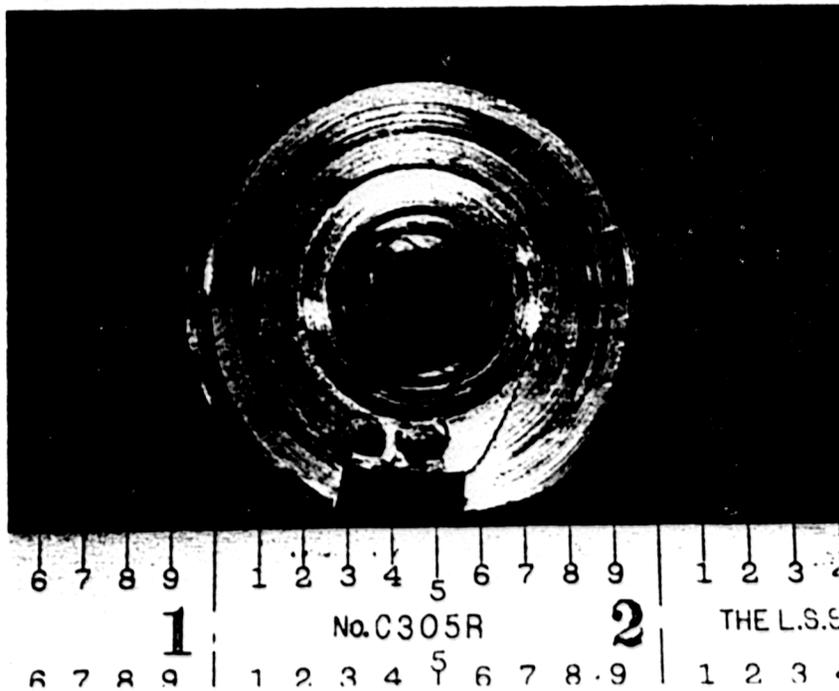
TVA considers, at present, that the mechanism for failure of the motor shaft was initiated by slight deformation of the key, which resulted in increased clearance between the key and shaft. This increased clearance resulted in higher impact loading, which, after repeated cycling, further deformed the key. These factors eventually led to the key working one-third to one-half of the way out of the slot. This reduced the contact area between the key and shaft, which significantly increased the overall loading and moved the load concentration to the open outer end of the shaft keyway slot. This increased loading eventually resulted in brittle fracture of the shaft initiating at the sharp keyway slot corners and propagating back into the shaft approximately 1-1/2" by ductile tearing of the metal. This conclusion is based on visual examination of the nonuniform shaft and keyway deformation and the metallurgical failure analysis.

Both Limitorque and Westinghouse considered incomplete key engagement to represent a significant factor in the failure. TVA agrees that this was the primary cause of the motor shaft failure. However, neither Limitorque nor Westinghouse addressed the key working its way out of full engagement or why the key which maintained full engagement was cracked and deformed. It should be noted that the keys for both valves were staked in place at the factory.

Figure 1 - End view of shaft showing cracks which initiated at the corners of the keyway.

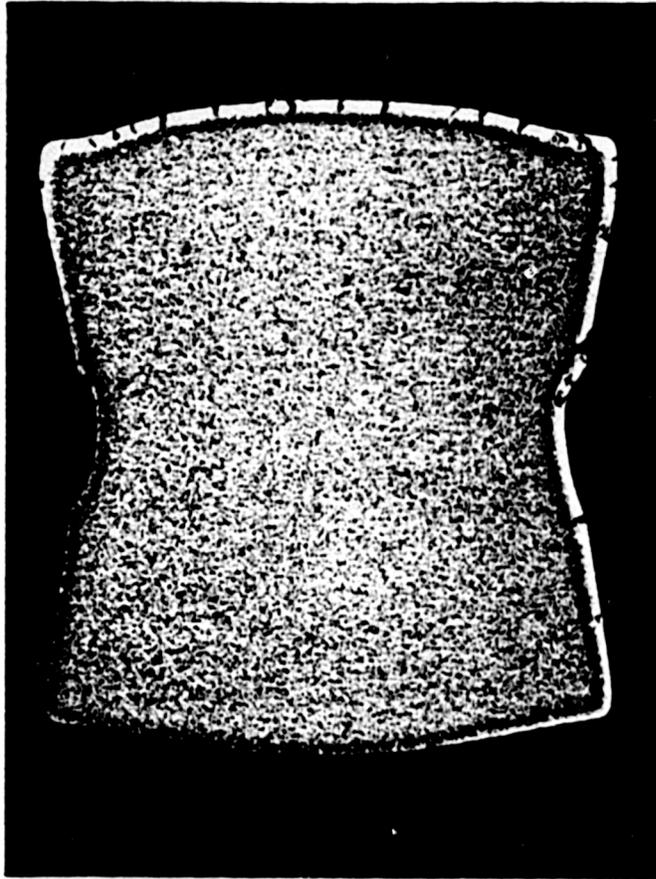
The TVA metallurgical report on the failures indicates that the metallurgical properties of the two keys and the failed shaft are within the limits of the material specifications (AISI type 1018 carbon steel for the keys and AISI type 1144 for the shaft), and that no metallurgical defects were involved in the failures.

Figure 2 - Photograph of key at 12X magnification showing deformation at centerline and cracking in the case.
