UNITED STATES
NUCLEAR REGULATORY COMMISSION
OFFICE OF NUCLEAR REACTOR REGULATION
WASHINGTON, D.C. 20555

March 12, 1991

NRC INFORMATION NOTICE NO. 91-19: STEAM GENERATOR FEEDWATER DISTRIBUTION
PIPING DAMAGE

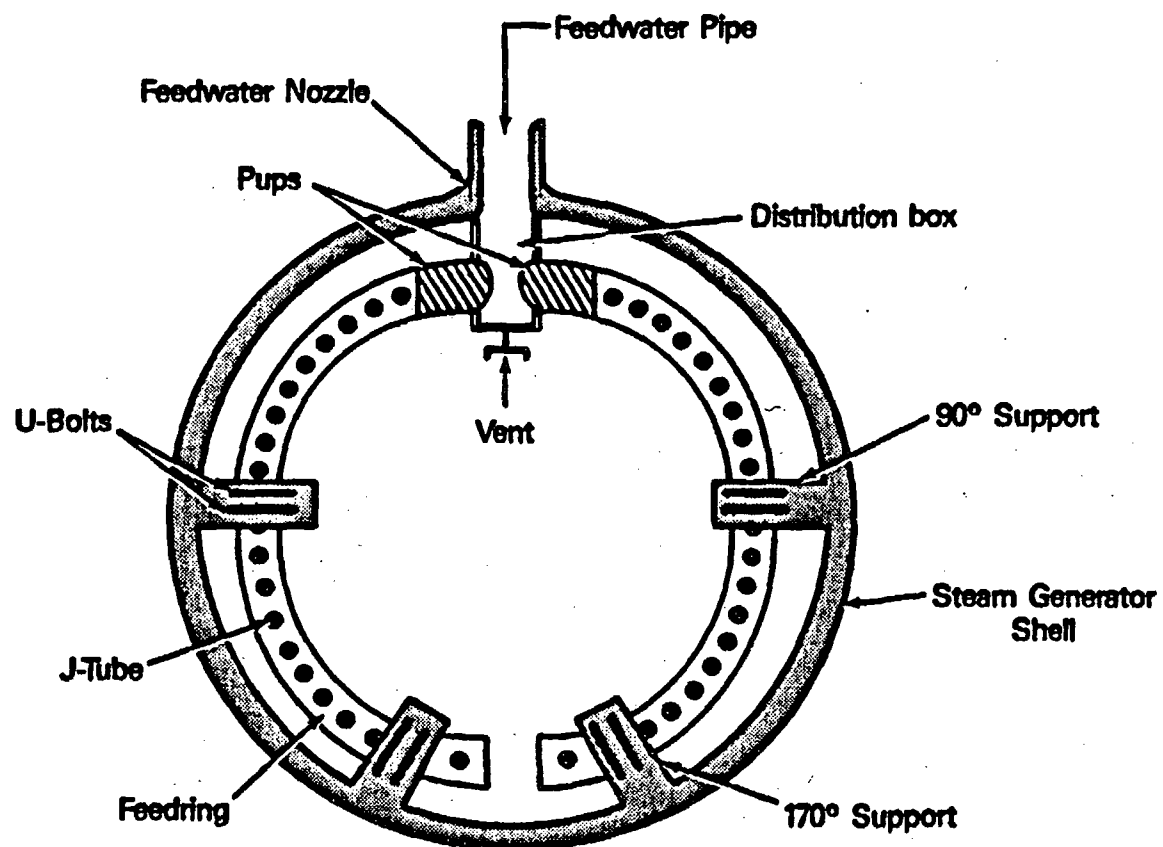
Figure 1: Top View of the Feedwater Distribution Piping

At San Onofre Units 2 and 3, both main feedwater and auxiliary feedwater enter the steam generators through a feedwater nozzle. The feedwater enters a distribution box and 12-inch diameter piping (feedring) that distributes the flow through top-mounted discharge elbows (J-tubes) around the periphery of the steam generator shell (Figure 1). The feedring is attached by two U-bolts at each of four supports that are welded to the shell wall. A 3-inch elbow and tee vent assembly is attached to the upper portion of the innermost (toward the interior of the steam generator) end of the distribution box (Figure 2).
