WATTS BAR NUCLEAR PLANT UNITS 1 AND 2 - FAILURE OF AN ERCW SHAFT  
WBRD-50-390/84-44 AND WBRD-50-391/84-39 - FINAL REPORT

WATTS BAR NUCLEAR PLANT UNITS 1 AND 2  
FAILURE OF AN ERCW PUMP SHAFT  
NCR W-195-P  
WBRD-50-390/84-44 AND WBRD-50-391/84-39  
10 CFR 50.55(e)  
FINAL REPORT

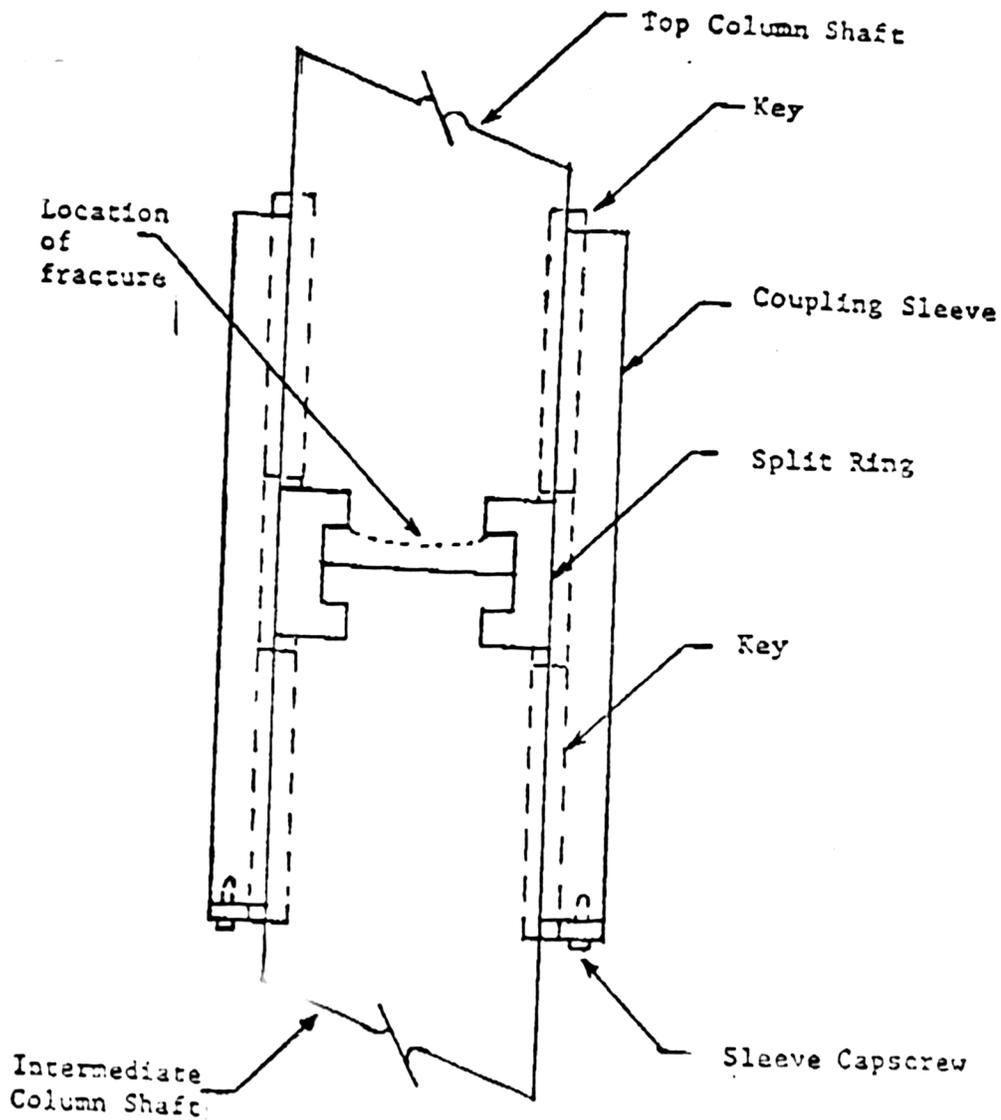
FIGURE 1

On August 17, 1984, the motor was removed to provide access for removing the adjusting plate, which had to be cut off. The threads on the pump top shaft were found to be destroyed. Maintenance Instruction (MI) 67.1 was then initiated to remove and replace the top shaft section. When the coupling at the first shaft joint was removed, the bottom section of the shaft was found to be broken off (see figure 1).

Failure analysis of the fractured shaft indicates that the break was caused by a brittle fracture which most likely occurred under the impact loading induced during the testing of the motor. At the time of the testing, the pump and motor had been uncoupled so that the impeller was resting on its bowl. The energy of the pump-motor impact was transmitted down the pump shaft and dissipated in the coupling threads which caused shaft fracture. The brittle fracture was initiated at a stress corrosion crack (SCC) (which was located approximately 0.030-inches deep and beneath a pit at the shoulder/neck junction of the shaft extension) area of high local stress due to the severe fillet radius of the extension.

Failure analysis of the fractured end of the shaft revealed three significant observations--random corrosion pitting, numerous small stress corrosion cracks in the radius of the reduced section at the fracture, and a predominantly intergranular fracture. Microscopic inspection of the fracture surface indicated the failure initiation site to be at a small stress corrosion crack located beneath a pit at the shoulder/neck junction of the shaft extension. The small size of the initiating flaw and the predominantly intergranular crack propagation indicates a material of low fracture toughness. This is consistent with results of the Charpy test which indicates that failure was by brittle fracture.
