WATTS BAR NUCLEAR PLANT UNITS 1 AND 2 - FAILURE OF AN ERCW SHAFT
WBRD-50-390/84-44 AND WBRD-50-391/84-39 - FINAL REPORT

WATTS BAR NUCLEAR PLANT UNITS 1 AND 2
FAILURE OF AN ERCW PUMP SHAFT
NCR W-195-P
WBRD-50-390/84-44 AND WBRD-50-391/84-39
10 CFR 50.55(e)
FINAL REPORT

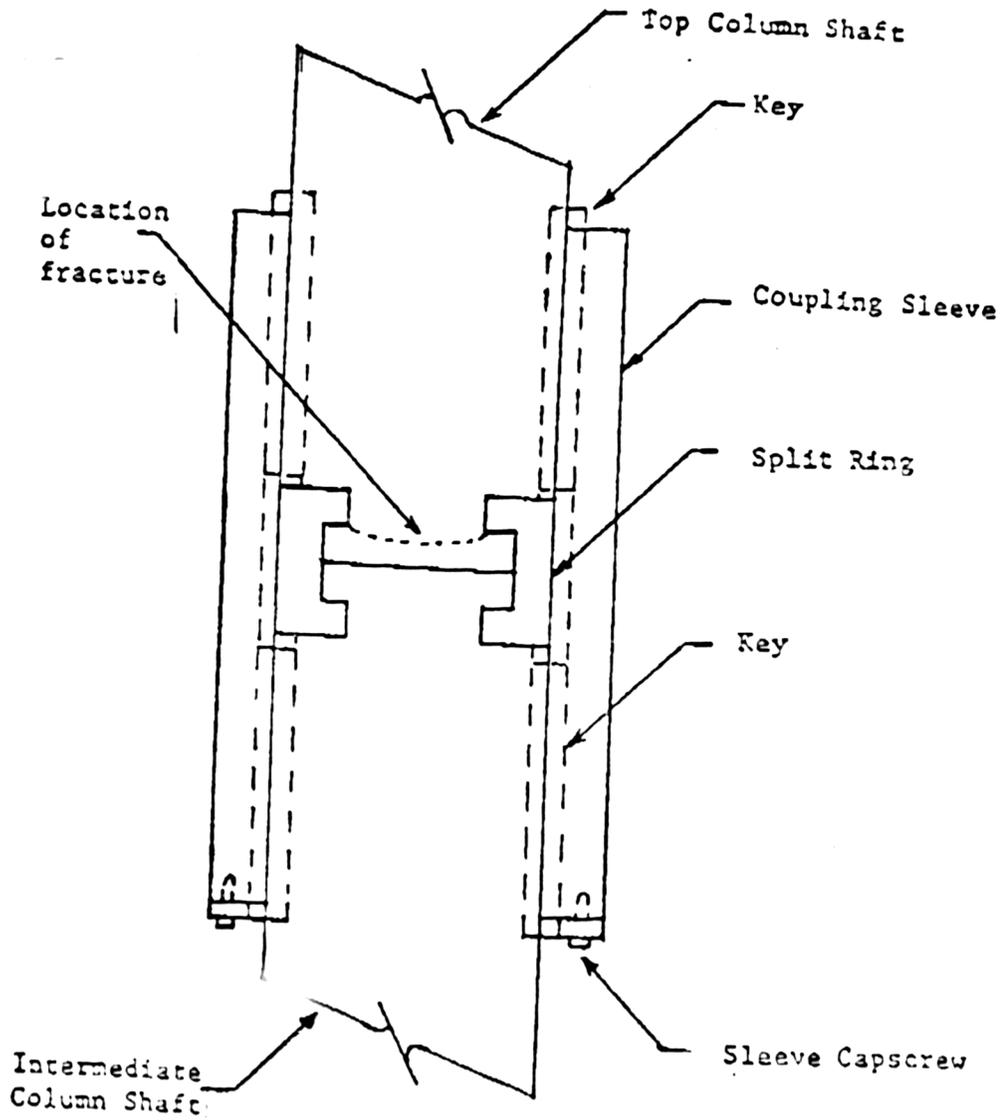
FIGURE 1

On August 17, 1984, the motor was removed to provide access for removing the adjusting plate, which had to be cut off. The threads on the pump top shaft were found to be destroyed. Maintenance Instruction (MI) 67.1 was then initiated to remove and replace the top shaft section. When the coupling at the first shaft joint was removed, the bottom section of the shaft was found to be broken off (see figure 1).

Failure analysis of the fractured shaft indicates that the break was caused by a brittle fracture which most likely occurred under the impact loading induced during the testing of the motor. At the time of the testing, the pump and motor had been uncoupled so that the impeller was resting on its bowl. The energy of the pump-motor impact was transmitted down the pump shaft and dissipated in the coupling threads which caused shaft fracture. The brittle fracture was initiated at a stress corrosion crack (SCC) (which was located approximately 0.030-inches deep and beneath a pit at the shoulder/neck junction of the shaft extension) area of high local stress due to the severe fillet radius of the extension.

Failure analysis of the fractured end of the shaft revealed three significant observations--random corrosion pitting, numerous small stress corrosion cracks in the radius of the reduced section at the fracture, and a predominantly intergranular fracture. Microscopic inspection of the fracture surface indicated the failure initiation site to be at a small stress corrosion crack located beneath a pit at the shoulder/neck junction of the shaft extension. The small size of the initiating flaw and the predominantly intergranular crack propagation indicates a material of low fracture toughness. This is consistent with results of the Charpy test which indicates that failure was by brittle fracture.

WATTS BAR NUCLEAR PLANT
SCHEMATIC OF BYRON JACKSON ERCW PUMP SHAFT COUPLING

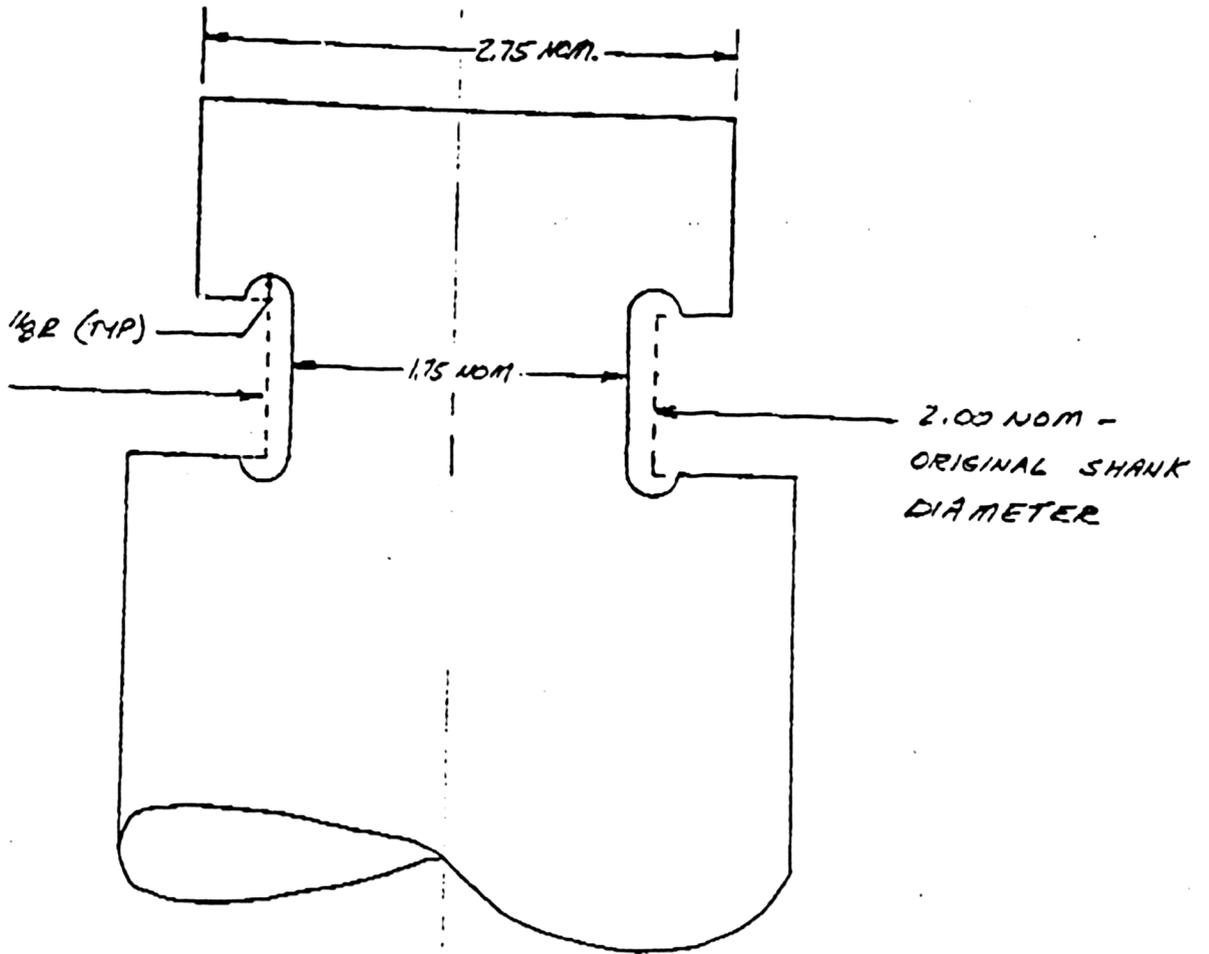
FIGURE 2

WATTS BAR NUCLEAR PLANT
PROPOSED MODIFICATIONS OF THE ERCW PUMP SHAFT ENDS

However, TVA does plan to modify the pump shaft ends. This modification involves machining down the shaft to eliminate existing pits and turning a radius in lieu of the existing sharp fillet (see Figure 2). This will eliminate the propensity for SCC in the fillet and will reduce the stress concentration to the point that nonductile failure of the shaft end, due to normal plus seismic loading, will not be a concern for the range of flaw sizes that are expected to occur during the design life of plant. The scheduled date of completion for this work on the four pumps needed for unit 1 is January 2, 1985. The remaining pumps will be modified by August 1, 1985.
