PP 7028 FAC INSPECTIONS 2004 REFUELING OUTAGE

2003-2004 Program Scope Memo Vermont Yankee -Engineering Department	
WBS Element:	6098
Title:	Piping Flow Accelerated Corrosion (FAG) Inspection Program 2003 & 2004 Efforts
Department:	Design Engineering - Mechanical / Structural
Owner:	James Fitzpatrick
Backup:	Thomas O'Connor
Procedure No. & Title:	pp 7028, Piping Flow Accelerated Corrosion Inspection Program
<p>Detailed Scope of Project (explanation): Engineering activities to support ongoing Inspection Program to provide a systematic approach to insure that Flow Accelerated Corrosion (FAC) does not lead to degradation of plant piping systems. Program Procedure PP 7028 controls engineering and Inspection activities to predict, detect, monitor, and evaluate pipe wall thinning due to FAC. Activities include modeling of plant piping using the EPRI CHEGWORKS code to predict susceptibility to FAG damage, selection of components for inspection, UT inspections of piping components, evaluation of data, trending, monitoring of industry events and best practices, and recommending future repairs and for replacements prior to component failure.</p>

VY Piping FAG Inspection Program PP 7028 - 20

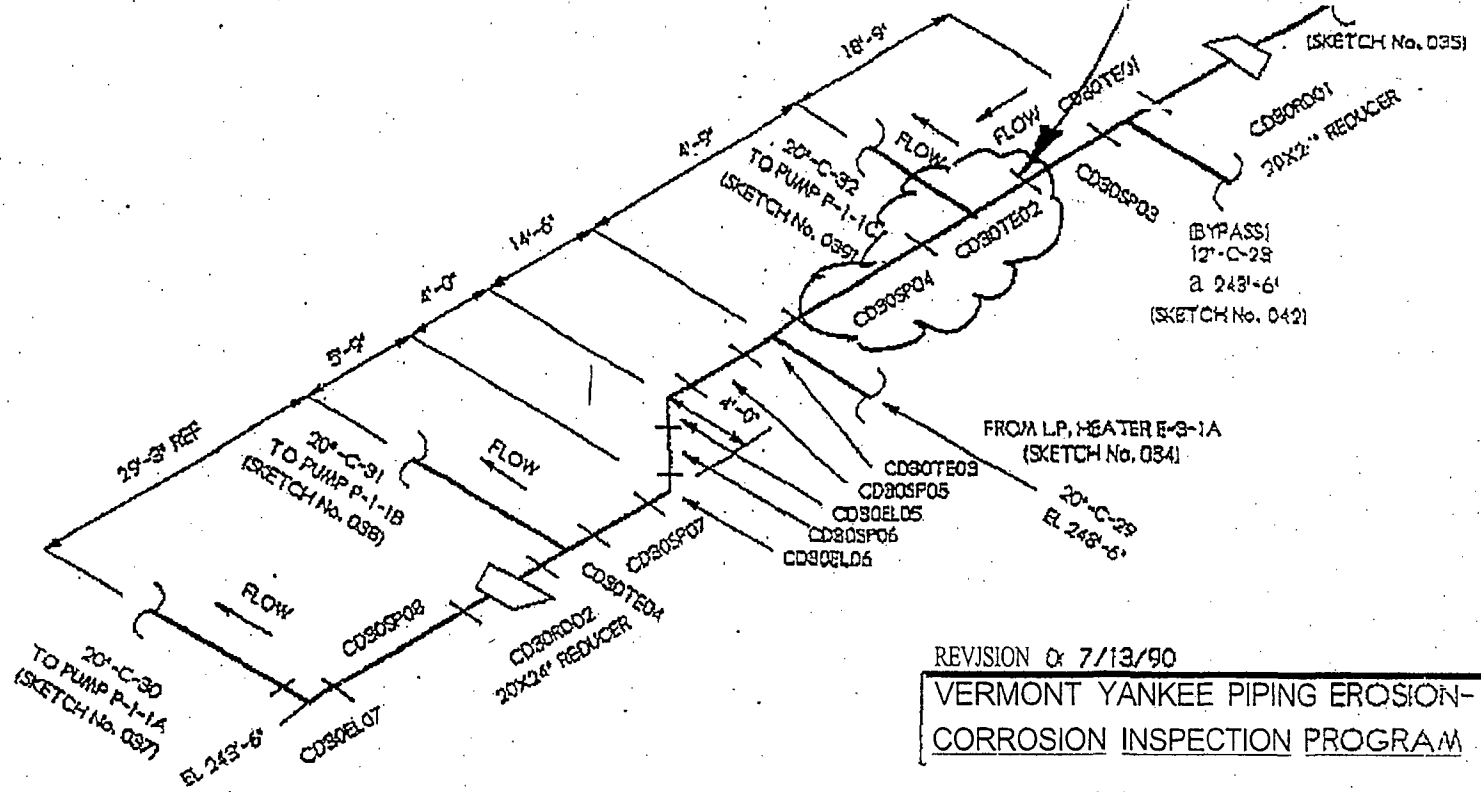
2004-18
2004-19

Point No.	Component ID	Location Sketch	Location	Previous Inspections	Reason / Comments / Notes
2004-18	CD30TE02	036	T.B. FPR EI v.243.	NO	Ranked high by CHECWORKS include 12 inch long stub between CD32LE01 & CD32EL02.
2004-19	CD30SP04	036	" " "	NO	
2004-20	CD32EI01	039	" " "	NO	
2004-21	CD32EL02	039	" " "	NO	
2004-22	ES1ASP01	063	T.B. HB Elev. 255.	1998	Highly susceptible to FAC damage. This is the only remaining carbon steel section in Extraction Steam system. Baseline data for over urate.
2004-23	MSD9TE01 thru MSD9TE08	097	T.B. HB Elev. 249.	NO	Industry Experience with numerous through wall leaks in drain collector headers. Scan as much of header below drains from LeV 38A to 380 and ST-6D-2A to 20 as accessible. See Note 3.
2004-24	MSD9EL05	097	T.B. HB Elev. 237.	NO	Industry Experience with numerous through wall leaks in drain collector headers. Inspect a minimum of 16 inch length on MSD9SP06US. See Note 3.

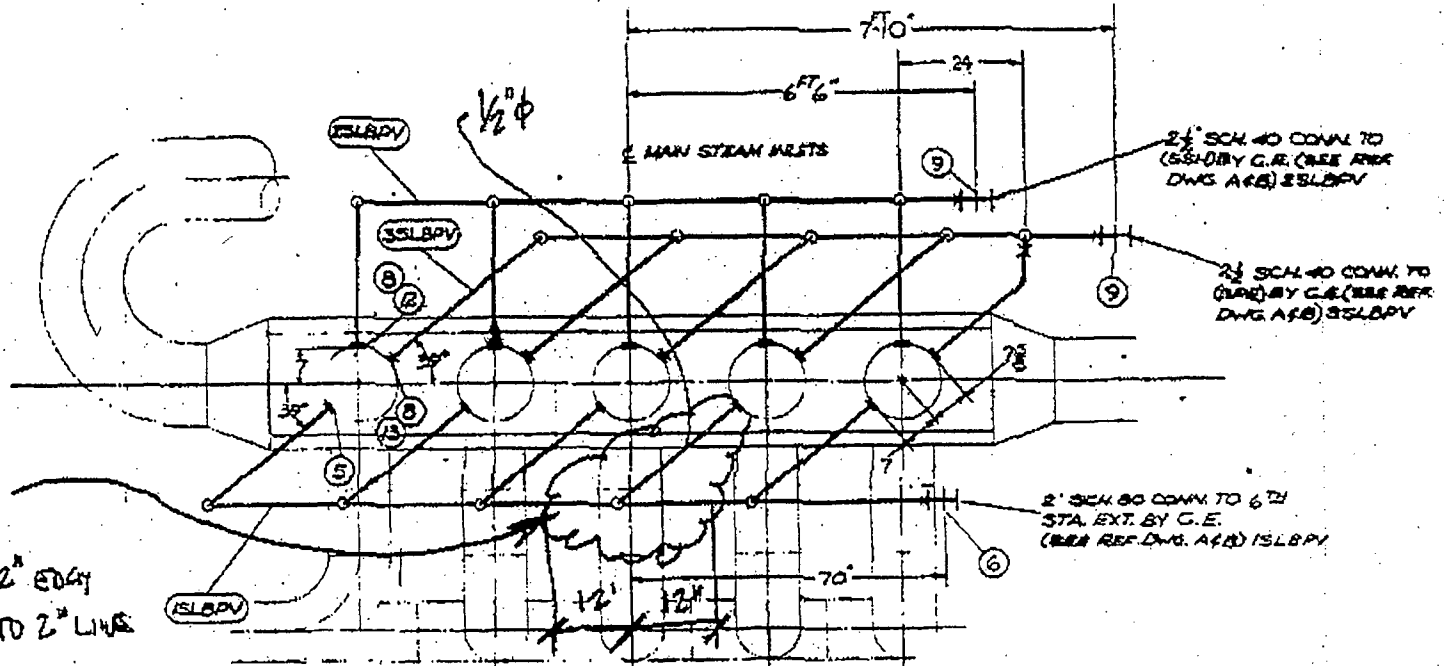
2004 SMALL BONES
04-SB01

A through wall leak in the turbine bypass valve chest 1st seal leak-off line from the No.1 bypass valve occurred in 2003. (ER 2003-044) A temporary leak enclosure has been installed (T.M.2003-002 to contain the leak). W.O. 03-0364 was written to inspect/repair/replace line. The line should be completely replaced with chrome-moly piping. (Dresden has already done this) Given the amount of work already scheduled for the heater bay during the 2004 RFO a complete replacement will be deferred. A local code repair of the piping will be performed to remove the temp Mod during the 2004 RFO. Additional inspections should be performed to insure the integrity of the line. The long term solution (if license renewal is pursued) should include replacement the entire line with chrome-moly material.

System 2" ISLBPV	Description 2 inch header off the turbine bypass valve chest first seal leak-off connections. Inspect five locations on this line. include the 1/2 line at the No.2 valve. It has the next highest usage from the no.1 valve.	Inspection No. 2004 5B01 to 5805
2-112" ISPL2	HP Turbine pocket drains. inspect first two elbows and connecting piping under turbine based on reading from 1993 inspections 93-5849 to 93-SB52)	20045B06 & 5807
