Interim Summary on Secondary Piping Rupture  
Accident at Mihama Power Station, Unit 3 of  
the Kansai Electric Power Co., Inc.

September 27, 2004  
The Nuclear and Industrial Safety Agency

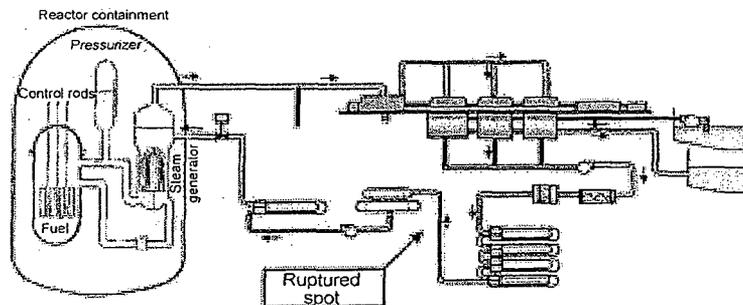
Figure 1 Major systems of PWR and the ruptured spot

The operator made an inspection in the turbine building and confirmed a rupture opening in a A-loop condensate pipe at 17:30, which was the feed water line from the 4th feed water heater<sup>2)</sup> to the deaerator<sup>3)</sup> running near the ceiling on the deaerator side at the 2nd floor of the turbine building. After that, the nuclear security inspector also confirmed the same situation.

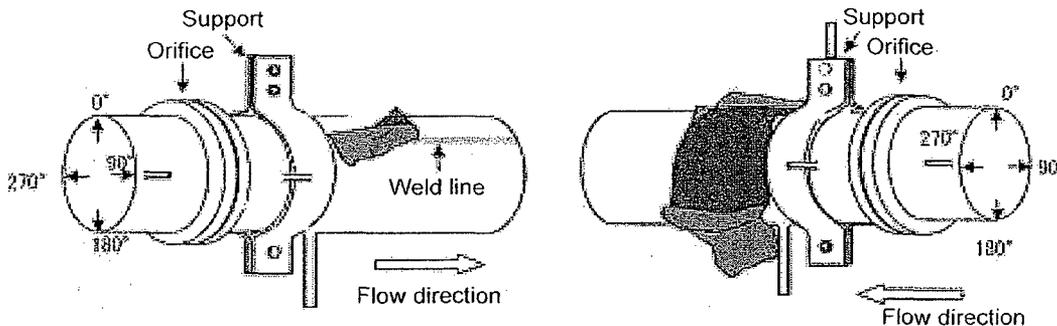
Figure 2 Ruptured condition of pipe

NISA conducted an on-the-spot inspection and as a result confirmed a fracture opening in the ruptured portion, which extended a maximum of 515 mm in the axial direction and 930 mm in the circumferential direction of the pipe. KEPCO measured the pipe in the presence of the police, and the result was 0.4 mm at the thinnest portion of the pipe. As shown in Appendix 3, thinning was striking in the upper part of the pipe.

The A-loop pipe was cut out including the ruptured portion in question and examined at the Japan Atomic Energy Research Institute (abbreviated to JAERI hereinafter). As a result, a portion was found out downstream of the vent hole of the orifice<sup>7)</sup> where pipe wall thinning reached to the flange for the orifice support.

The inner surface of the pipe was observed using a digital microscope and it exhibited a fish scale-like pattern, which is characteristic of so-called erosion/corrosion<sup>8)</sup>, downstream of the orifice and over the entire surface except at the bottom (180°) of the pipe. At the bottom (180°) of the pipe, a portion of almost nominal wall thickness existed where a thick surface

From these, the cause for the pipe rupture in question is estimated to be so-called erosion/corrosion, which has gradually reduced the pipe wall thickness with the lapse of operation time. At last, the pipe strength became insufficient and the pipe ruptured under the load during operation.

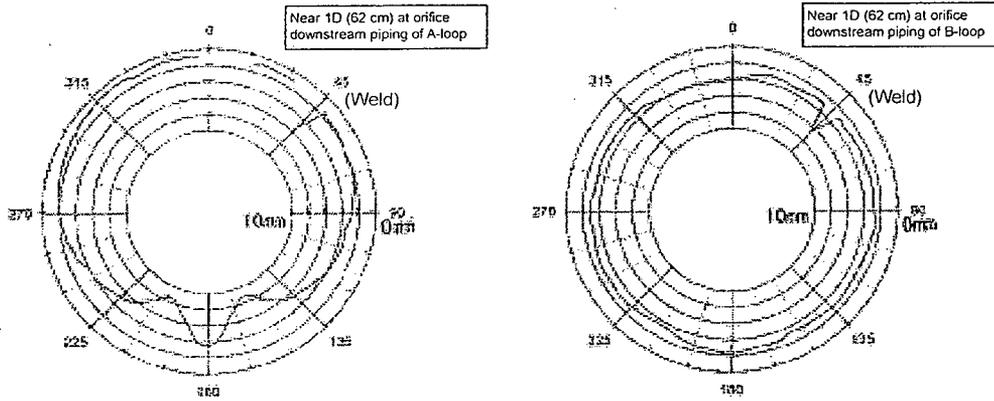
Near 1D from orifice downstream end

A-1 Situation of reduced thickness at orifice downstream piping

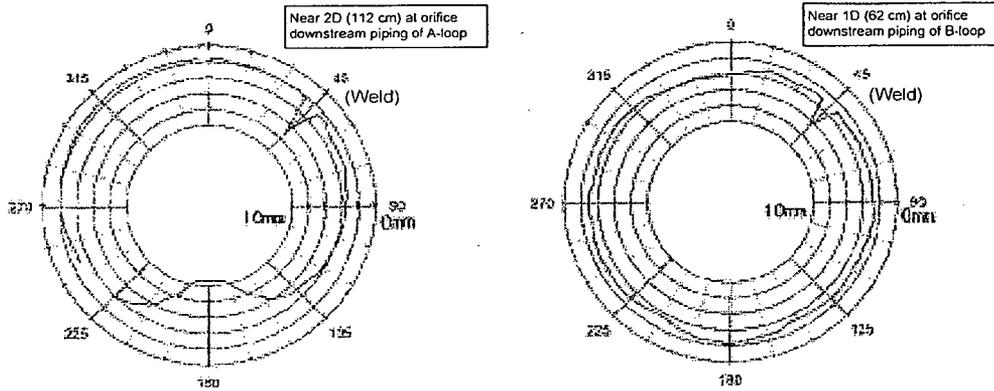
Near 2D from orifice downstream end

B-1 Situation of reduced thickness at orifice downstream piping

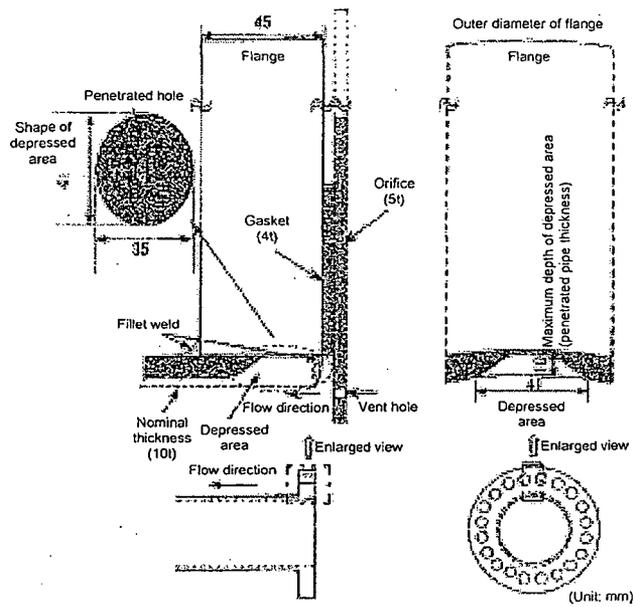
A loop orifice downstream flange

As a result, a thinning tendency was observed almost over the entire surface downstream of the orifice as shown in Appendix 3. Pipe wall thinning was observed downstream of the vent hole in the orifice. Upstream of the orifice, however, no significant thinning tendency was observed. At the thinnest portion of the wall, the thickness was 1.8 mm.

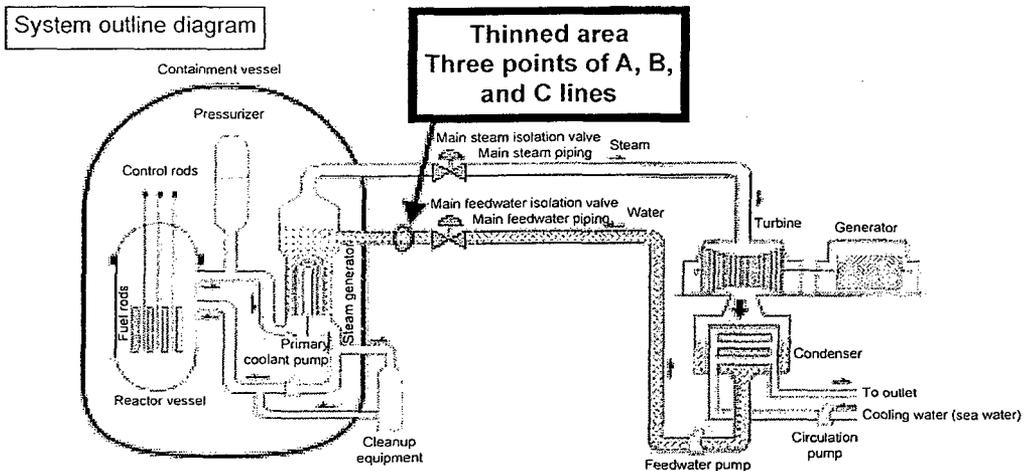
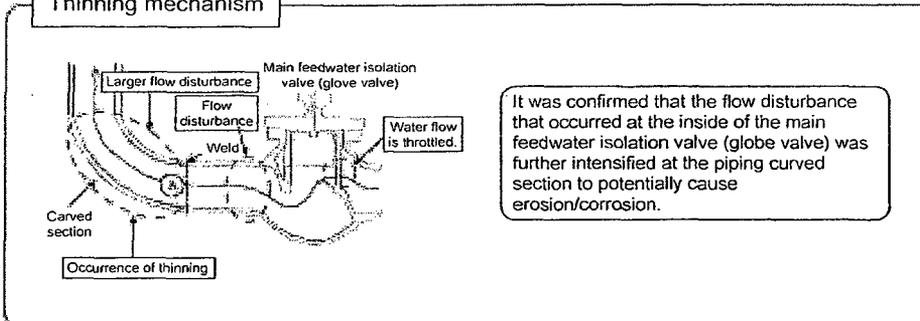
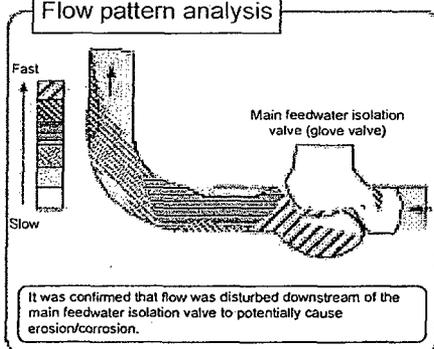
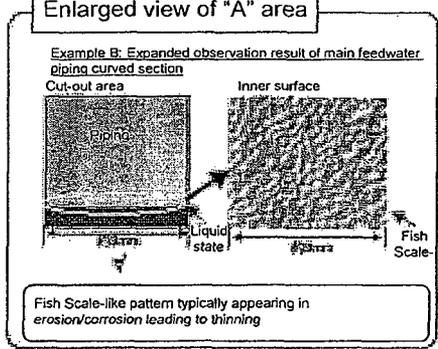
Figure Investigation results of thinning at secondary system main feedwater piping elbow area at Ohi Power Station, Unit 1

This thinned area belongs to the water piping operated at 230°C, so it is classified into "other systems" in the PWR Management Guidelines. "Other systems" require inspection on a sampling basis. The thinning causes a need to review the PWR Management Guidelines regarding whether the sampling inspection requirement is adequate for "other systems" and how to manage the D system, because no significant thinning was detected in the D system, which has the same structure and environment as the area concerned.

Piping shape	Required thickness on calculation	Measured minimum thickness
A main feedwater piping curved section (45°)	15.7 mm	14.5 mm
B main feedwater piping curved section (90°)		12.1 mm
C main feedwater piping curved section (90°)		13.9 mm
D main feedwater piping curved section (90°)		20.0 mm

- 1) To replace the elbow area concerned with piping manufactured at the same dimensions using the same material.
- 2) To strengthen, in the future, monitoring of thinning trends at the areas concerned including Ohi Power Station, Unit 2 with the same type of main feedwater isolation valve, and to take the same countermeasures for areas with the potential to generate significant thinning at the main feedwater system, including at other plants.
- 3) To review the total maintenance management system mainly for issues clarified this time regarding the maintenance management and to take measures based on the results.
