INGERSOLL-RAND
PUMPS

Subject: 10CFR21 Reportability of a Potential Safety Hazard
From Broken Cast Iron Diffusor Pieces in Auxiliary
Feed Water Pumps

The purpose of this letter is to update the NRC on Ingersoll-Rand's evaluation of damage experienced by several utilities on auxiliary feedwater (AFW) pumps of Ingersoll-Rand manufacture with cast iron internals. These are our model HMTA units.

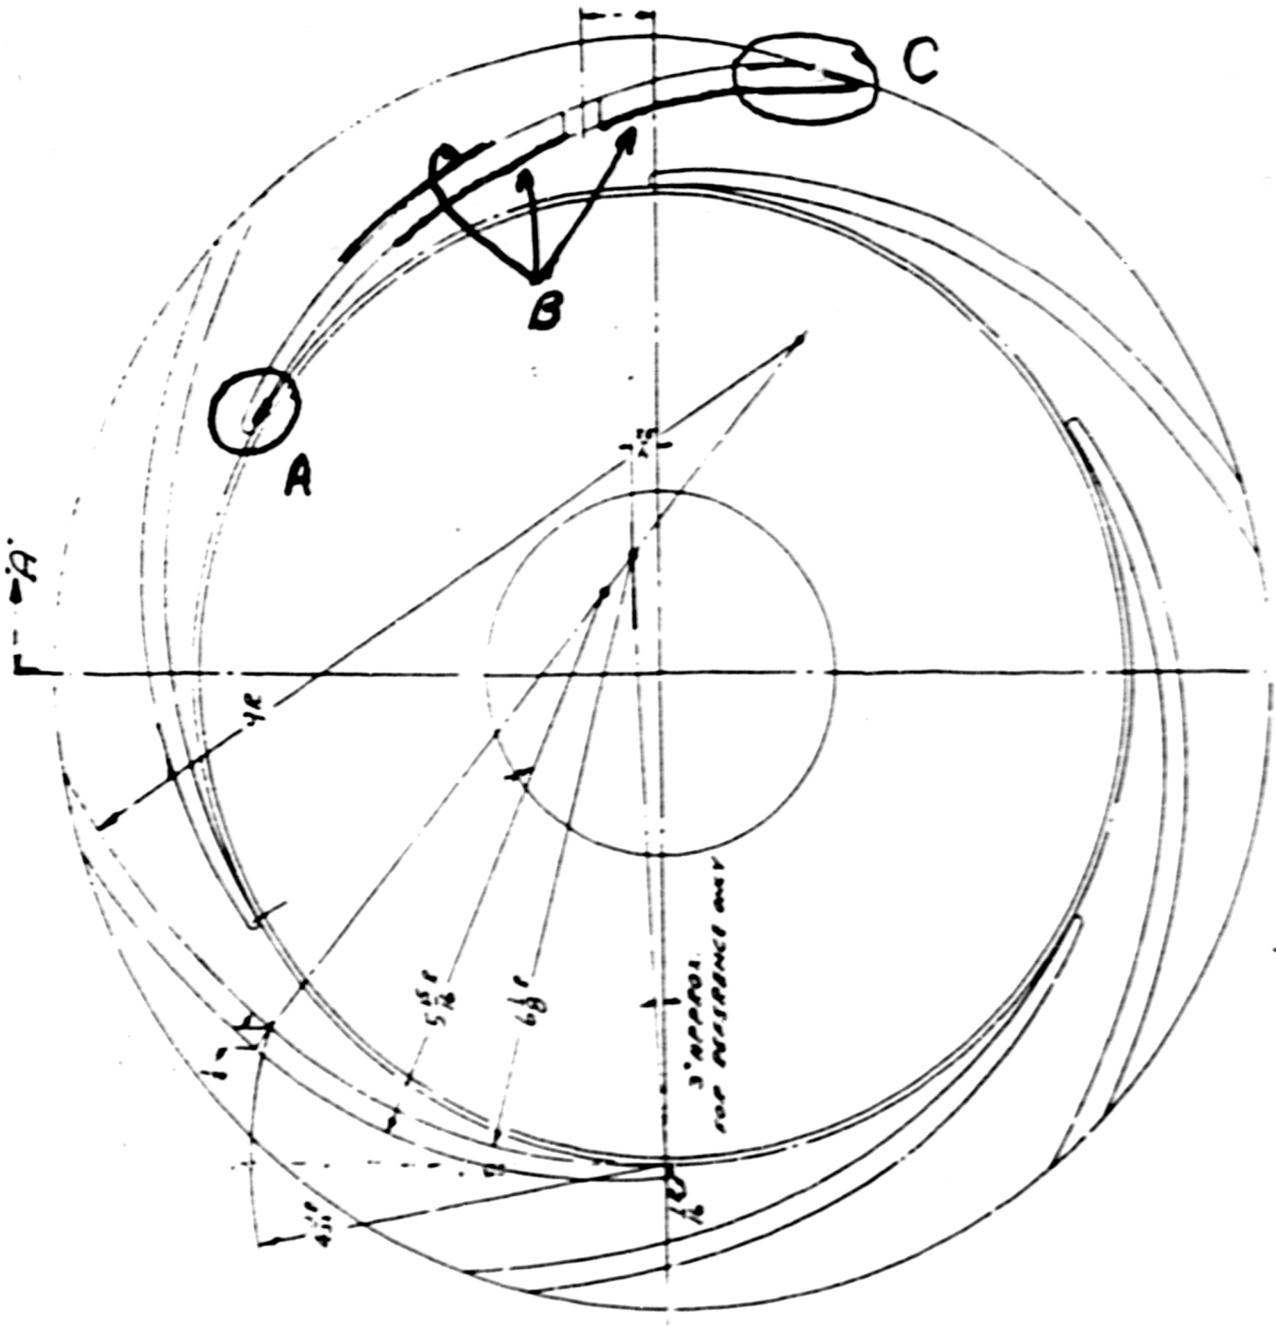
Typical Damage Patterns

Shown above, on one vane, are the locations of the damage patterns observed to varying degree on all of the vanes of the first stage diffuser, and to a lesser degree on some of the other diffusers.
