MORRISON-KNUDSEN COMPANY, INC.

L-QTS-84-009

10CFR21 COMMITTEE MEETING HELD MAY 16, 1984

PSD DOCUMENT NO. 10CFR21-0018-003

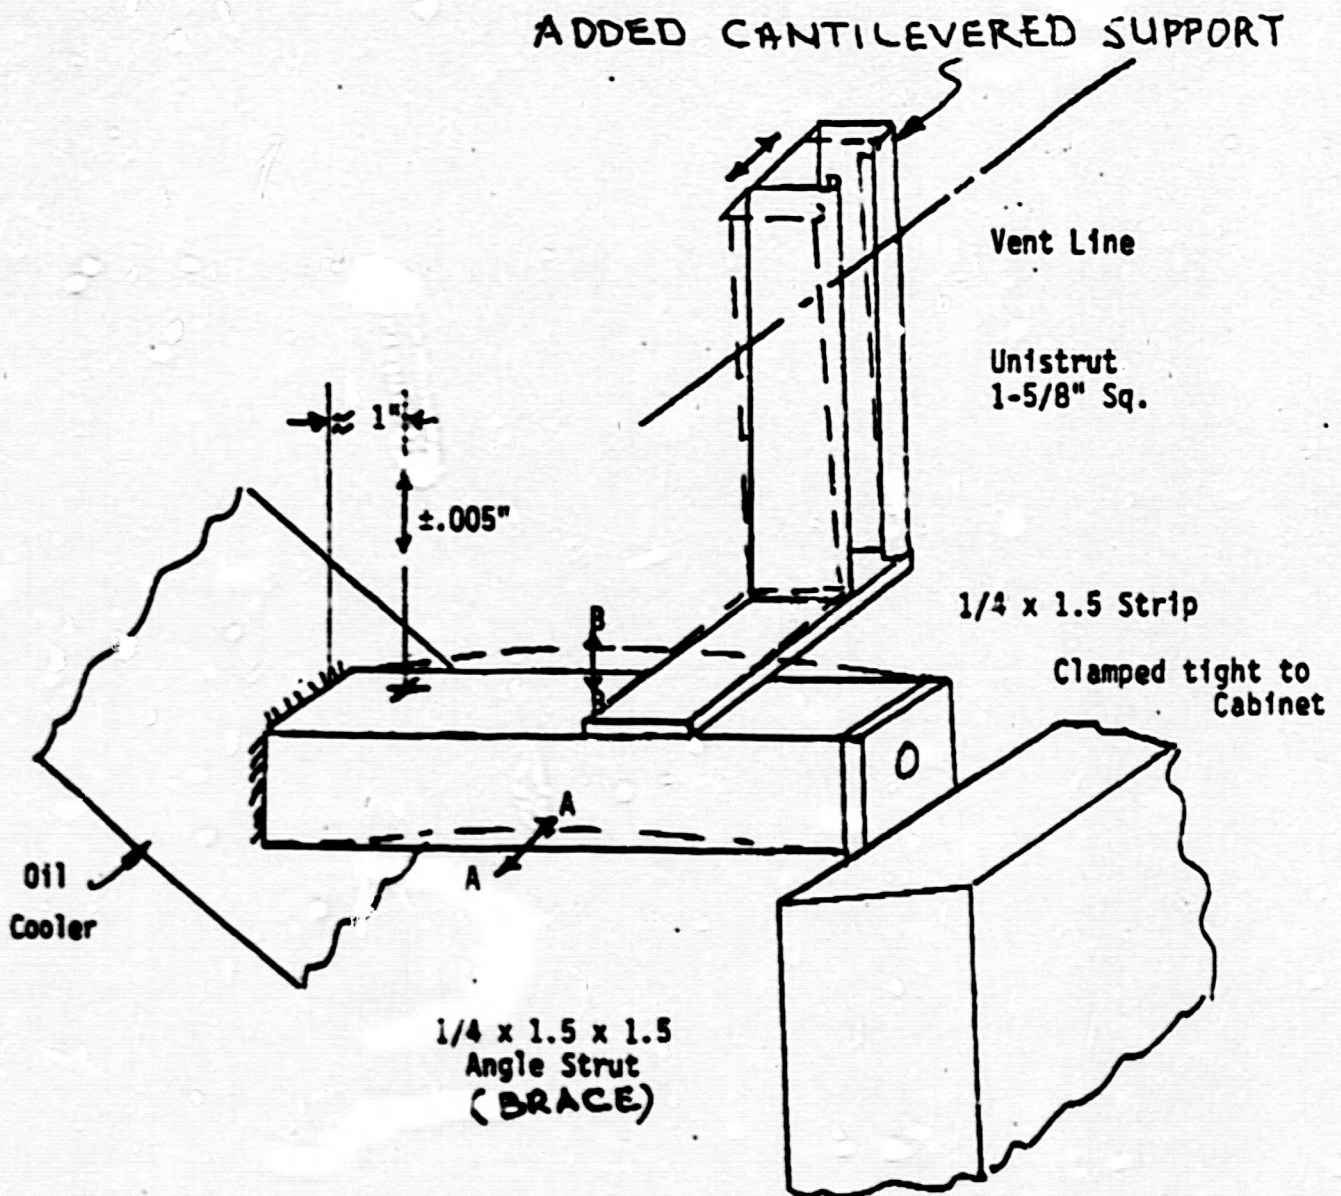
FIG 1

A control panel bracket support welded to the diesel lube oil cooler has developed cracks in the weld and resulted in a small lube oil cooler leak.

- a) The original arrangement was not the cause of failure. The report shows very low stress levels.
- b) The addition of the supports caused excessive stress at the subject weld joint as a result of its cantilevered construction, coupled with the fact that some of the assemblies had a natural frequency close to the 3d harmonic of the engine speed. The structures where natural frequencies were higher showed no weld distress.

- DISCUSSION:
- 1) Power Systems issued a 10CFR21 Report #10CFR21-0018, based upon initial information furnished by the Owner.
 - 2) Subsequently, it was discovered that a cantilevered structure (FIG. 1) had been added recently to the brace to support newly added vent piping for the diesel engine lube oil system.
 - 3) A site investigation was initiated jointly by the Owner and Power Systems to determine the actual cause of the defect.
 - 4) The result of this investigation is contained in Flight Dynamics, Inc. Report A-10-84.

The report shows, by calculation, that the stresses at the brace and lube oil cooler junction are low as it was originally installed. However, the addition of the cantilevered support introduced high cyclic stresses in cases where the added support structure was close to the 3d harmonic (45 Hz) of diesel speed (900 RPM/15 Hz) as indicated on Table II. Note, those with considerable higher natural frequencies showed no weld distress.

- 5) The conclusion that the added cantilevered supports are the cause of failure is supported by the fact that the joint between the lube oil cooler and the angle brace showed no distress after approximately 200 hours of engine operation but showed distress within a few hours of operation following the addition of the support.

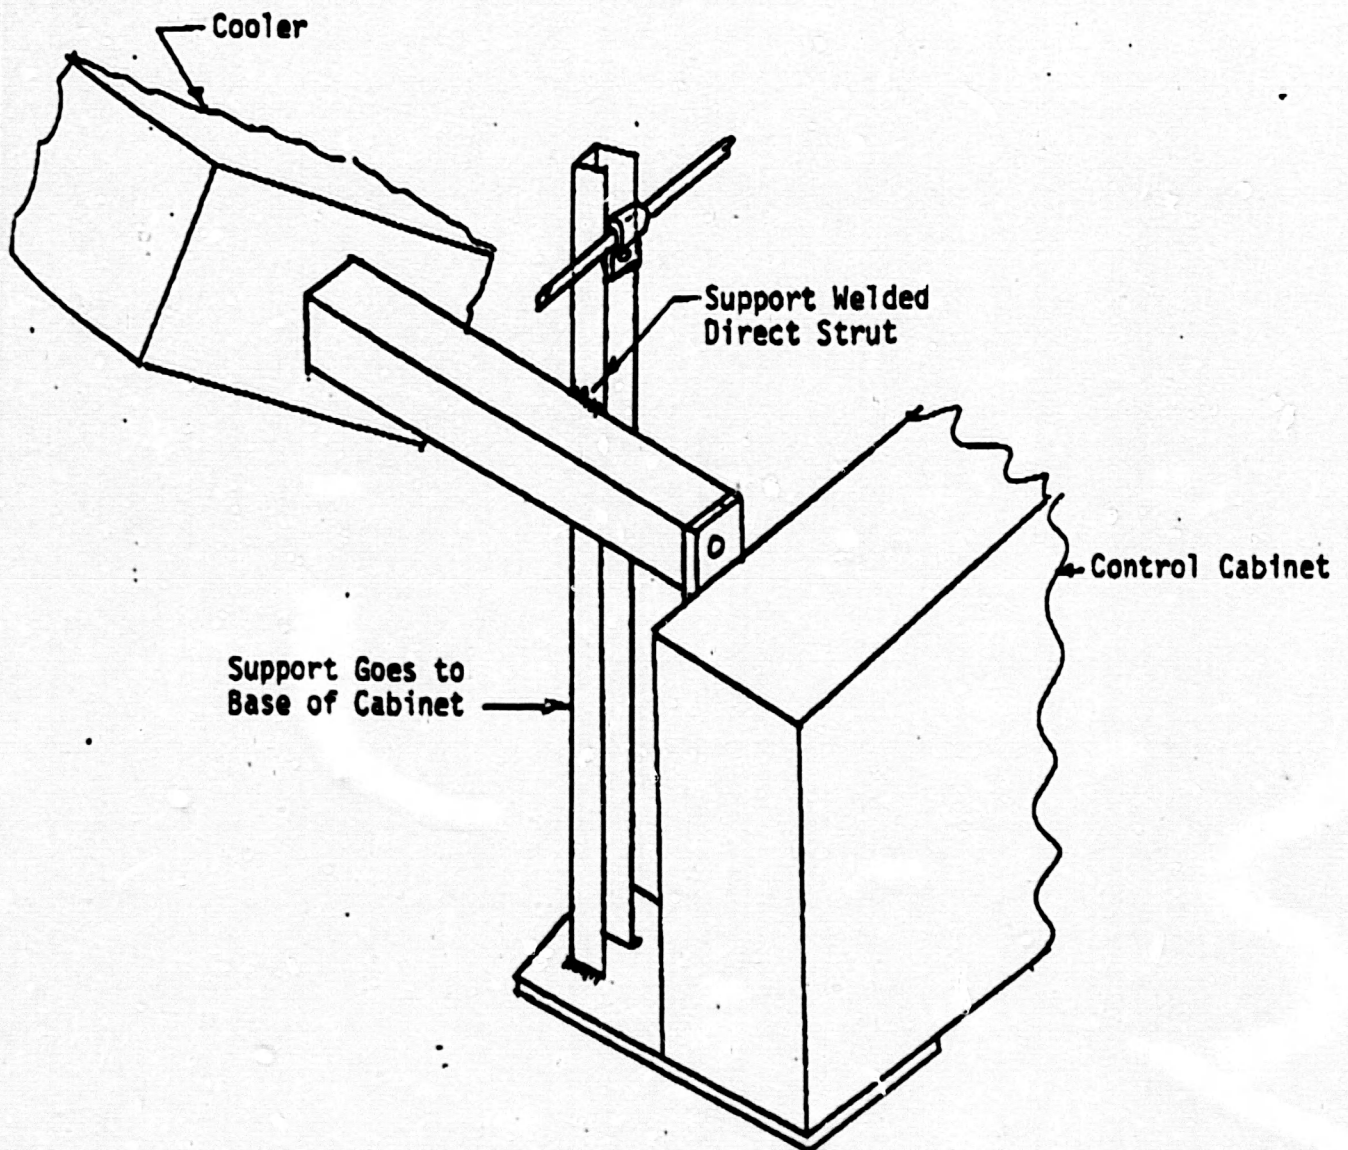
FIGURE 2

DIAGRAM SHOWING STIFFENED SUPPORT FOR
COOLER VENT PIPE

The corrective action taken at the site was to remove the cantilever type support and install a support that is to be connected down to the skid base as shown in Figure 2.
