Westinghouse
Electric Corporation

NS-EPR-2744

March 31, 1983

UV TRIP DEVICE IN PLACE CHECKING PROCEDURE

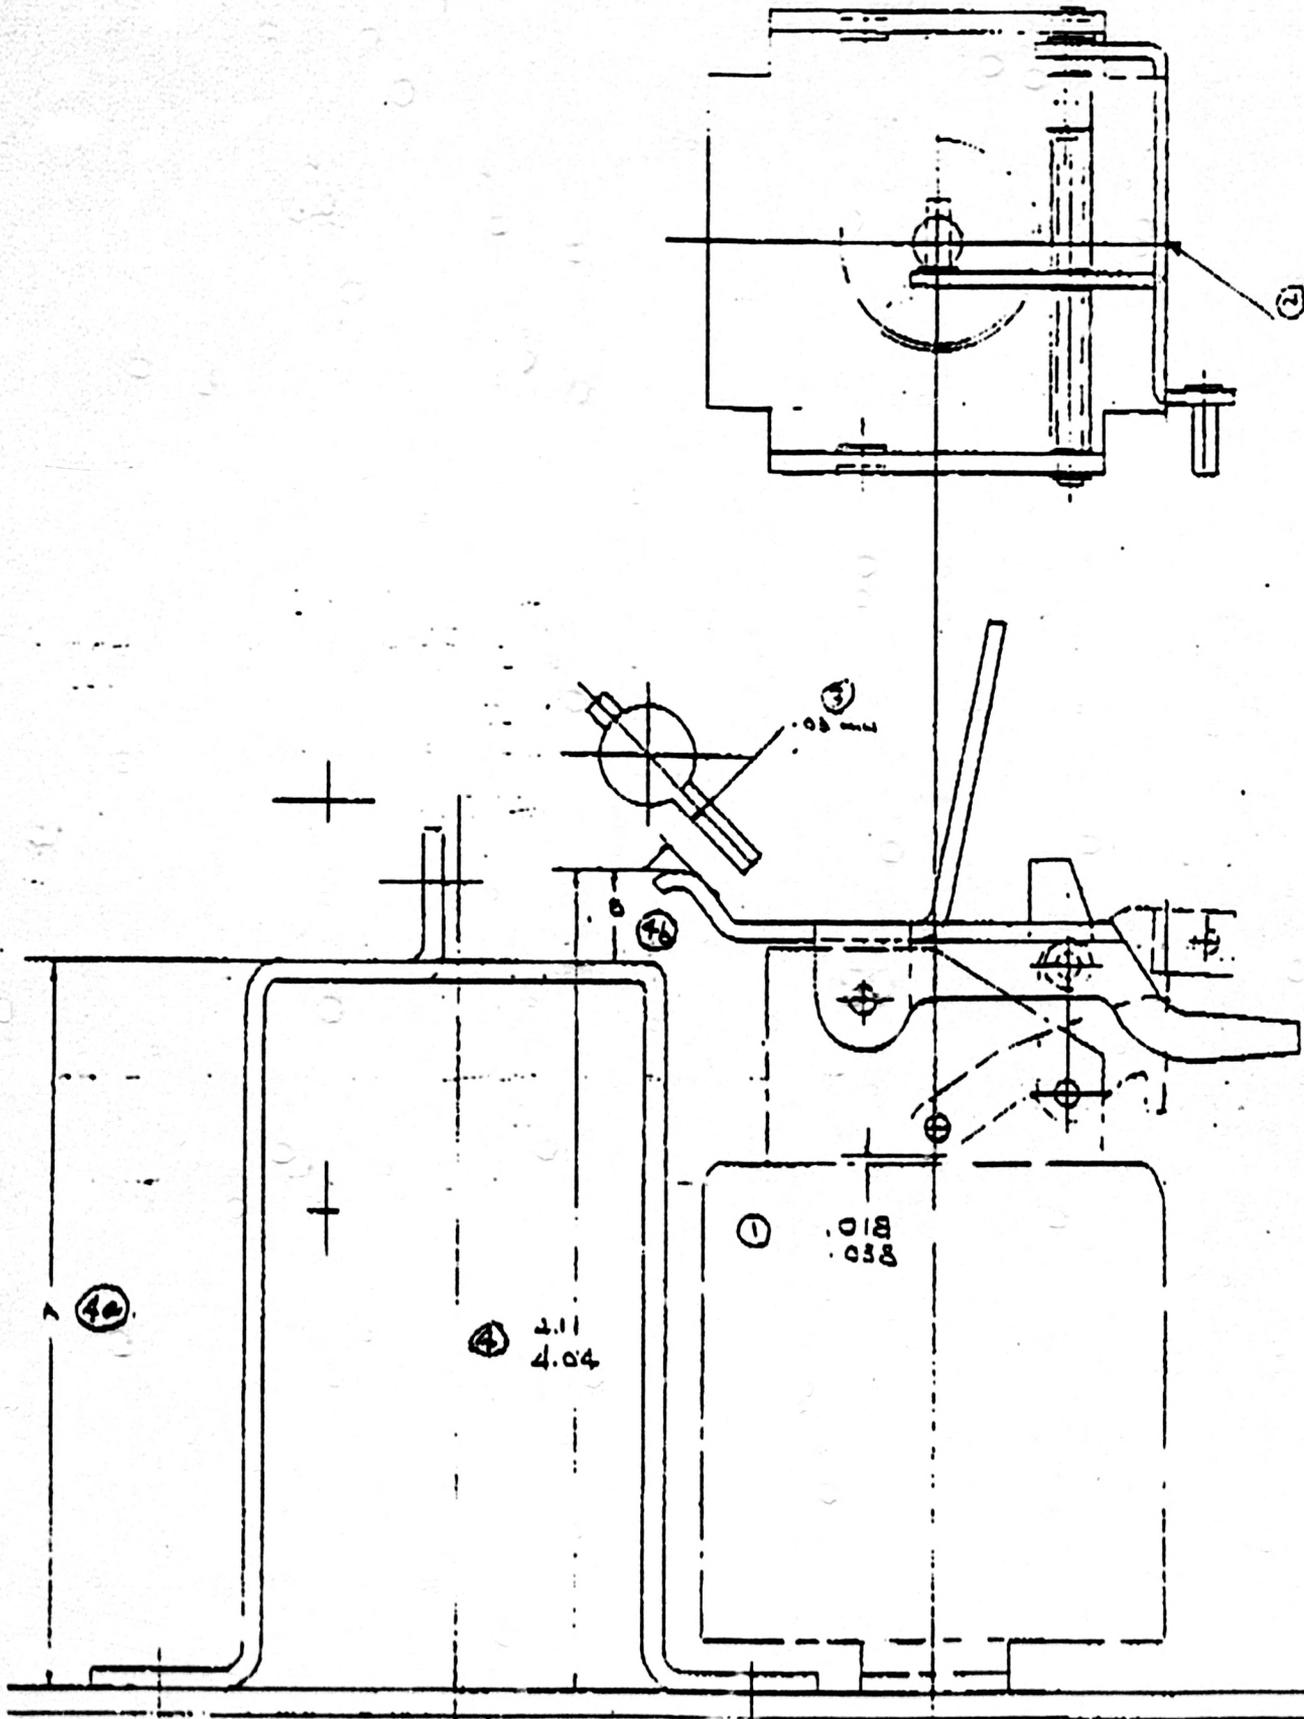
Figure 1
Sheet 1 of 2

6. With suitable filler gauge, check gap between trip pin and reset lever as shown at (3). .03 inch minimum indicates satisfactory interface.
7. These measurements are to be made only if dimension (3) is not met. Measure A & B. A+B should add up to 4.04 to 4.11, (4). If dimension (4), i.e., A+B, is within the specified range, the trip bar should be replaced. If dimension (4) is outside the specified range, the UV assembly should be replaced.

- a. Manufacturing variations permitted interference between the moving core and the roller bracket on one of the UV devices which appears to be related to the intermittent malfunctions. A further factor may have been lack of side-to-side clearance of the roller bracket
- b. Lack of minimum gap between the UV trip reset lever and the breaker trip bar pin appears to be related to the malfunction of the second UV device.

To determine if other DS-416 UV trip devices installed in the field are also susceptible to similar malfunctions, the dimensions identified in Figure 1 must be verified. Westinghouse is requesting that the utilities listed in Table 1 make these dimensional measurements and provide us with the results for our further evaluation of this potential unreviewed safety question.

Until the dimensions are verified, Westinghouse has further recommended that the control room operators actuate the manual reactor trip switch at the Main Control Board when a demand for an automatic reactor trip is observed. If the installed devices meet all the critical dimensions identified in Figure 1, the recommendation for manual reactor trip may be removed. However, if either the UV trip device or the trip bar is found to be out of tolerance with respect to the dimensions identified in Figure 1, Westinghouse recommends that replacement devices be installed.
