Re: Mine Permit No. 633; Smith Ranch-Highland Uranium Project (SR-HUP):
Release of Solutions Report pursuant to WDEQ-LQD Non-Coal R&Rs, Chapter 11,
§12(a)(ii)(A-D), Mine Unit K Injection Trunk line to Header House K-6, 17 August 2008

Power Resources, Inc Smith Ranch-Highland Uranium Project URANIUM IN SITU FLUID RELEASE REPORT

**MINE UNIT K
 SPILL AND SAMPLE
 LOCATIONS**

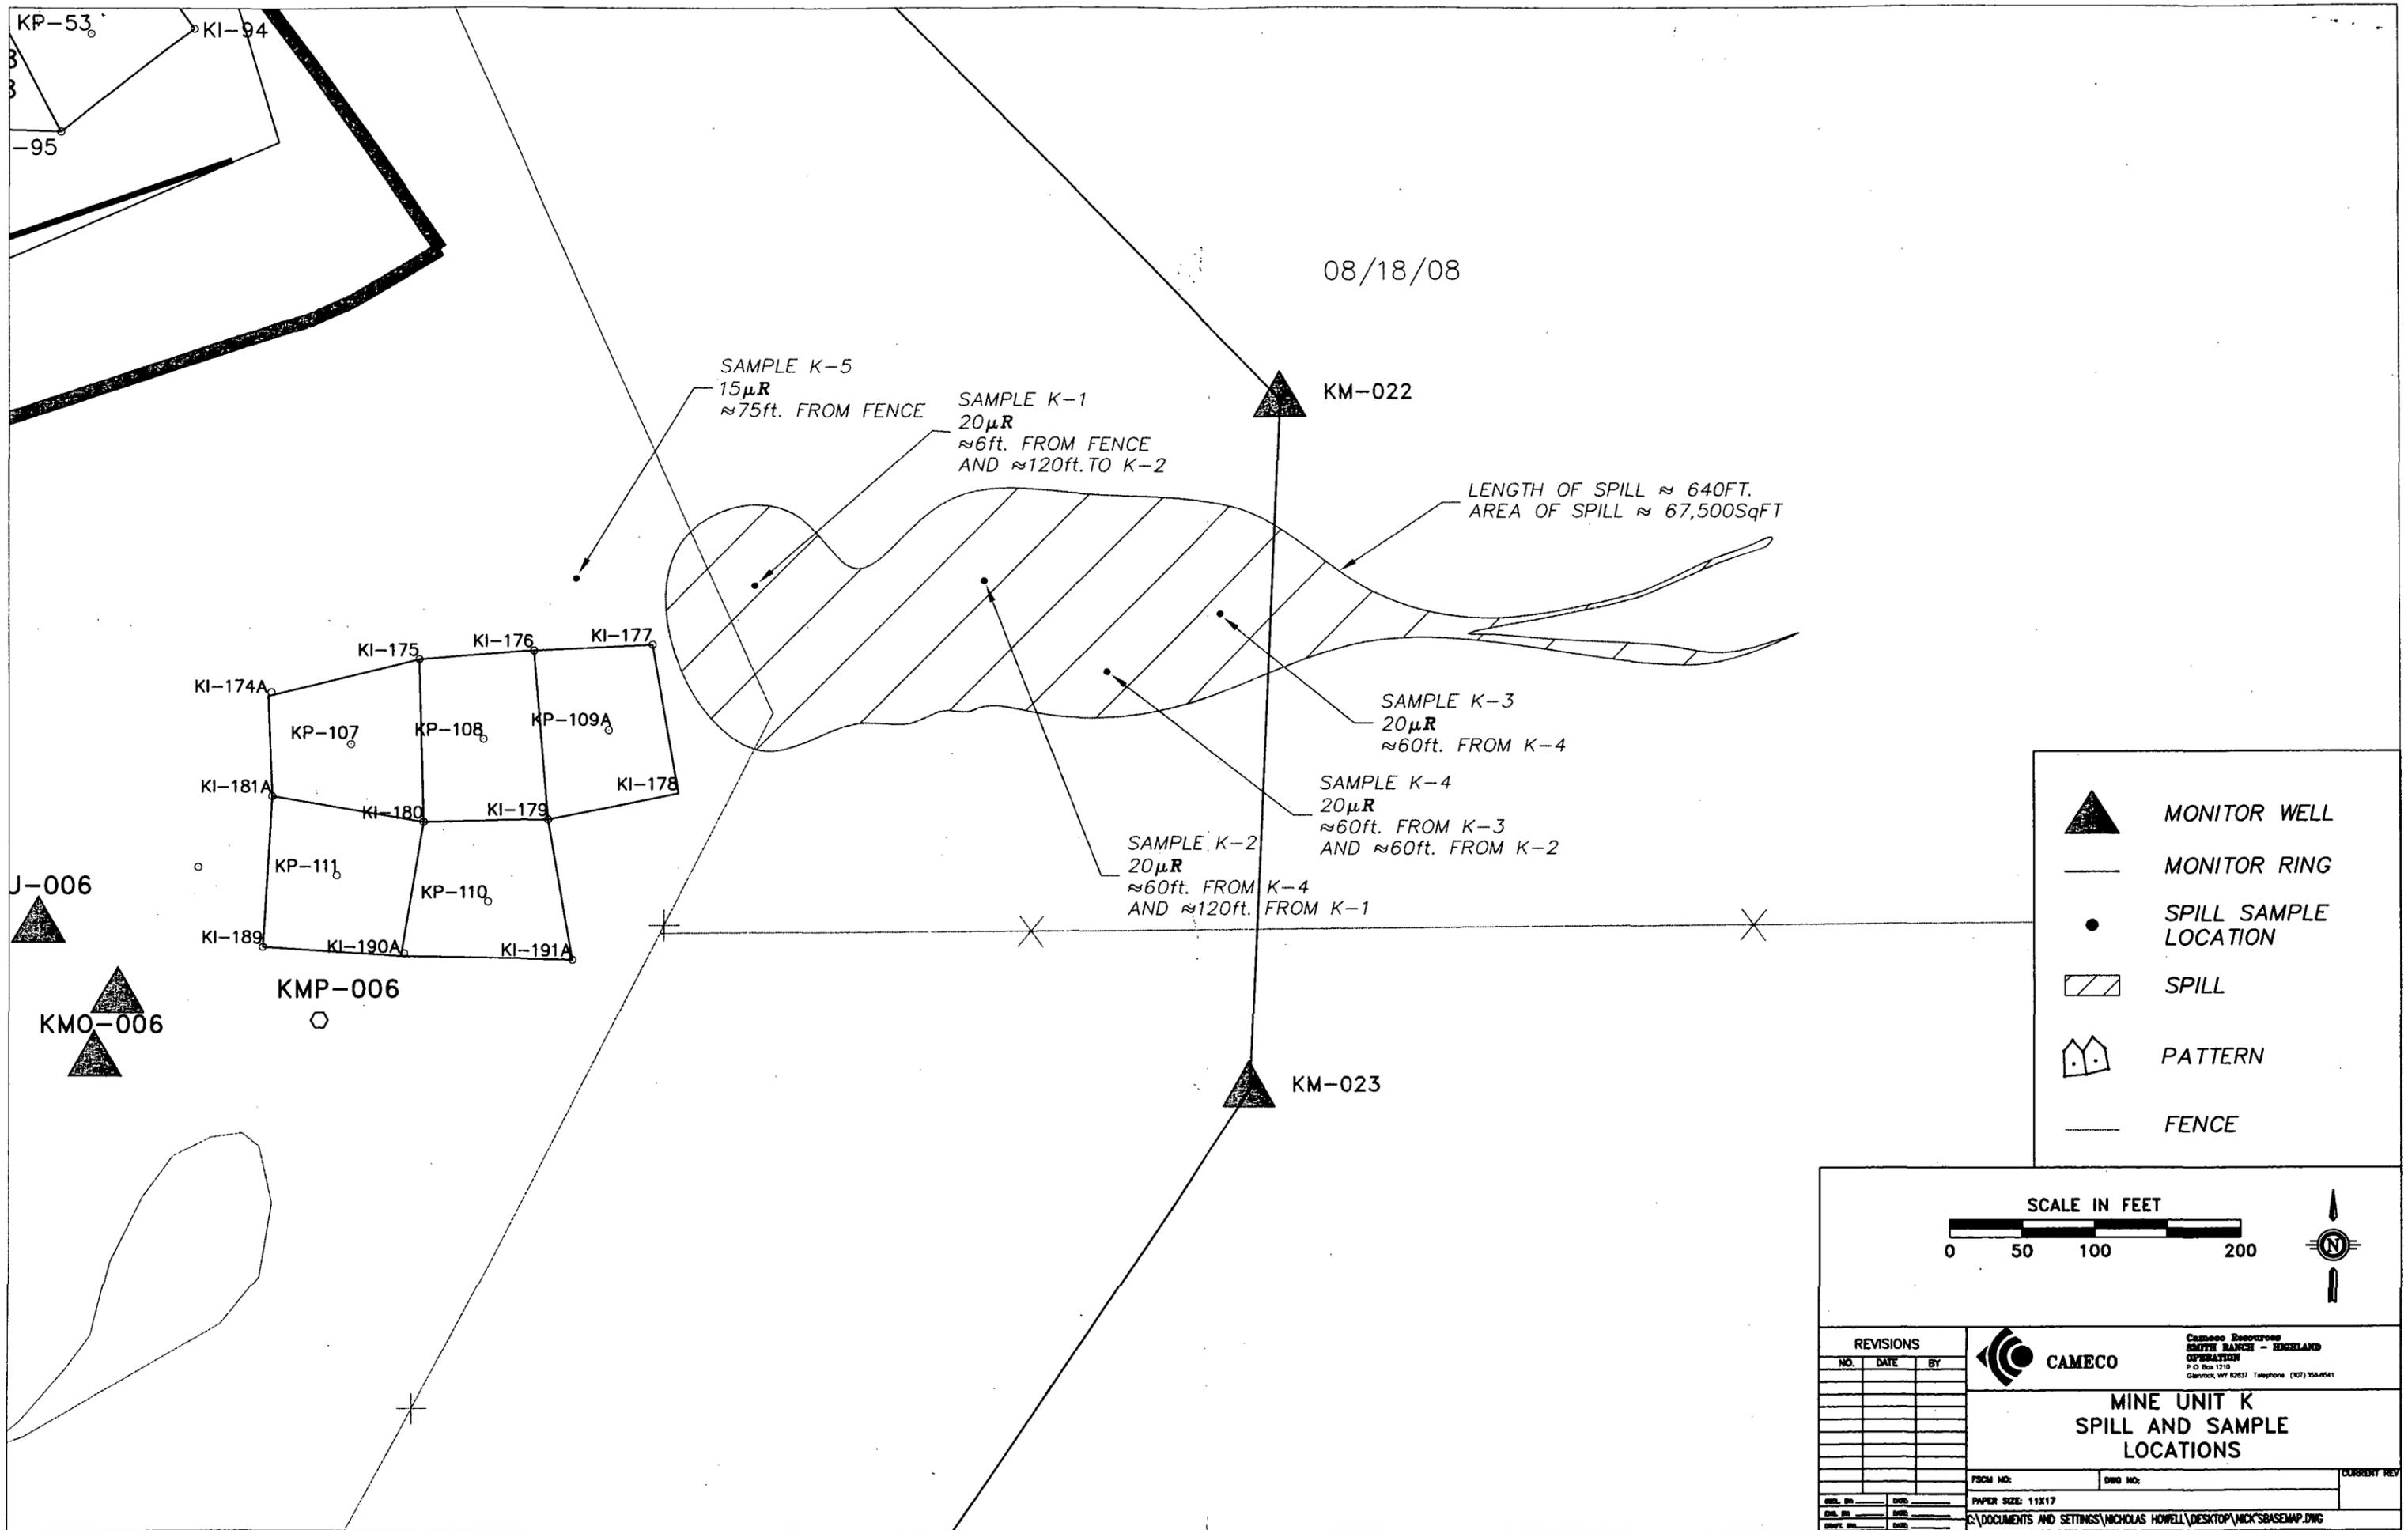
map, which also gives the gamma readings in microrems (μR). Readings from the spill area were 20 μR ; a background reading at K-5 showed 15 μR , a negligible difference. The fluid is not considered hazardous material under RCRA and is not reportable under SARA.

SAMPLE K-5
15µR
≈75ft. FROM FENCE

SAMPLE K-1
20µR
≈6ft. FROM FENCE
AND ≈120ft. TO K-2

LENGTH OF SPILL ≈ 640FT.
AREA OF SPILL ≈ 67,500SqFT

SAMPLE K-3
20µR
≈60ft. FROM K-4

SAMPLE K-4
20µR
≈60ft. FROM K-3
AND ≈60ft. FROM K-2

SAMPLE K-2
20µR
≈60ft. FROM K-4
AND ≈120ft. FROM K-1
