Re: Mine Permit No. 633; Smith Ranch-Highland Uranium Project (SR-HUP):
Release of Solutions Report pursuant to WDEQ-LQD Non-Coal R&Rs, Chapter 11,
§12(a)(ii)(A-D), Mine Unit K Injection Trunk line to Header House K-6, 17 August 2008

Power Resources, Inc Smith Ranch-Highland Uranium Project URANIUM IN SITU FLUID RELEASE REPORT

A. DESCRIPTION OF THE EVENT AND MITIGATIVE ACTIONS TAKEN

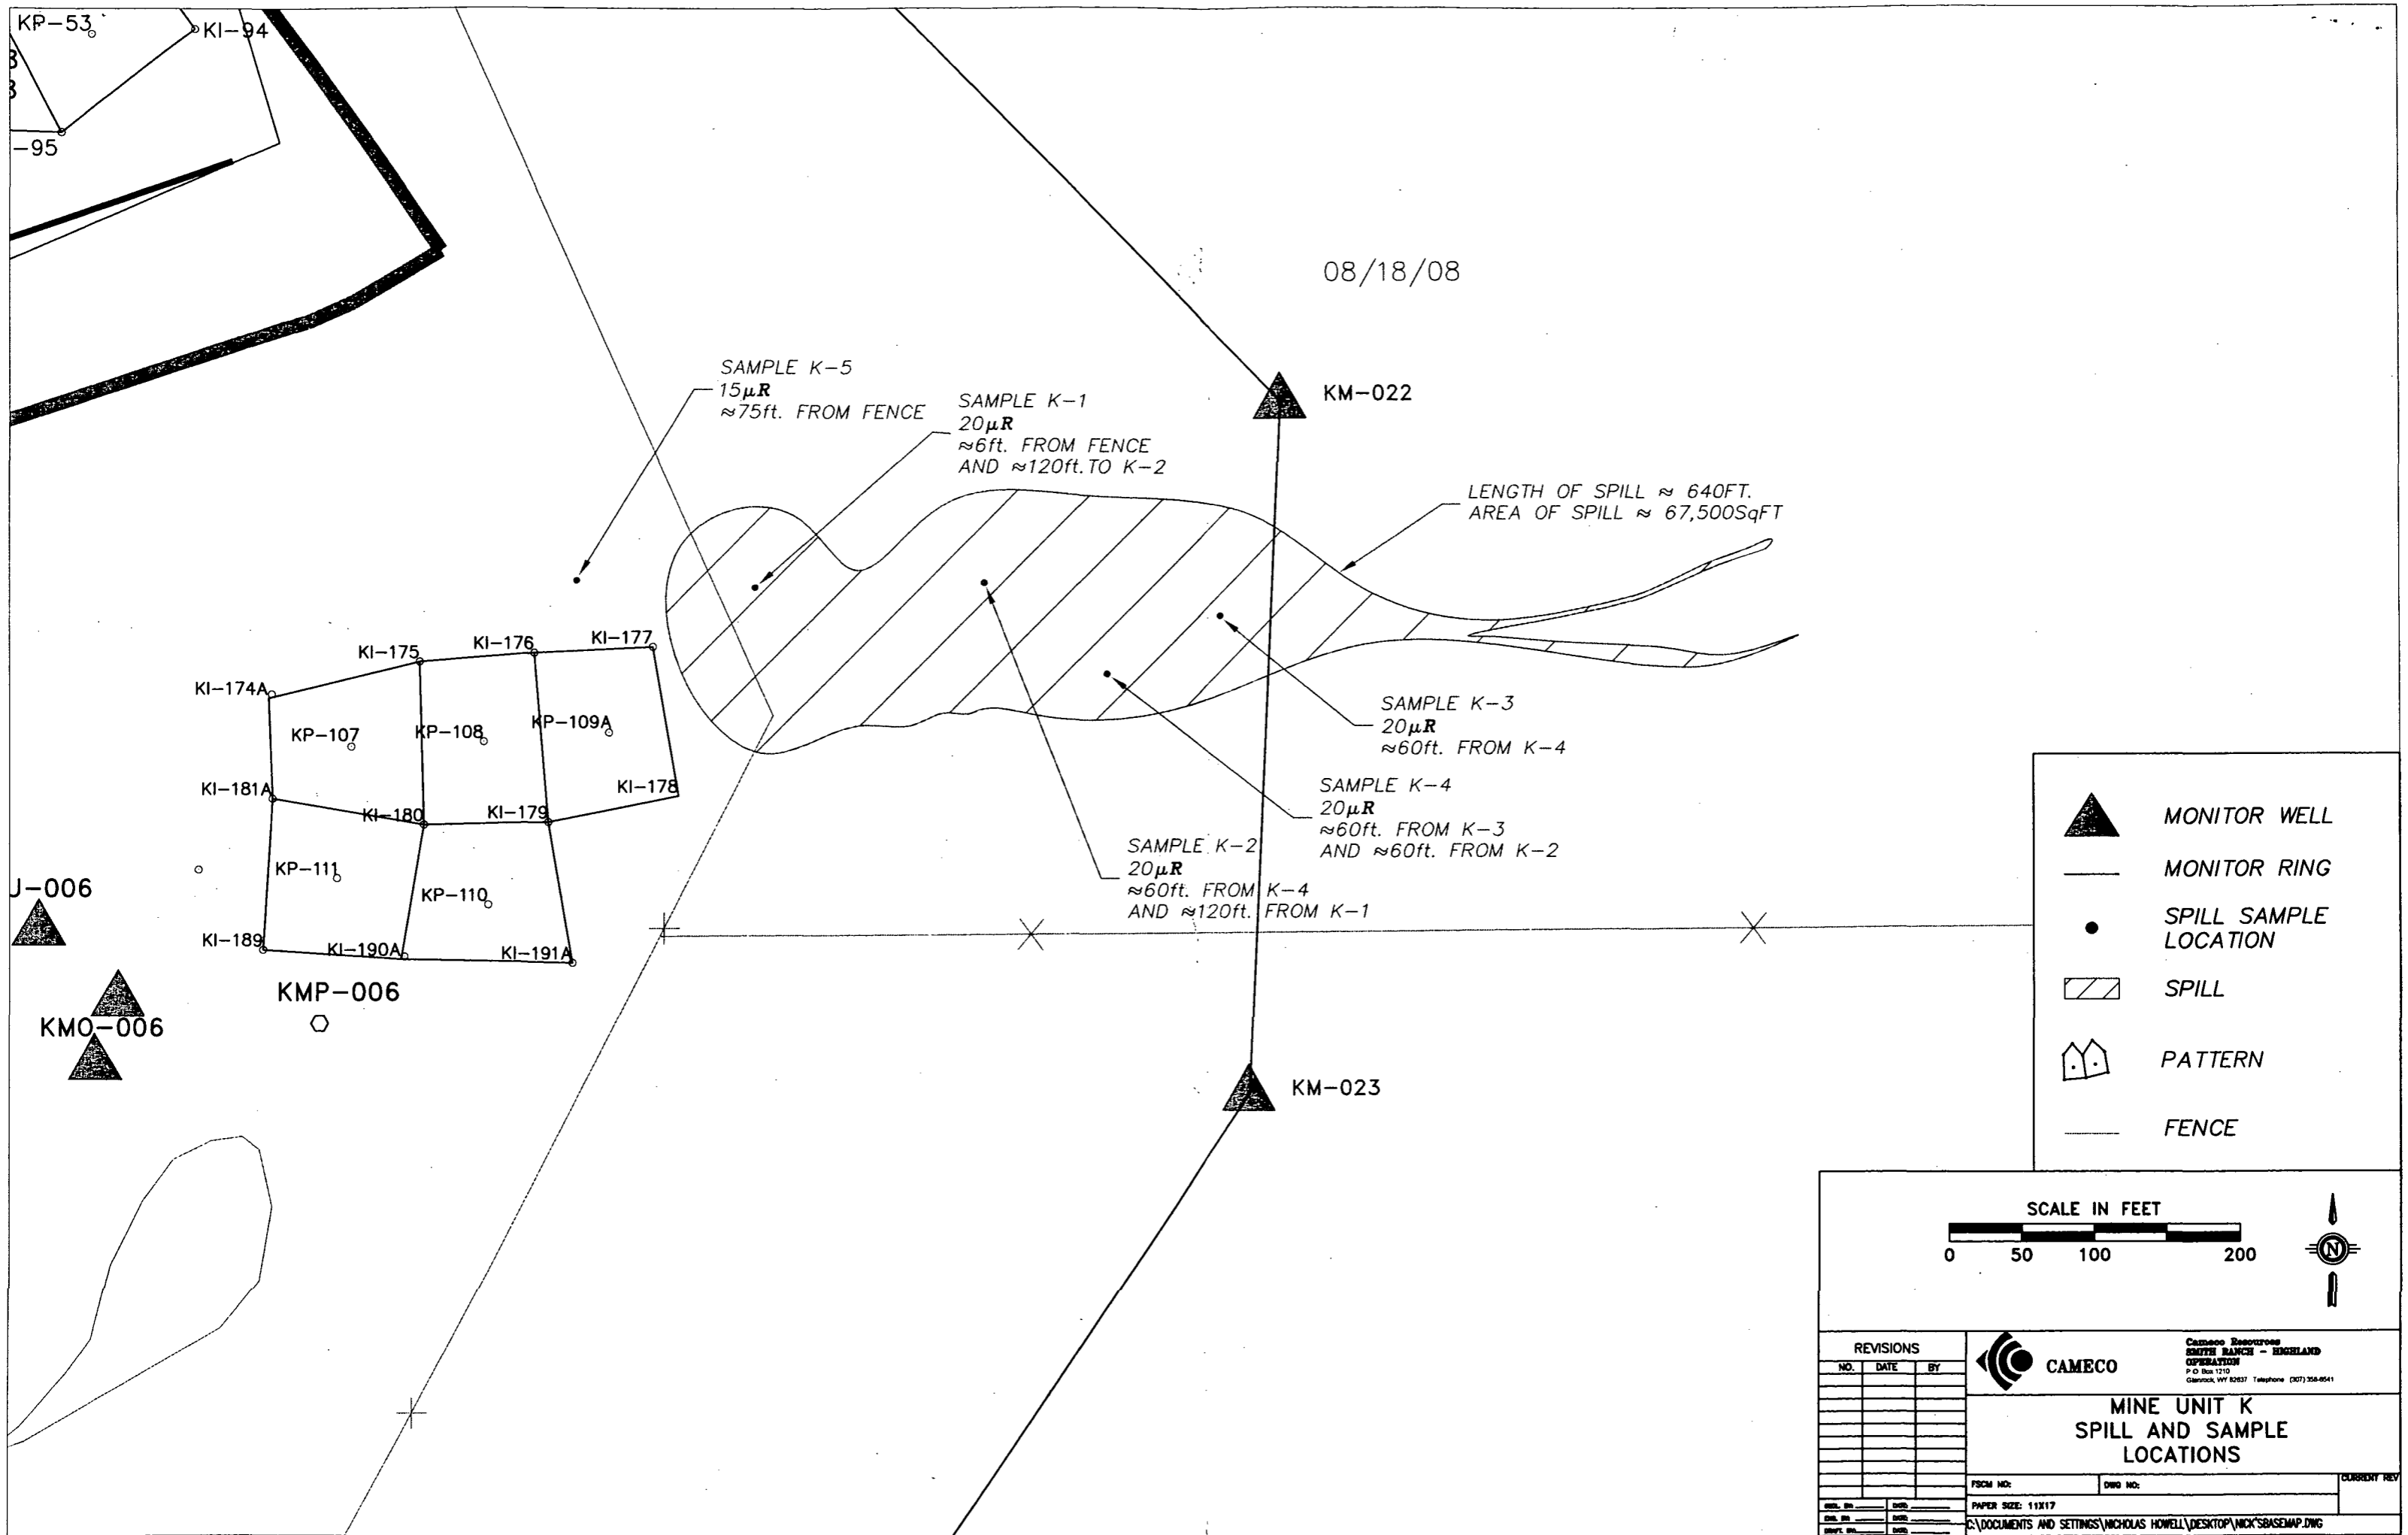
**MINE UNIT K
 SPILL AND SAMPLE
 LOCATIONS**

map, which also gives the gamma readings in microrems (μR). Readings from the spill area were 20 μR ; a background reading at K-5 showed 15 μR , a negligible difference. The fluid is not considered hazardous material under RCRA and is not reportable under SARA.

SAMPLE K-5
15µR
≈75ft. FROM FENCE

SAMPLE K-1
20µR
≈6ft. FROM FENCE
AND ≈120ft. TO K-2

LENGTH OF SPILL ≈ 640FT.
AREA OF SPILL ≈ 67,500SqFT

SAMPLE K-3
20µR
≈60ft. FROM K-4

SAMPLE K-4
20µR
≈60ft. FROM K-3
AND ≈60ft. FROM K-2

SAMPLE K-2
20µR
≈60ft. FROM K-4
AND ≈120ft. FROM K-1
