Building Engineering Report

Defense National Stockpile Depot

GS05P90GBD0028RIN91011, Work Order No. 10

Climate Controlled Occupied Buildings

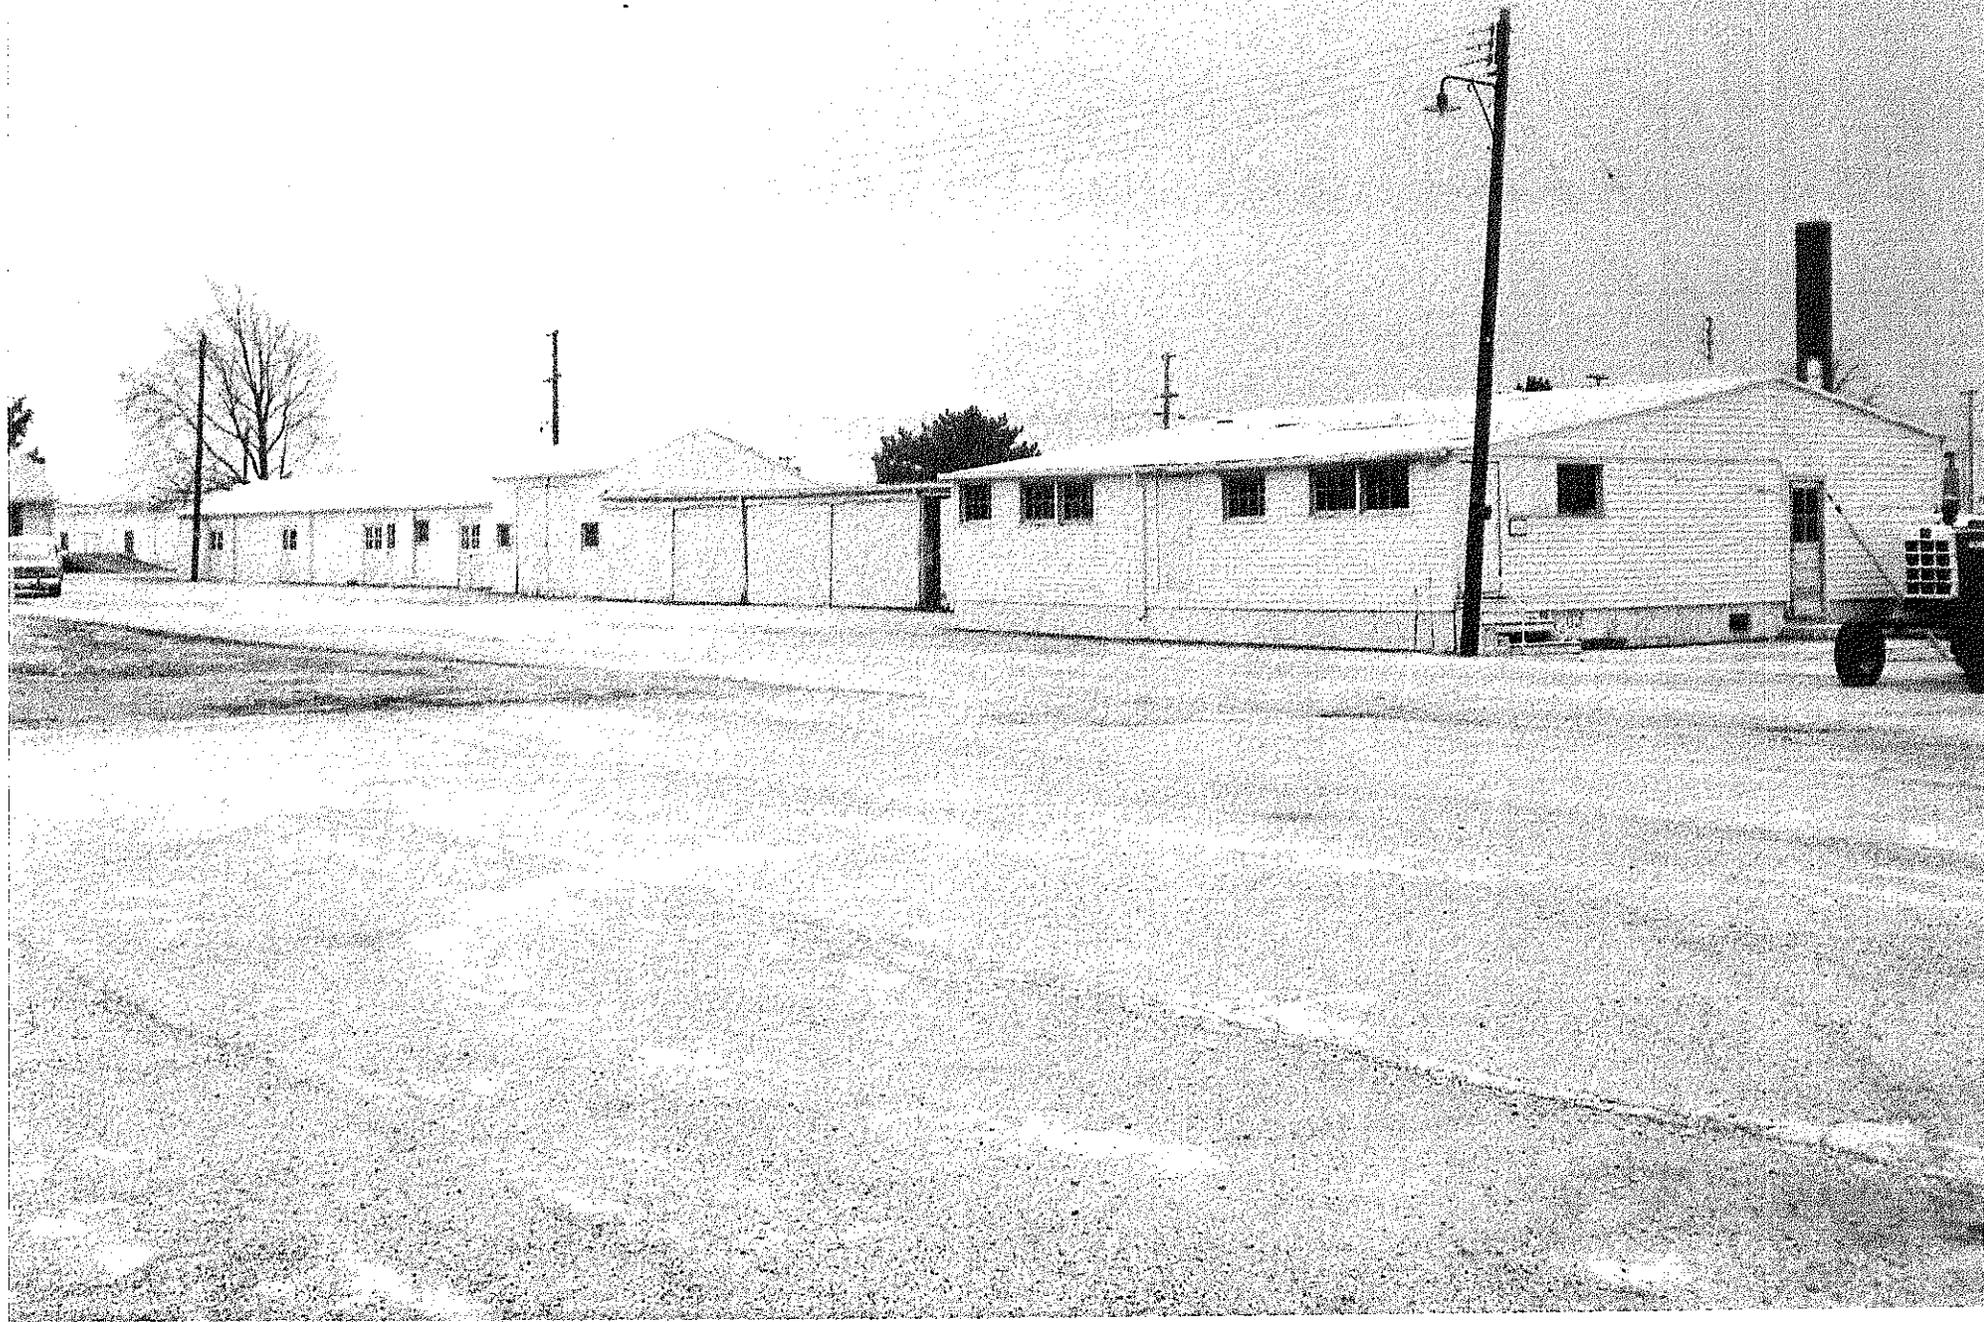
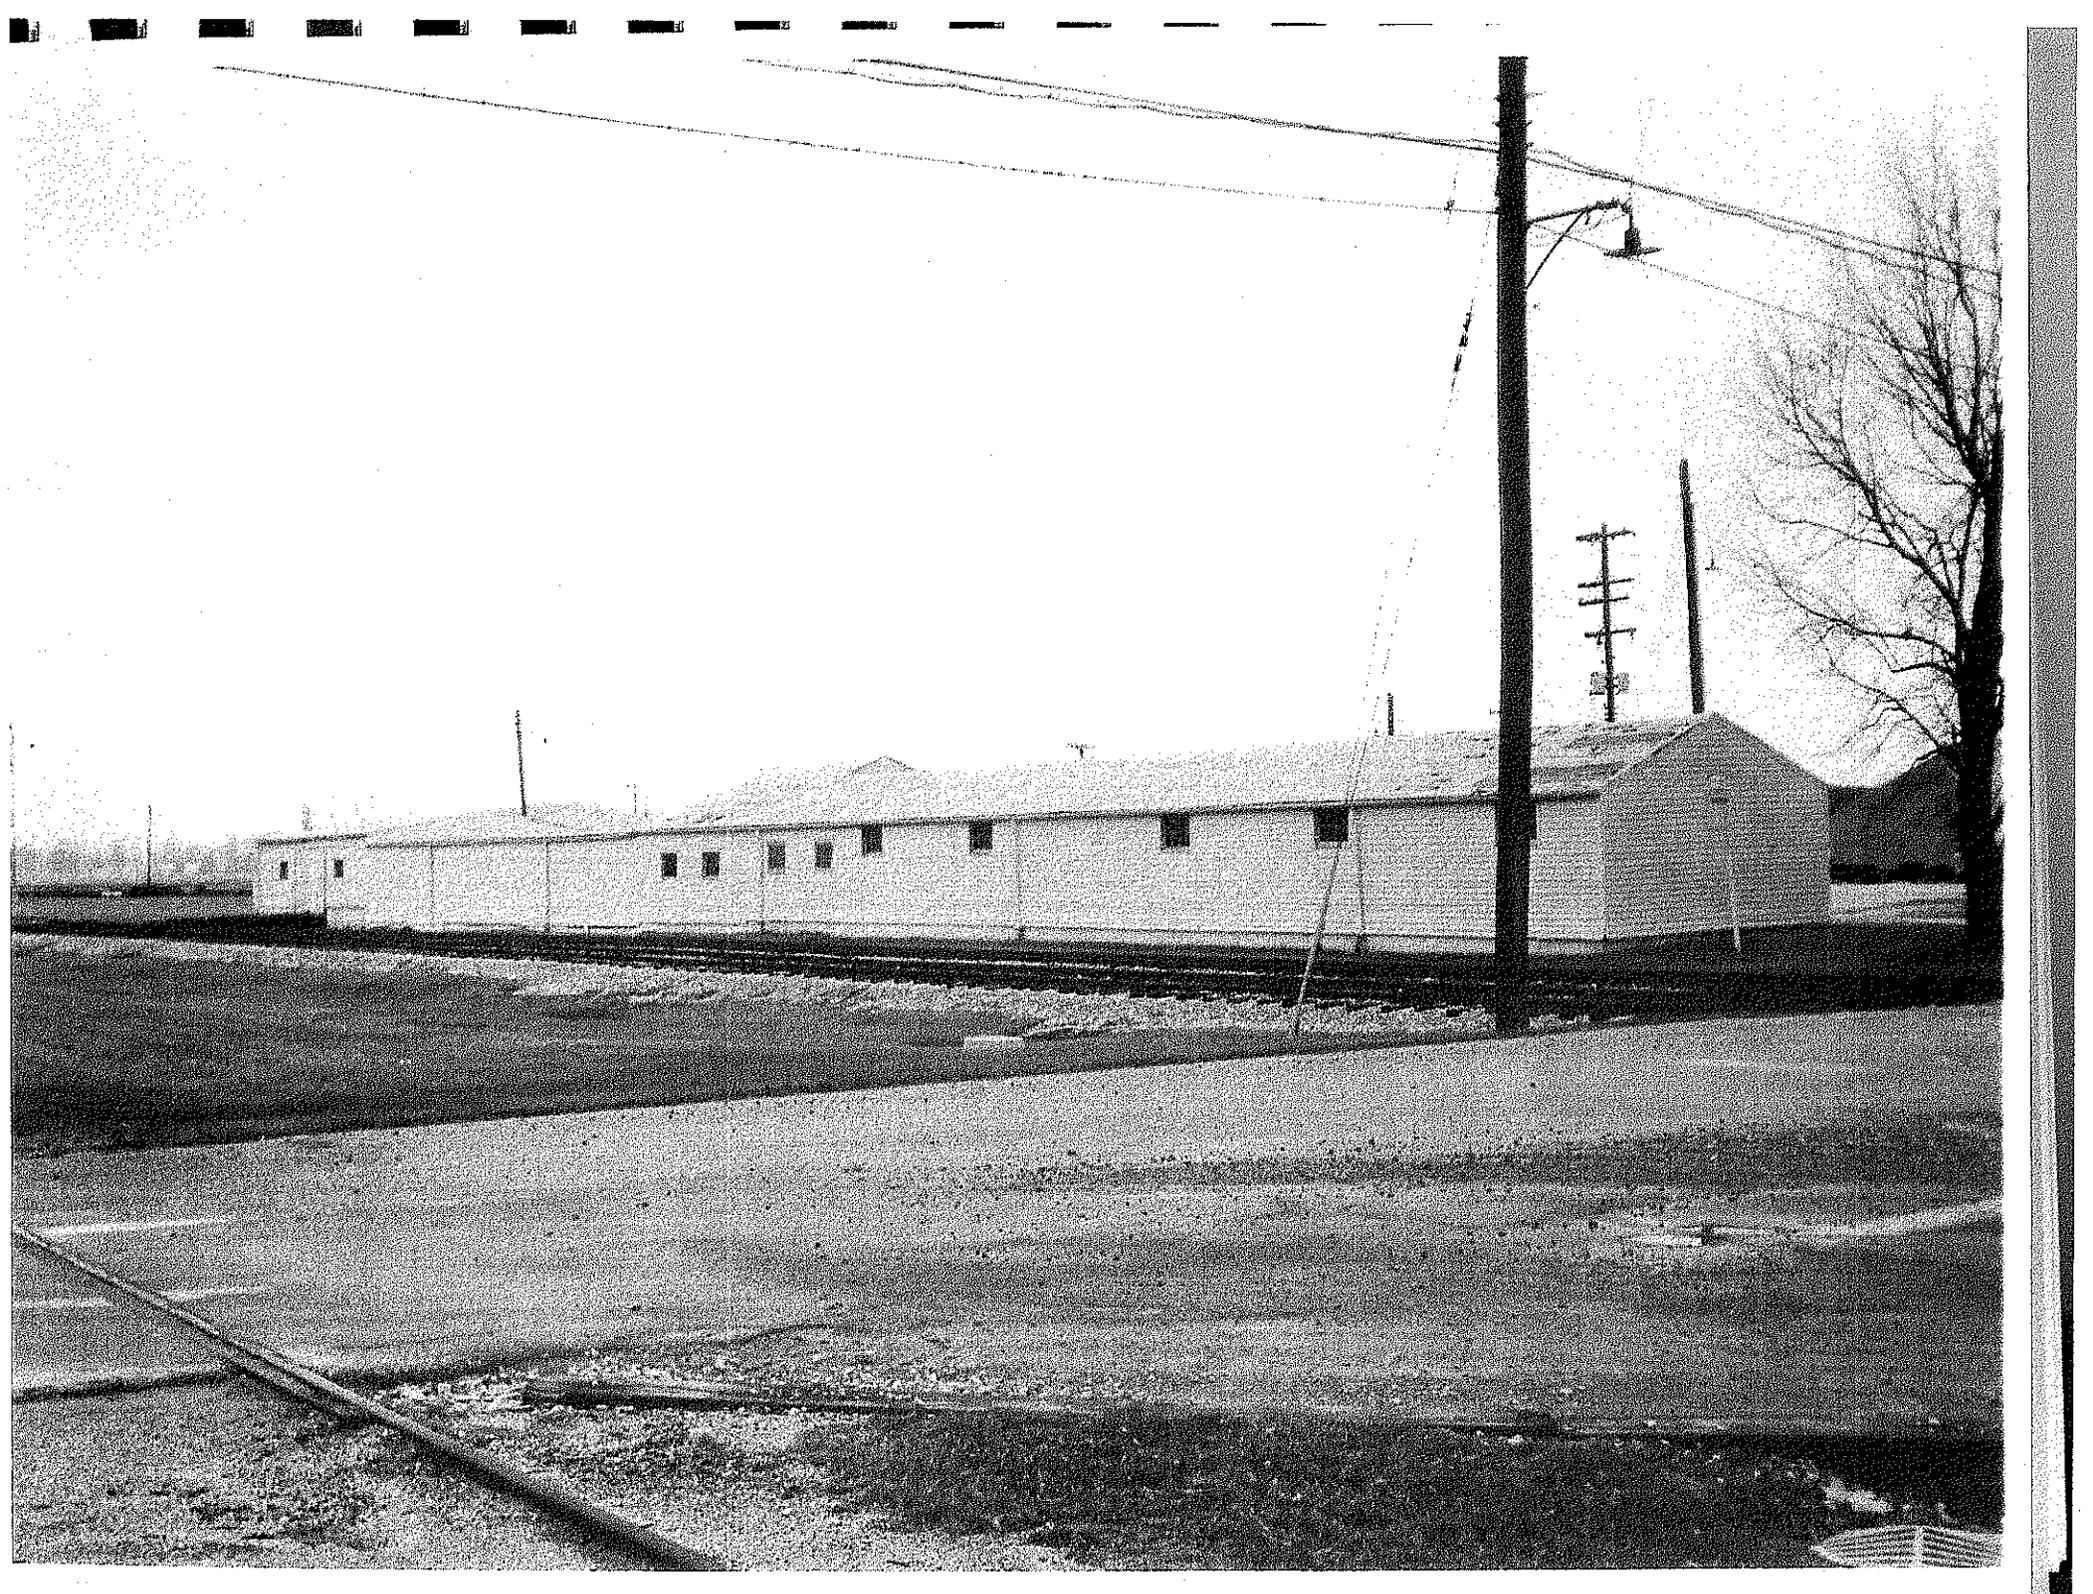
T141 (IN0643NH)

This building has rotted siding and should be scraped, painted and caulked. The roof should be replaced as well as the gutters and downspouts. Splashblocks should be added to divert the water away from the building. In the second and third sections of the building there is evidence of water entering the building. This damage should be repaired and replaced. The exposed rafters in the section are also water-marked. The floor is concrete and has a major crack running down the center of the building in an east to west direction. This crack should be repaired.

This is a wood framed building with a wood structural system and rolled roofing. There are some siding that has rotted as well as the window sills and the doors. The doors and windows should be replaced. The entire building should be scraped, painted and caulked. The roof needs to be replaced as well as the downspouts and gutters. Splashblocks should be added to divert the water away from the building.

This portion of the building is used for equipment storage by on-site maintenance staff. The outside of the building is in bad need of paint and should also be caulked. The roof should be replaced. The sliding doors and jambs have rotted areas. Part of the siding and sill at the south elevation also is rotted. Gutters and downspouts should be replaced and splashblocks added to divert the water away from the building. The interior slab is badly cracked and settled. It should be replaced. There is as much as 3" of differential settlement and some of these cracks are 1 1/2" - 2" wide. There is a heating pipe that is insulated and wrapped running the length of the building. The insulation and pipe wrap should be checked for asbestos. Towards the west end of the building there are some water damage and rotted roof joists that should be replaced. Also, there is split corner bracing and diagonal column braces that should be replaced.

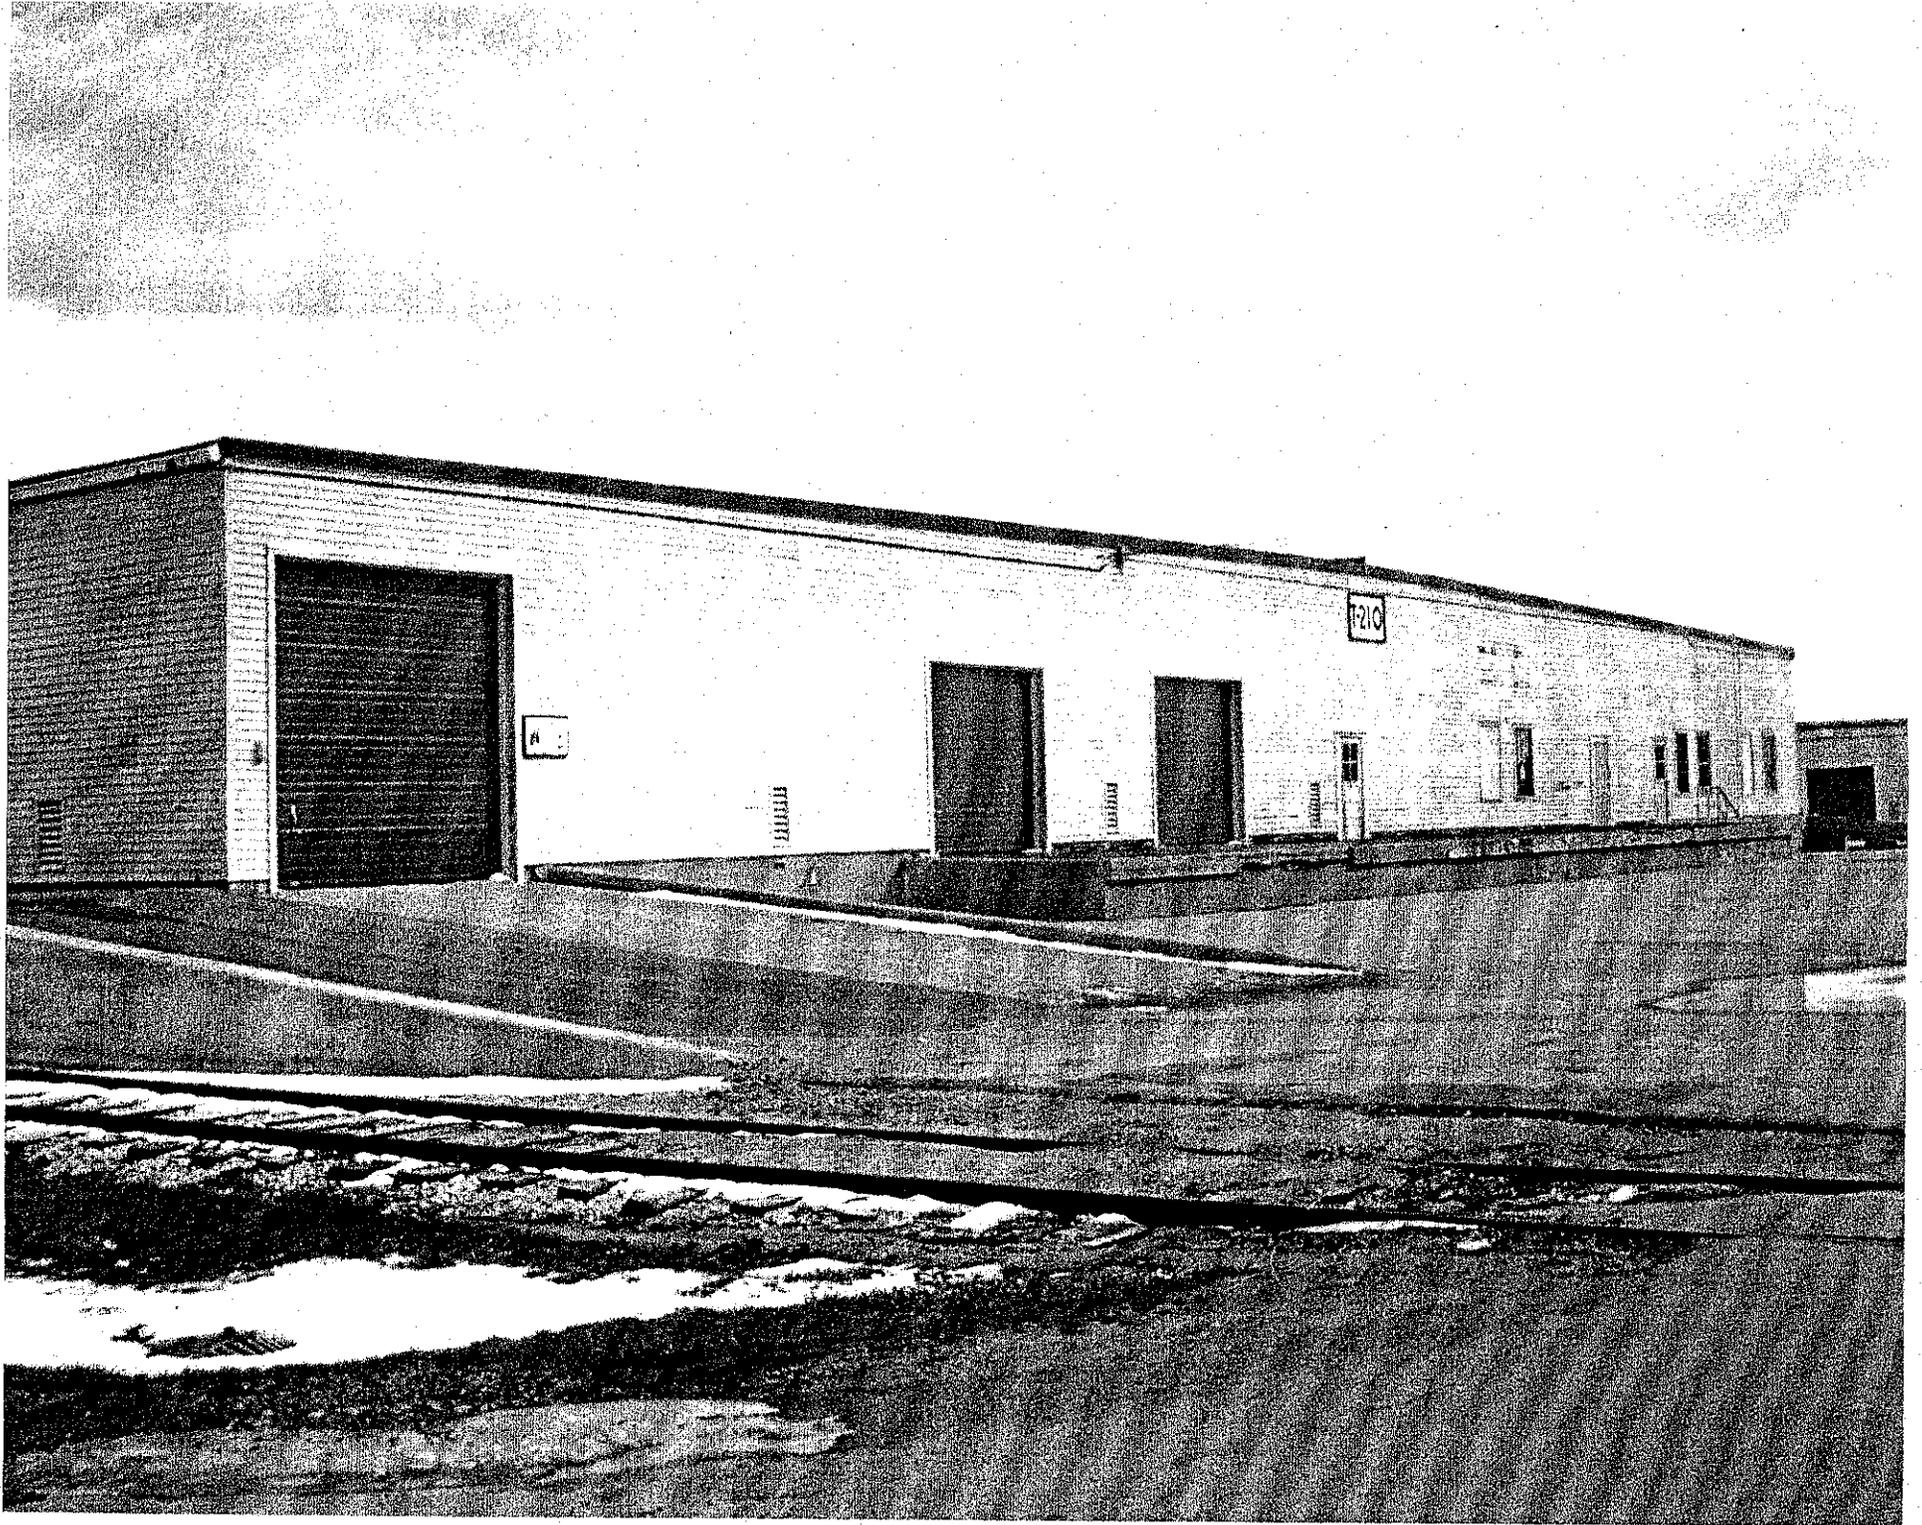
T210 (IN0612NH)

This warehouse building is 960' long by 180' wide. It is a wood construction, wood structural system, wood deck and a modified bitumen roof. The docks at either end of the building as well as the ramps are concrete and filled with asphalt. The wood bumpers for the dock should be replaced. The concrete steps at either end of the building are spalling and should be replaced. The wood rail is rotted and deteriorated. It also should be replaced. The platform at the south elevation of the building has several areas where the asphalt has been patched. These are at the downspout leaders. The patching was done incorrectly and has heaved. This should be corrected. The wood windows and wood personnel doors are deteriorated and should be replaced. The entire building is in bad need of paint and should be scraped and caulked also. Any trim that has deteriorated as well as siding should be repaired and replaced. The building has a relatively new modified bitumen roof, however, the gutters and downspouts were not replaced at that time. These need to be replaced. The building is divided into four sections by brick fire walls. The ends of the firewalls should be sealed at the exterior walls. Above the roof the parging on the firewalls is pulling the brickface off. This should be corrected. There are interior offices and restrooms located at the west end of the building as well as the east. Some of the drywall for these offices and restrooms should be replaced because they are water damaged. All areas if used should be repainted. A small basement exists at the southwest corner of the building. At one time it housed the boiler and coal bins. It extends under the south dock. There is a small amount of water standing on the floor. The reinforcing in the ceiling is exposed. The side walls are leaking. The basement is not used at this time and the boiler does not exist. The sprinkler system also should be upgraded to function properly.

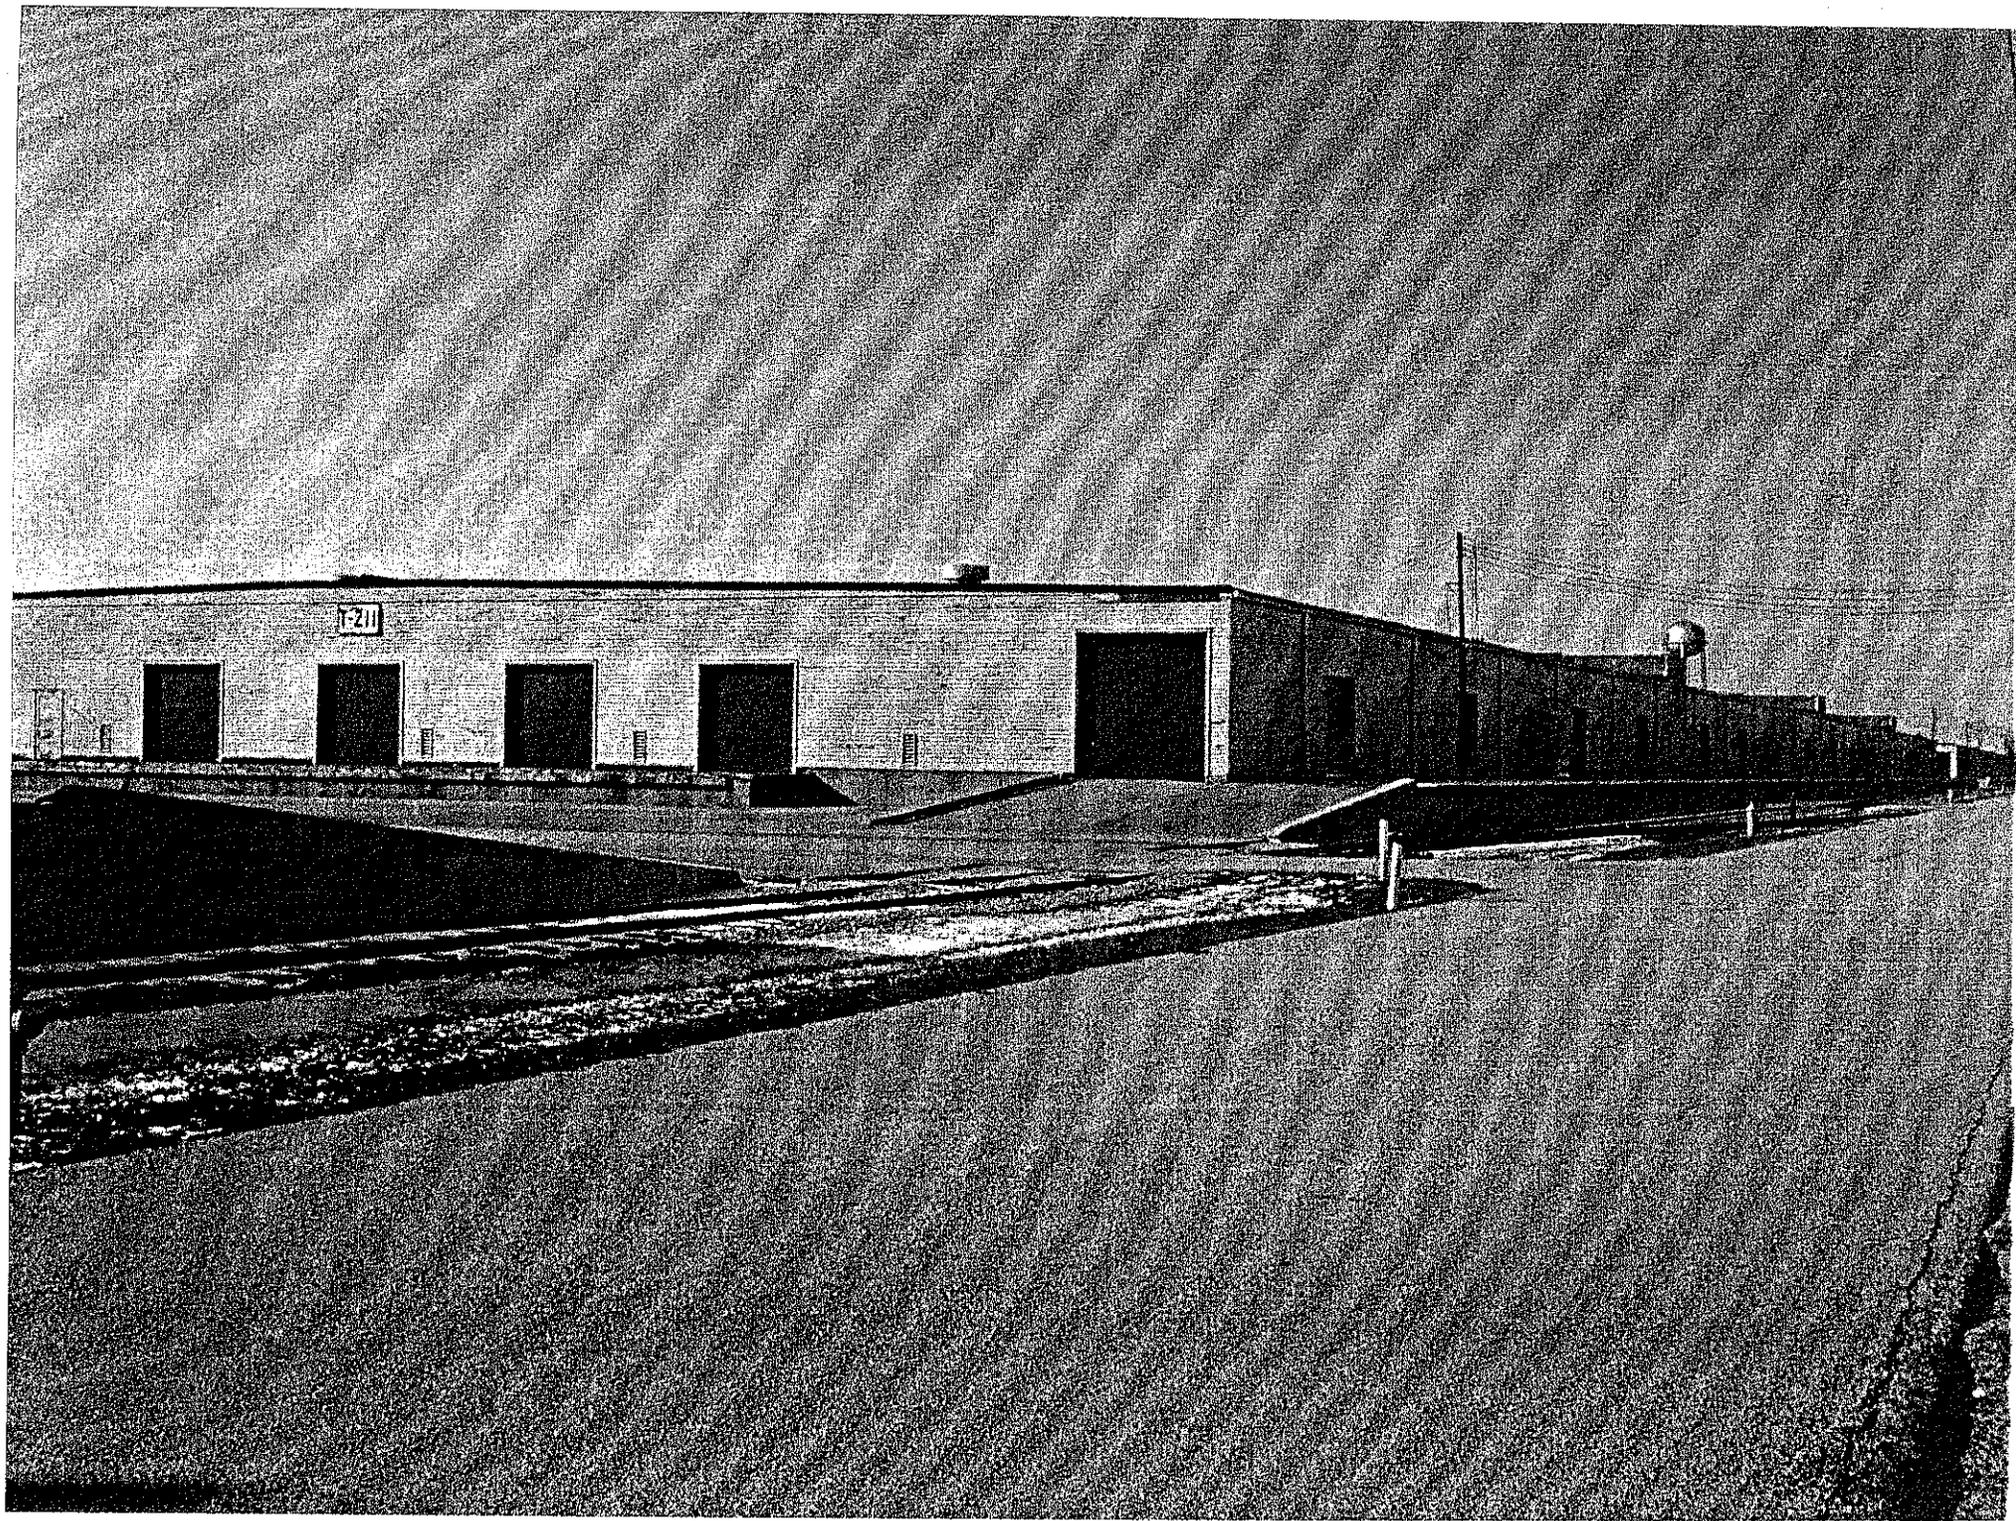
T211 (IN0613NH)

This is a 960' by 180' warehouse building with a slab-on grade, wood exterior walls with a wood structural frame system, wood roof deck and a modified bitumen roof. The east and west docks are concrete with asphalt fill. The wood dock bumpers are rotted and deteriorated and should be replaced. The concrete steps are spalling and should be replaced. The wood rails are deteriorated and should be replaced. There are scattered areas of spald concrete at the edges that should be repaired. The north and the south retaining walls are out of plumb. The gutters and downspouts drain under the platforms and empty onto the railroad tracks on both the north and the south elevation. There is no swale evident to carry the water away. The roof has been replaced recently, however, the gutters and downspouts were not and should be replaced. Also, the cast iron leaders should be checked for blockage. There are indications that they may be stopped up. The windows and personnel doors in the entire building should be replaced. The entire building should be scraped, caulked and painted. All of the trim work should be repaired or replaced as needed. The wood louvers on the exterior walls are in very bad repair and should be replaced. In general, the concrete floor is cracked, however, at the northwest ramp door and around the overhead doors they are especially bad. This building also has a partial basement at the northwest corner. It is standing in one inch of water. The offices and restrooms at the east and west end are of wood partition with drywall construction and show some signs of water stain and damage. It was suggested that these rooms be demolished and the space used for additional storage. The floors at the fire doors as reported on the previous report have not been corrected. The corrections per the fire sprinkler survey have not been made.

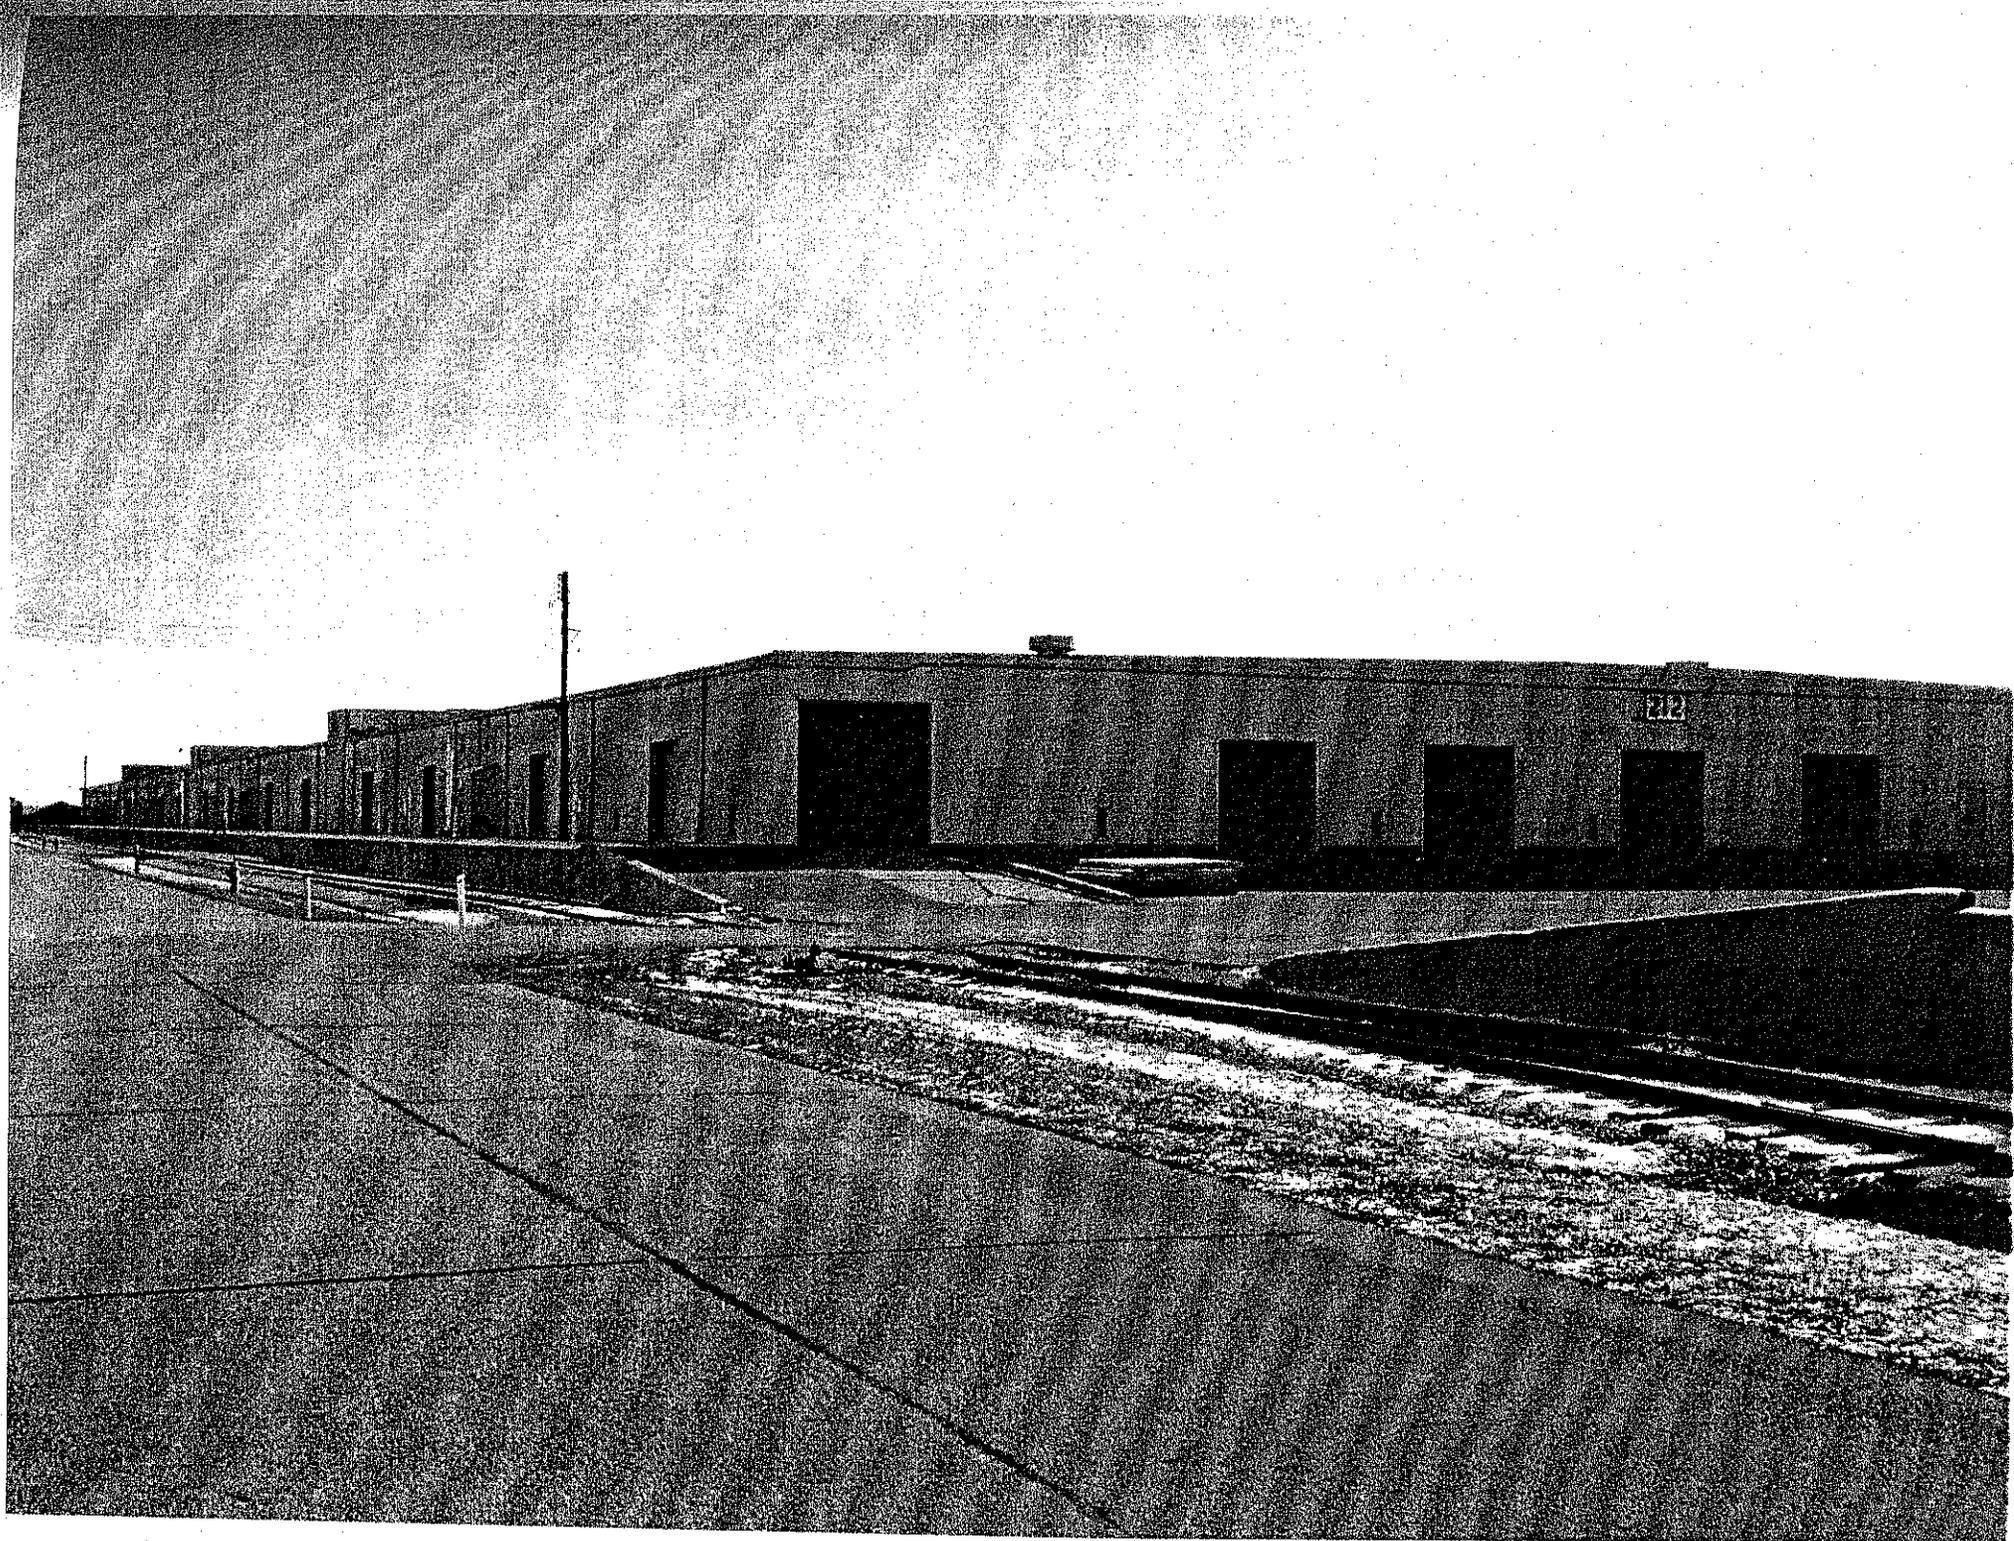
T212 (IN0614NH)

This building is used as a warehouse. It is elevated approximately 3 1/2' and has a dock on all four sides. At the east and west end the docks have concrete ramps for access to the platforms. There are concrete steps in the truck dock area. The concrete for the most part is spald. The asphalt on the east and the west end is breaking up and is cracked. The handrails for the steps are of wood and are rotted. At the north elevation the concrete retaining wall for the elevated dock is out of plumb. The building is of wood frame construction and has wood siding. The roof is a rolled roof and is in bad condition. The entire exterior paint is cracked, chipped and peeled. All of the siding and trim should be replaced as necessary. The entire exterior should be scraped, primed and painted after it has been caulked. Nine person doors at the exterior are in poor condition and are coming apart. The doors, frames and hardware should be replaced. Where the elevated dock joins the building there is a crack. This crack should be filled with sealant. At the outer end where the asphalt meets the concrete retaining wall there also is a joint that is allowing water to penetrate behind the concrete. This joint should be filled with sealant. The gutters and downspouts for this building are corroded. The joints are open and the brackets and nails are loose. All gutters and downspouts should be replaced. The building is divided into four areas by brick firewalls. Above the roof on these firewalls the flashings have failed and should be replaced. In general the floor slab is cracked, especially bad are bays 51, 52, 55 and 56. The slabs at most overhead doors are cracked and fall away towards the doors. At each end of the building there are offices and restrooms that are no longer used. If it is determined that these need to be brought back into operable condition, extensive repairs will be necessary. At the southwest corner of the warehouse a partial basement exists that once housed a boiler. The sidewalls, floors, and ceiling are in need of repair. Water is standing on the floor. In some cases the reinforcing is exposed at the ceiling, however the boiler has been removed. Inspection of the electrical system reveals that the light levels from the incandescent lights is at a very low level. The roof leaks are damaging the electrical system to the point of being very dangerous. This situation should be corrected at once. There are some siding panels at the exterior of the building that appear to be transite. Those panels should be tested for asbestos. The sprinkler risers were renovated approximately three years ago and appear to be in good condition. However, the sprinkler mains and branch lines may not be in such good shape.

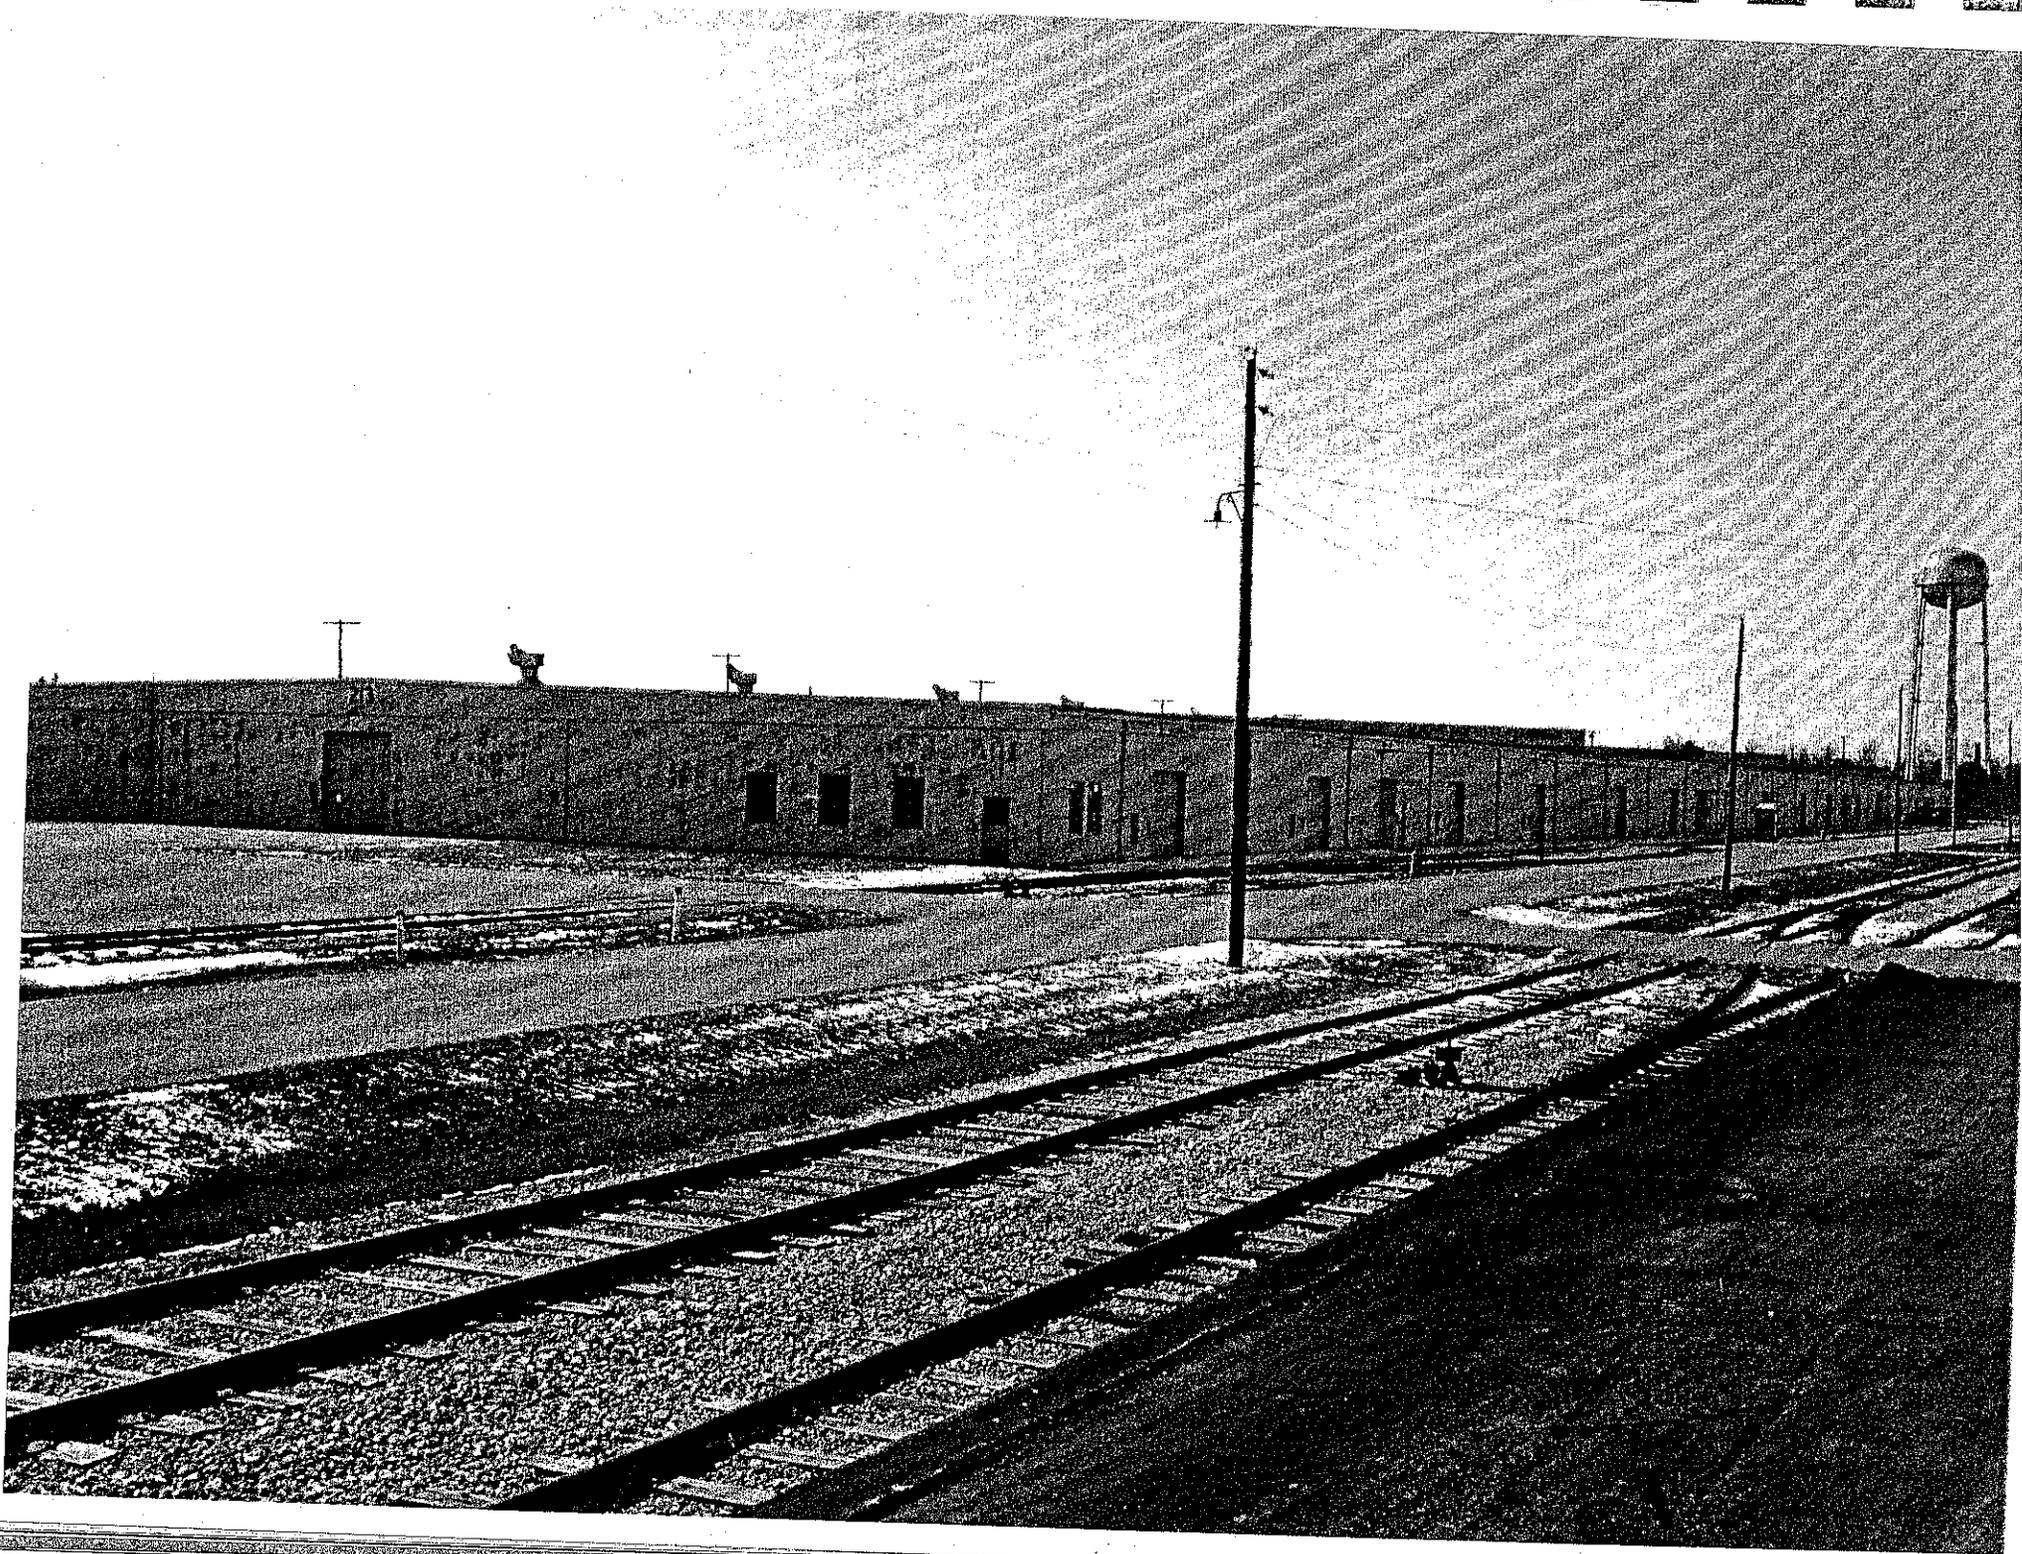
T213 (IN0615NH)

This building is used as a warehouse and has poured concrete exterior walls, has a wood frame, wood roof deck and rolled roofing. There are asphalt drives at the east and west end and concrete walks on three sides of the building with a railroad track on the fourth side. All overhead doors are new steel insulated sectional overhead doors. The person doors are for the most part in bad shape and disrepair, as are the windows. The building is divided into four sections separated by brick firewalls. The floors are concrete. The walks along the south elevation are in bad repair and should be patched and/or replaced. At several locations around the building there are cracks in the concrete wall that should be repaired. The building is painted, however, the paint is cracked, chipped and peeled. All exterior surfaces should be caulked scraped, primed and painted. The joint between the sidewalk and the building should be filled with sealant. The lawn at the west end of the building during periods of rain stands in water as does the drive at the east end of the building. The roofing is old and deteriorated and should be replaced. At the time the roof is replaced the roof deck should be inspected and rotted decking replaced. The gutters and downspouts for this building are in bad repair and should be replaced. The flashing on the firewalls above the roof have pulled loose and are in bad repair. These flashings should be replaced. There are offices and restrooms located at the west and the east end of the building that are no longer used. It was suggested that these offices and restrooms be removed to allow additional storage space. The sprinkler risers were updated approximately three years ago and are in good condition. The sprinkler system, mains and branch lines may be in need of repair.
