Building Engineering Report

Defense National Stockpile Depot

GS05P90GBD0028RIN91011, Work Order No. 10

Climate Controlled Occupied Buildings

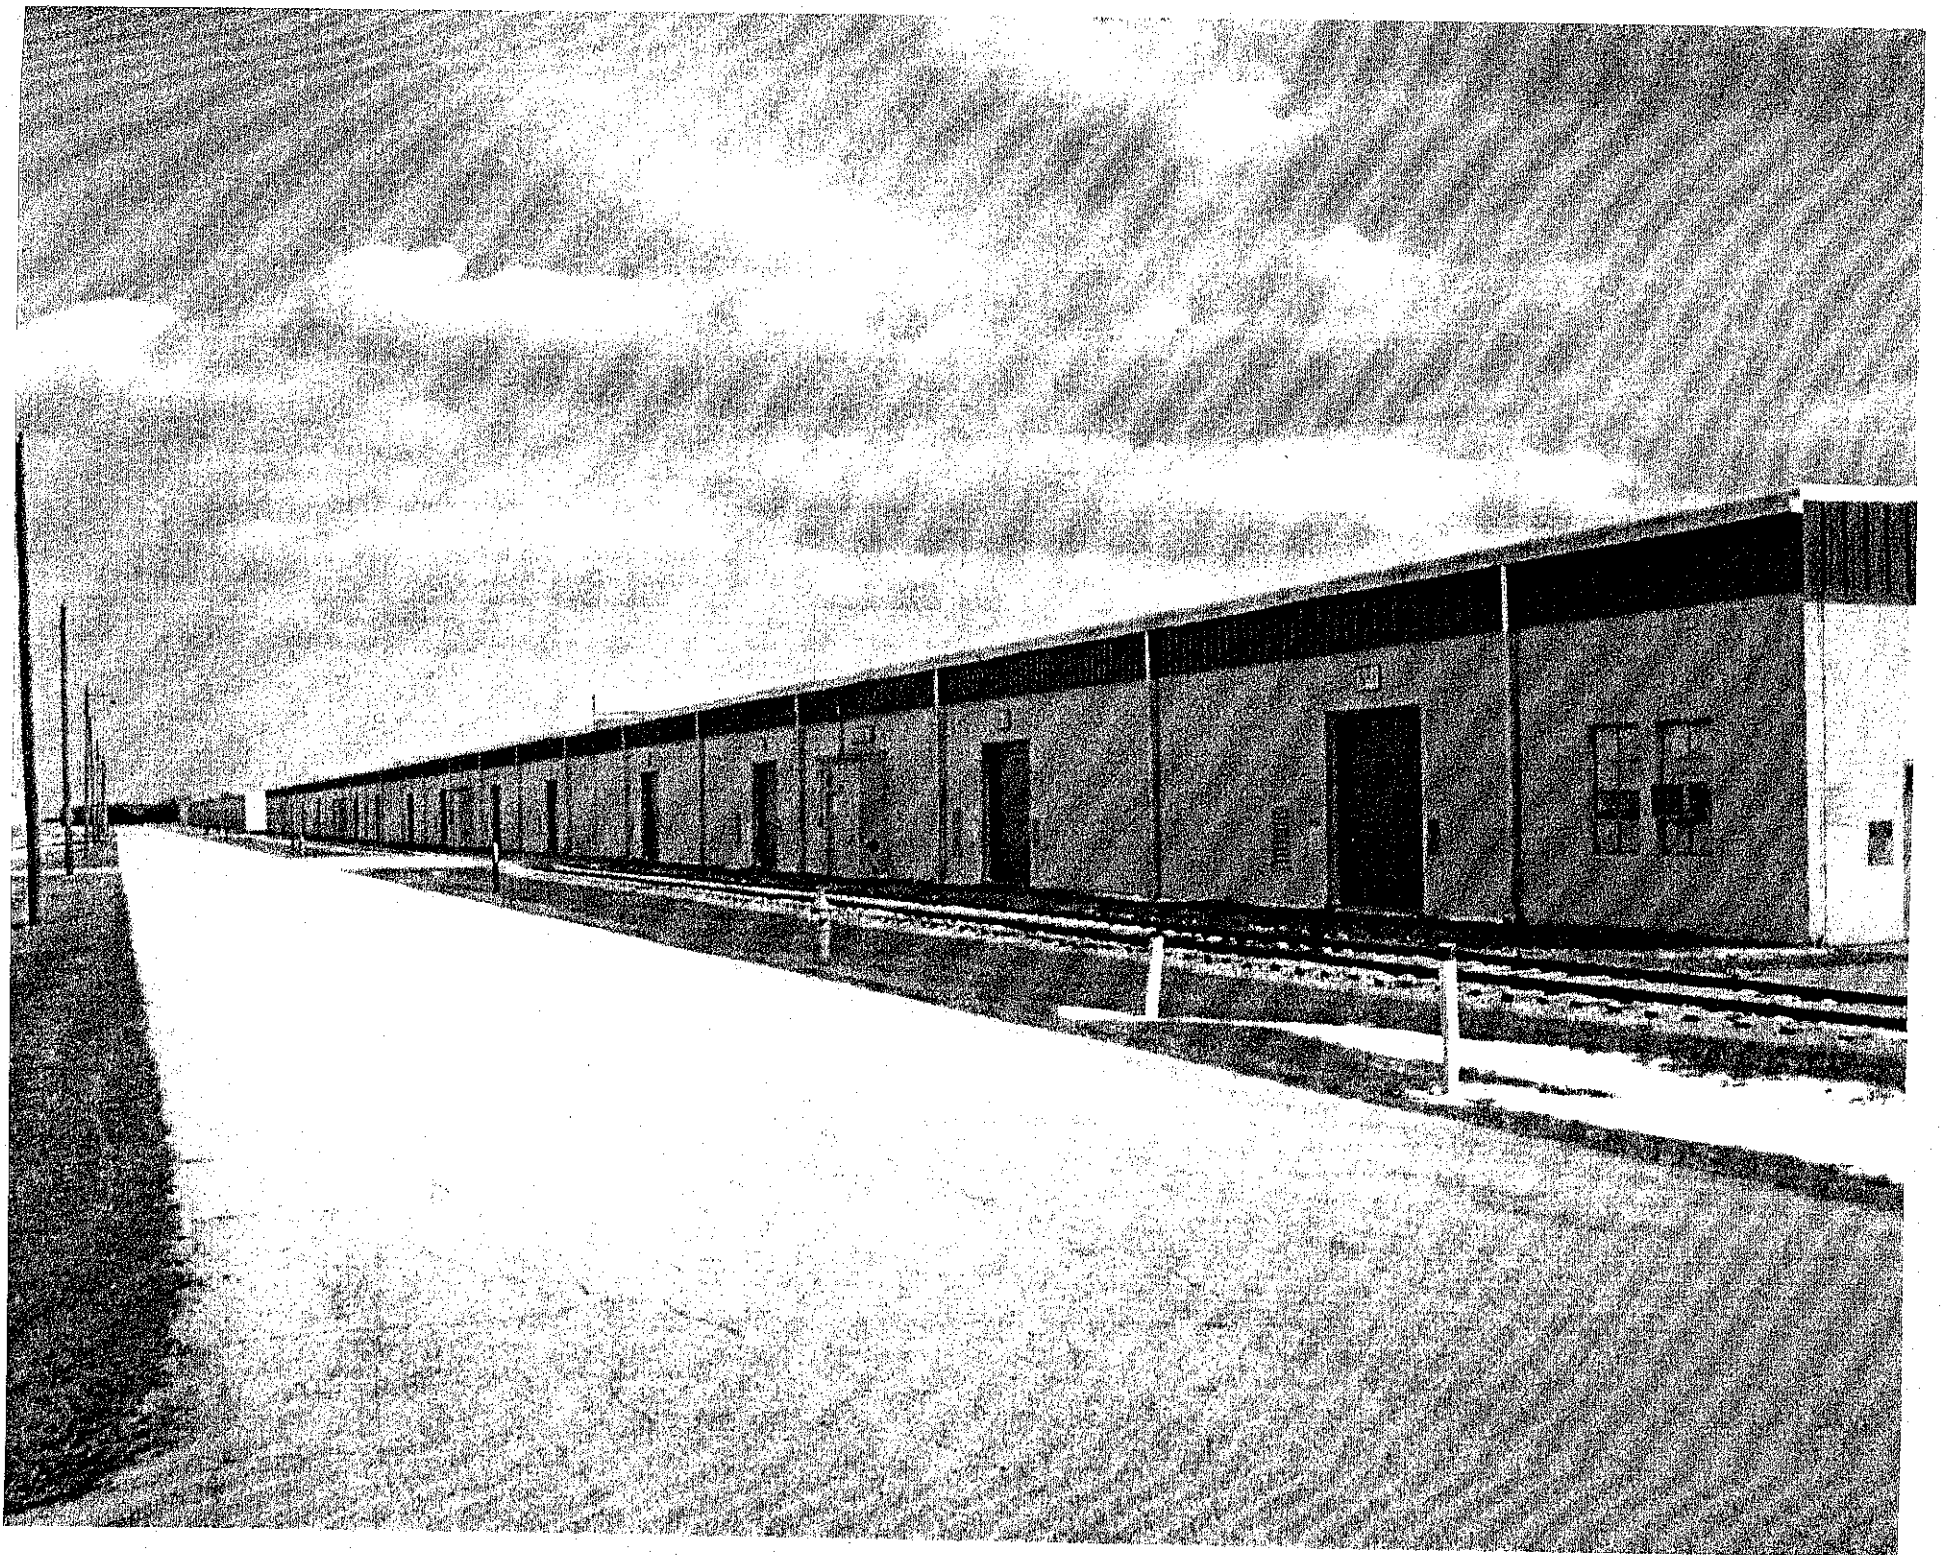
T214 (IN0616NH)

This warehouse is 960' long by 180' wide, has poured concrete perimeter walls, a wood frame structural system, a wood roof deck, and a new modified bitumen roof. All of the flashings, gutters and downspouts have been replaced recently. There is a concrete walk on three sides of the building that is in bad repair. Inside of the building at the northwest corner is a de-contamination room for the employees. At the opposite end of the building there are offices and restrooms that are no longer in use. The partition walls are wood and drywall. The asbestos panels at the east and west ends of the building have been removed and a new metal panel has been installed around the perimeter at the roof. The entire building should be scraped, caulked and painted. All of the control and expansion joints should be filled and caulked. The overhead doors have been recently replaced. The drives at either end of the building should be seal-coated. The personnel doors and the windows in the office areas should be replaced. This building is sprinklered and the sprinkler riser housings appear to be in good shape. Modifications to the floor slab at the fire doors have not been made.

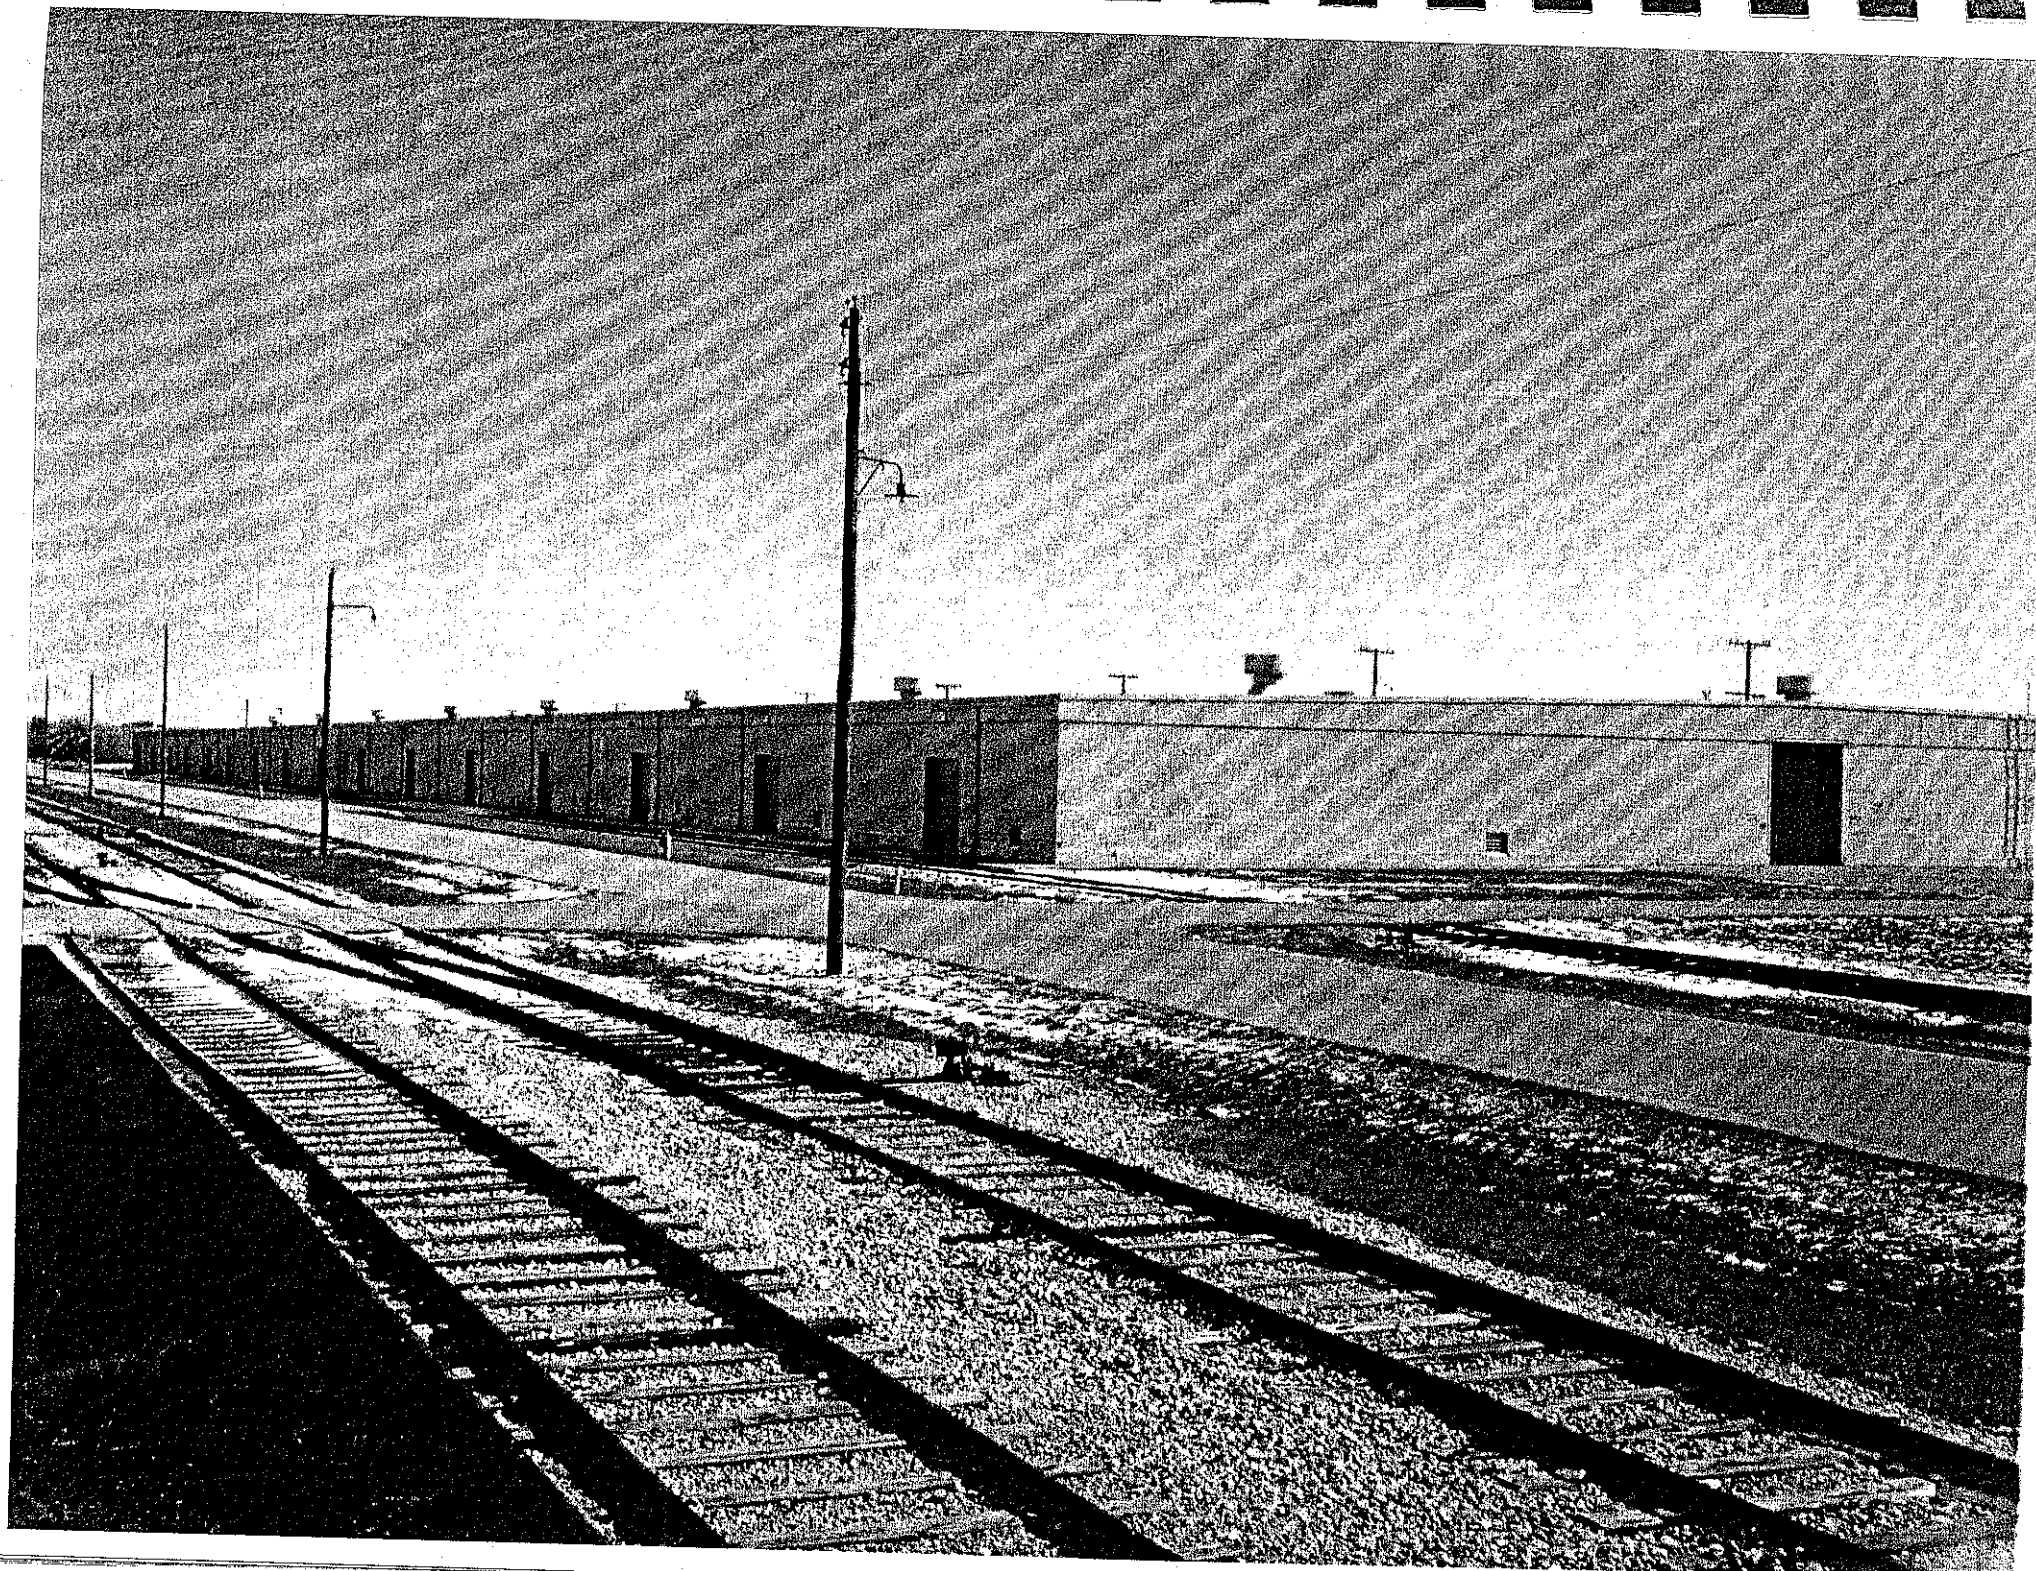
T215 (IN0617NH)

This building is a 960' by 180' warehouse having concrete block exterior walls with a wood frame structure, a wood roof deck and rolled roofing. The concrete block throughout this building is very badly cracked and deteriorated. Also, the paint is chipped and flaking throughout the building. Part of the reason for this is that water is cascading down the building from the roof due to the poor condition of the gutters and downspouts. It is causing water to enter the building. Adding to the problem is the very poor condition of the roof itself. It is very badly blistered, even in cold weather, and shows evidence of the decking being rotted below. Around the perimeter of the building at the top there are panels which appear to be transite. These panels should be tested for asbestos content. The interior of this building is one big room and does not have the firewalls the other buildings have. At the east elevation of this building the block has two expansion joints. However, the building is making its own expansion joints between the existing joints. The concrete foundation extends approximately 16 inches above grade. At the east elevation the top of the concrete foundation is spalling almost the entire length. The interior slabs are broken and heaved in several areas. In general, the areas around the overhead doors are broken and sloped towards the doors. Along the north and south exterior walls there is evidence that the roof is leaking and that water is entering the building. Midway of the south wall, a pilaster has been damaged and the rebar is exposed. There is no sprinkler system in the building, however, there are pull stations located around the building on the exterior. There are offices and restrooms located on either end of the building. These offices and restrooms have wood partition walls with drywall. Neither are in use. To bring this building to a reasonable condition we would suggest that the roof be removed, the decking that has deteriorated be replaced and a new roof applied over. All of the flashings, gutters, and downspouts should be replaced. The asbestos or transite siding should be removed and replaced with a metal panel similar to what was done on building 214. The entire building should be tuckpointed and caulked and then painted. Although the sidewalks on this building are not nearly as bad as other buildings, we would suggest that the joint between the concrete sidewalk and the building be filled and sealed. The personnel doors and windows should be replaced at this time also. It was suggested that the offices and restrooms at either end of the building be demolished since they are no longer used and the space be used for additional storage. Since this building is being used as high pile storage we would suggest that the floor slabs be repaired

and in some cases replaced to facilitate the high pile storage.
