SUBJECT: LETTER OF NOTIFICATION FOR A 10CFR21 REPORTABLE CONDITION

Following our initial contact, Weed Instrument Company, Inc. has completed its evaluation of a possible defect in pressure transmitters assembled and sold by Weed Instrument Company.

Reference: Foxboro Model No. N-E13DM-IHM2 or Spare Part No. N0141FN

Weed Model N-E11 & N-E13 Pressure/DP Transmitters RE: 10CFR21 Notification

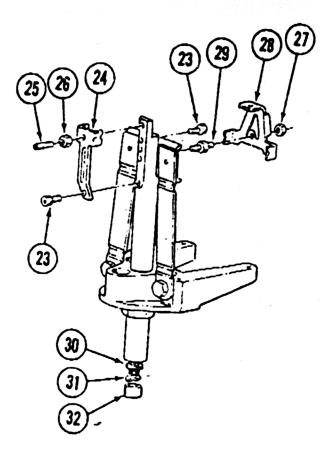
Figure No. 1

In compliance with 10CFR Part 21.21(a)(1) (ii), this letter is to notify you that we may have shipped you either a transmitter with an improperly processed part and/or the part itself. The subject part is Part No. N0141FN, a bracket, and is identified as number 24 in the attached Figure No. 1. The bracket is located in the transmitter topworks at the top of the force bar assembly and provides topworks static alignment and overrange protection. In August of 1989 the bracket material was changed to a 410SS, which requires a two step heat treating process, instead of a single step process, for proper material characteristics. The correct process change was not implemented until Jan.-Feb. 1990. Single step heat treatment of 410SS allows cracks to form near the bracket mounting hole and from which the cracks will continue to propagate, thus weakening the bracket. This discrepancy was discovered only very recently. Weakening brackets may cause one of the following to occur:

- a. Zero Drift and/or Span Drift in the downscale direction
- b. Static Alignment Errors Unable to Realign (DP's only)
- c. Excessive Calibration Non-linearity (>1%) Zero or Elev/Supp Ranges
- d. Inability to adjust from a Zero Based Range to a Suppressed Range Calibration (Using an Elev/Supp Bias Kit)
- e. Greater than normal Overrange Errors

Catastrophic failure of a transmitter with the faulty bracket is not expected based on futput performance failure analysis.

Visual inspection will not reveal the existence of cracks because of bracket painting but different bracket finishes do identify suspected or faulty processed brackets. Unfinished/ unpainted brackets and brackets with a "Gray" painted finish must be replaced. Brackets with a "Silvery" finish similar to the finish on the "Forcemotor" are correctly processed and replacement is not necessary.

- 23 Screw, Mounting 24 Bracket, Pt. No. NO141FN
- 25 Screw
- 26 Nut. Locking

Use of applicable Foxboro Master Instructions (MI's) will be required to properly align the specific transmitter after bracket installation. It is recommended that only personnel trained in Foxboro Transmitter servicing should perform bracket replacement and transmitter re-alignment. Replacement brackets 24 include screw 25 and locking nut 26 as in Figure No. 1, attached. The mounting screw 23 can be re-used for bracket replacement.
