Report No. 10CFR21-0076
SEPTEMBER 22, 1997

10CFR21 REPORTING OF DEFECTS
AND NON-COMPLIANCE

COMPONENT: EMD Air Start Motors #40047506 & #40047507

SYSTEM: Standby diesel generators with EMD diesel engines

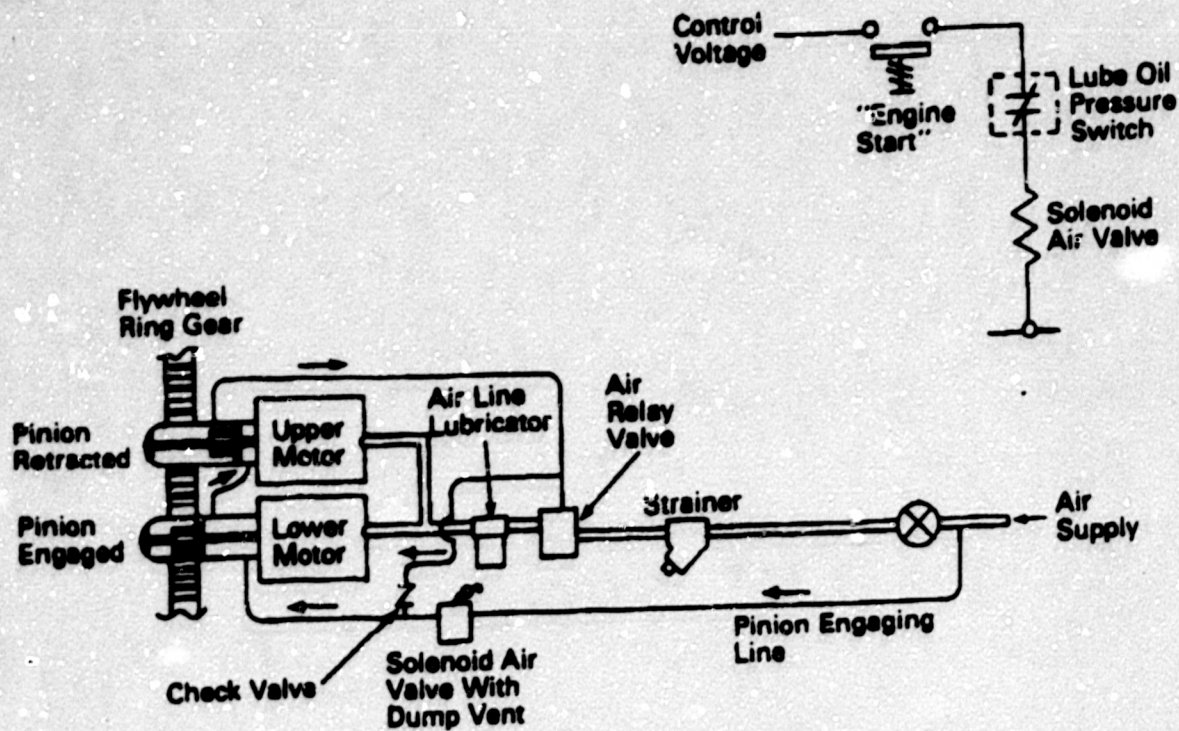
Fig.4-3 - Typical Air Starting System Diagram

The EMD design pipes the two air motor pinion lines in series before going to the main air valve "activate" input. The intent of this design is to pre-engage the pinion gear (achieve mesh between the pinion gear and the engine ring gear) before starting air is supplied to the motor to begin engine rotation (see Exhibit 1).
