Davis-Besse Reactor Pressure Vessel Head Degradation

Overview, Lessons Learned, and
NRC Actions Based on Lessons
Learned

NUREG/BR-0353, Rev. 1
August 2008

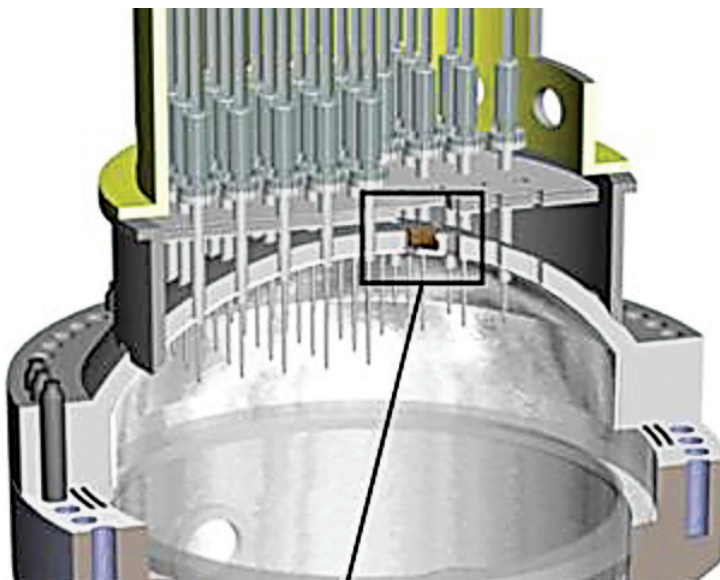
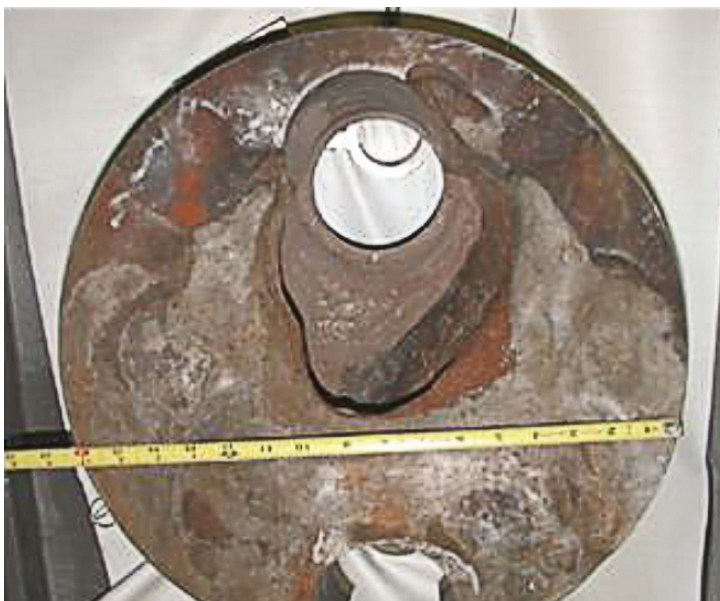
The licensee investigated the condition of the RPV head surrounding CRDM nozzle 3. The investigation included removing the CRDM nozzle and removing boric acid deposits from the top of the RPV head. Upon completing the boric acid removal on March 7, 2002, the licensee conducted a visual examination of the area and identified a large cavity in the RPV head on the downhill side of CRDM nozzle 3 (**Figure 2**). The corrosion was caused by borated water that leaked from the reactor coolant system onto the vessel head (**Figures 3 and 4**) through cracks in the nozzle and the weld that attached nozzle 3 to the RPV head (**Figures 5 and 6**). The remaining thickness of the RPV head in the wastage area was found to be approximately 3/8 inch. This thickness consisted of the thickness of the stainless steel cladding on the inside surface of the RPV head, which is nominally 3/8 inch thick. The stainless steel cladding is resistant to corrosion by boric acid, but it is not intended to provide structural integrity to the vessel. Failure of the stainless steel cladding would have resulted in a loss-of-coolant accident (LOCA). The LOCA would have resulted in actuation of the plant's emergency systems.

Figure 2. Region of the vessel head depicted by the model and photo of the cavity after it was removed from the vessel head

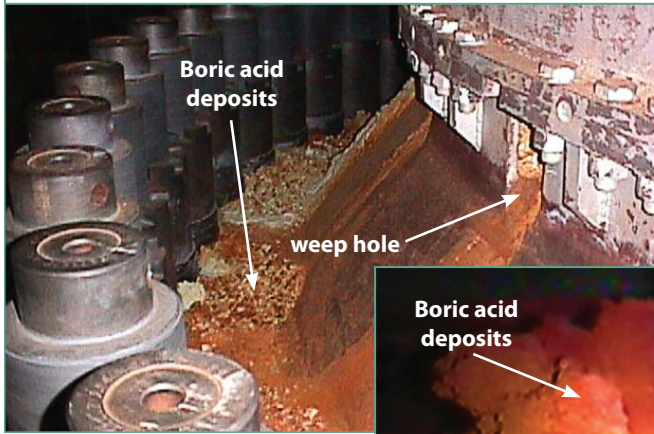
Figure 3a. RPV head flange area showing significant amounts of boric acid deposits (photo taken during the 2000 refueling outage at DBNPS)

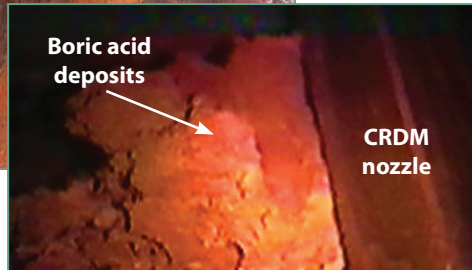
Figure 3b. Boric acid deposits accumulating near a CRDM nozzle (still photo of video taken during the 2000 refueling outage at DBNPS)

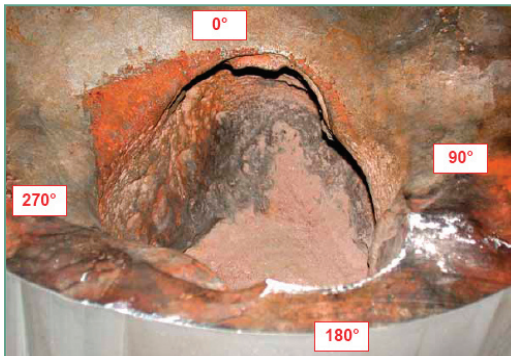
Figure 4a. Close-up view of the cavity

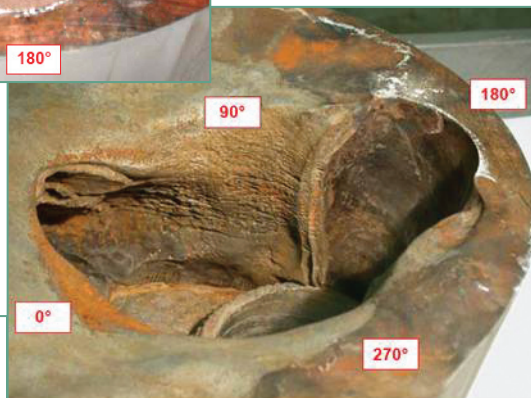
Figure 4b. Oblique view of the cavity partially showing the J-groove weld at the bottom of the cavity
