## BWR steam dryer integrity

### SIL No. 644 Revision 2

August 30, 2006

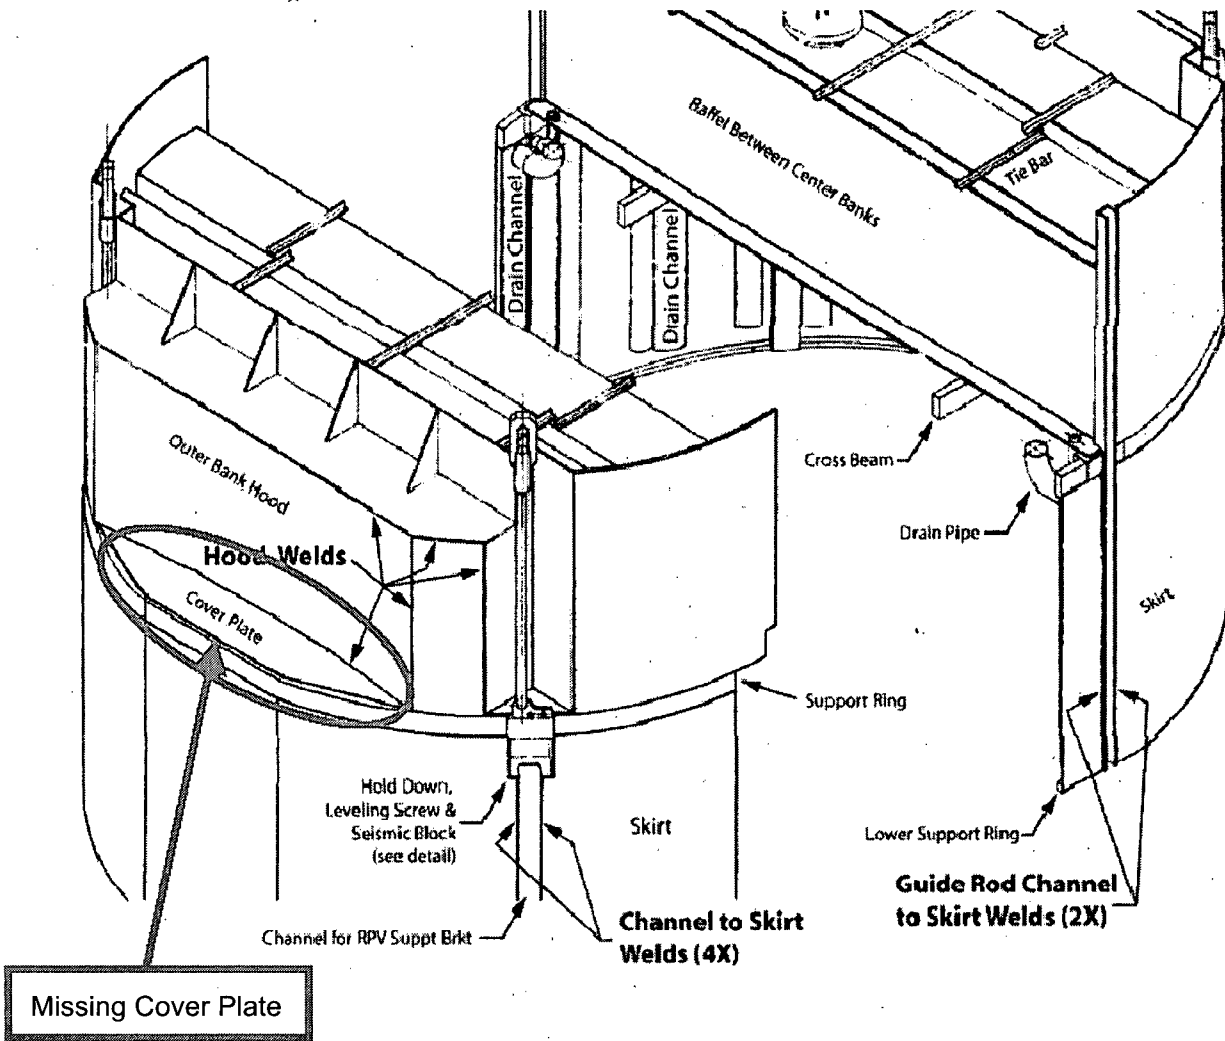
Inspection of the steam dryer revealed that a ¼-inch stainless steel cover plate measuring approximately 120" x 15" had failed near the MSL "A" and "B" nozzles (Figure A-1). The failure of this cover plate allowed steam to bypass the dryer banks and exit through the reactor MSL nozzles, causing the observed increase in moisture content. The majority of the cover plate was found as a single piece on top of steam separators. However, a piece of the cover plate (approximately 16" x 6") had failed and was found lodged in and partially blocking the MSL "A" flow venturi contributing to the MSL flow imbalance and water level perturbations. Several smaller loose pieces (believed to have come from a startup pressure sensor bracket which may have been knocked off by the cover plate) were located at the turbine stop valve strainer basket. Minor gouges and scratches from the transport of foreign material were noted in the "A" steam nozzle cladding, the main steam piping and the MSL "A" flow venturi. All loose pieces were recovered. No collateral damage to other reactor vessel components was observed.

Preliminary laboratory analysis has been completed. The main crack originated from the bottom side of the cover plate and propagated upward through both the plate base metal and weld metal. The transgranular, as opposed to intergranular, nature of the fracture surface and the relative lack of crack branching indicated that the failure was not caused by stress-corrosion cracking. The lack of macro and micro ductility features in and near the fracture indicated the cracking occurred over a period of time and not due to a mechanical overload. Additionally, there was no evidence that the failure was a result of an original manufacturing defect. Based on the available evidence, the most probable cause of the cover plate cracking was mechanical, high cycle fatigue.

The results of the metallurgical analysis confirmed that the failure mechanism is high cycle fatigue. The cause of this high cycle fatigue is believed to be flow induced vibration. At this time there are two probable root causes of the cover plate failure:

1. Increased pressure oscillations on the steam dryer due to the increased steam flows at extended power uprate conditions, aggravated by the potential presence of a pre-existing crack in the cover plate.
2. A flow regime instability that results in localized, high cycle pressure loadings near the MSL nozzles. When the natural frequency of the installed cover plate coincides or nearly coincides with the frequency of the cyclic pressure forcing function, and the acoustic natural frequency of the steam zone, the resulting resonance or resonances can lead to high vibratory stresses and eventual high cycle fatigue failure of the cover plate.

Figure A-1: Location of the 2002 Lower Cover Plate Failure

The cover plates on both sides of the dryer have been replaced with ½-inch continuous plates (this eliminates two intermediate welds on the original plates). The fillet weld connecting the plate to the support ring was increased to ¾-inch and the weld to the vertical face of the dryer hood was increased to ½-inch. The plant has been returned to service with interim, enhanced monitoring of moisture content, reactor steam dome pressure, MSL flow rates and reactor water level. As an additional measure, the plant has implemented dynamic response monitoring of the MSLs to determine if higher flow induced vibration occurs as the steam flow is increased.

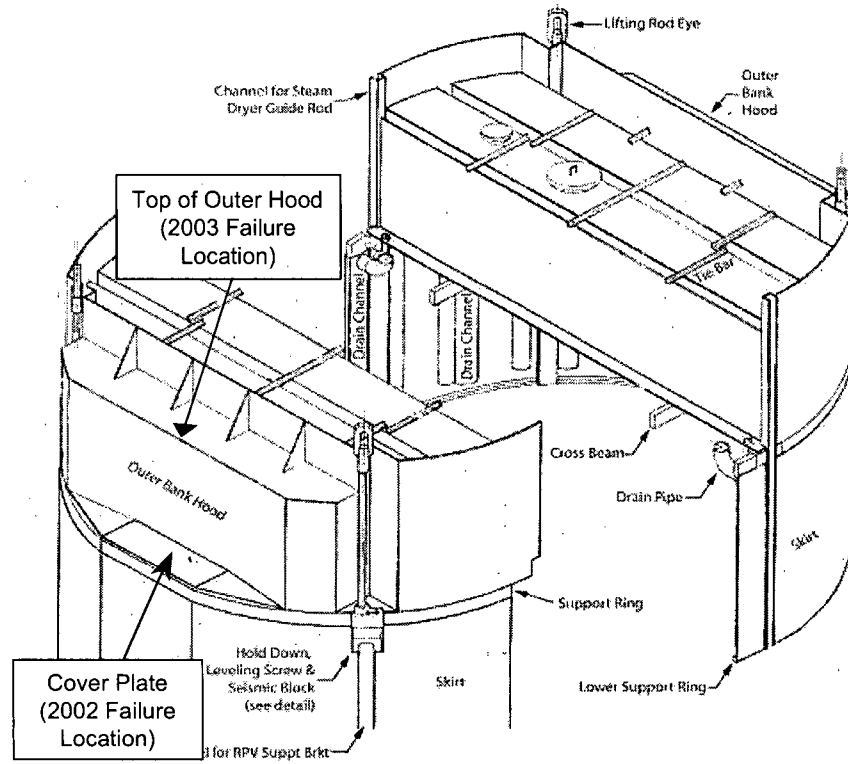
A detailed visual inspection of the accessible external and internal areas of the steam dryer revealed significant steam dryer damage. The damage was most severe on the 90-degree side of the steam dryer, the side that was closest to the PORV that had opened. On the 90-degree side, a through-wall crack approximately 90 inches long and up to three inches wide was observed in the top of the outer hood cover plate and the top of the vertical hood plate (refer to Figures B-1 and B-2). Three internal braces in the outer hood were detached and one internal brace in the outer hood was severed. The detached braces were found on top of the steam separator. All detached parts were accounted for and retrieved. On the opposite side of the steam dryer (270-degree side), incipient cracking was observed on the inside of the outer hood cover plate and one vertical brace in the outer hood was cracked. No damage was found in the cover plates that had been replaced following the first steam dryer failure in 2002.

Extensive metallurgical and analytical evaluations (e.g., detailed finite element analyses, flow induced vibration analyses, computational fluids dynamics analyses, 1/16<sup>th</sup> scale model testing and acoustic circuit analyses) concluded that the root cause of the steam dryer failure was high cycle fatigue resulting from low frequency pressure loading. There are two potential contributing factors to the failure:

1. Continued operation for approximately 1 month following the failed cover plate in 2002 which resulted in additional stress loading on the vertical hood plate, and
2. Inadvertent opening of the PORV resulting in a decompression wave, which subjected the steam dryer to two to three times the normal pressure loading. (It is believed that there was incipient cracking in the steam dryer and the PORV event caused the cracks to open up).

Figure B-1: Location of the 2003 Outer Hood Failure

The following repairs and pre-emptive modifications were made to both the 90 and 270-degree sides of the steam dryer:

1. replaced damaged ½ inch outer hood plates with 1 inch plates
2. removed the internal brackets that attached the internal braces to the outer hood
3. added gussets at the outer vertical hood plate and cover plate junction
4. added stiffeners to the vertical welds and horizontal welds on the outer hood

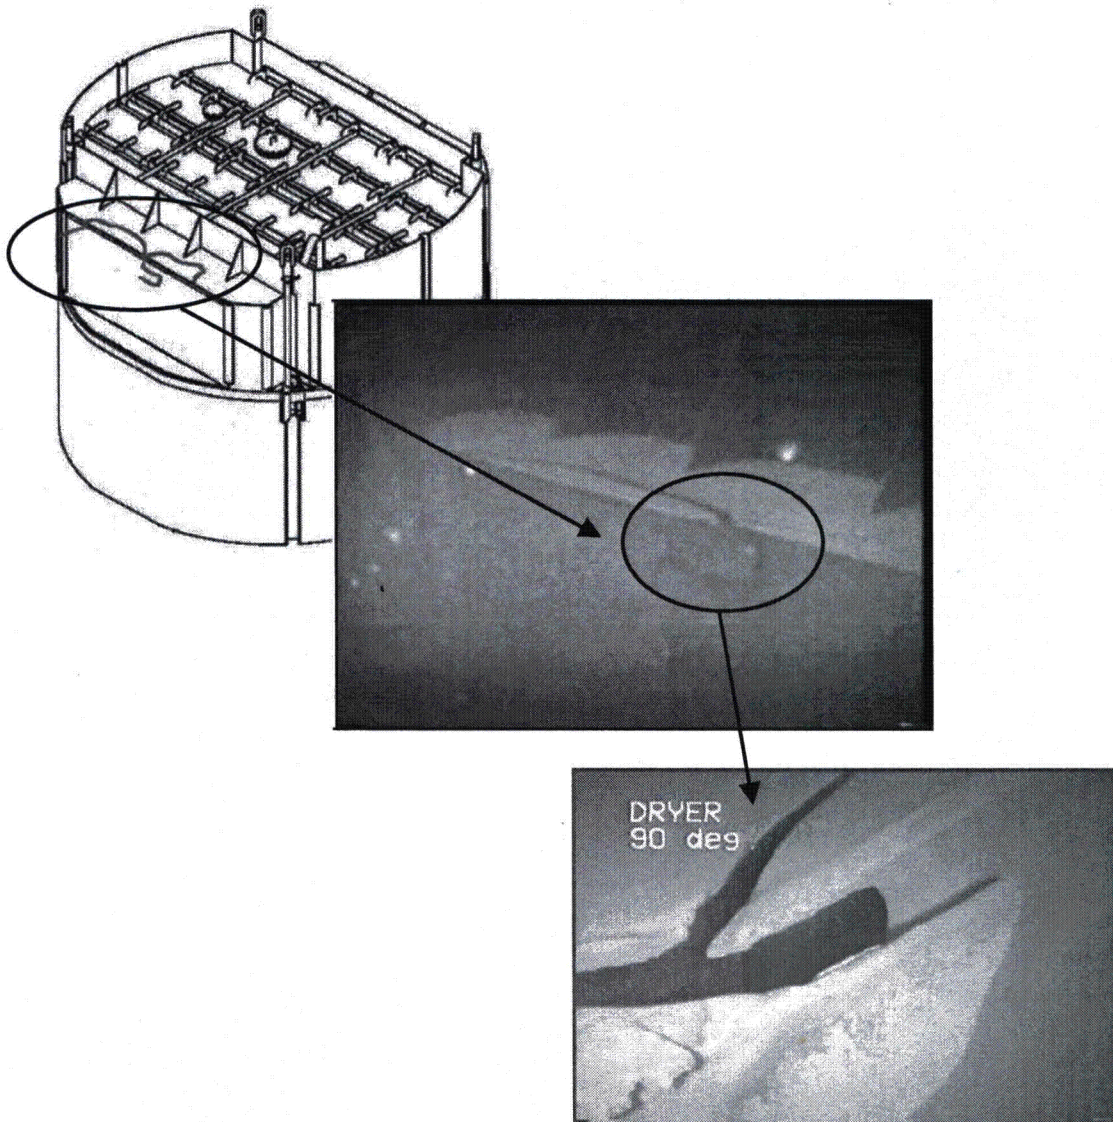
Figure B-2: Steam Dryer Damage 90 Degree Side
