Secondary Piping Rupture Accident at Mihama Power Station, Unit 3, of the Kansai Electric Power Co., Inc. (Final Report)

March 30, 2005
The Nuclear and Industrial Safety Agency

(Translated by JNES, Rev 1 as of May 14, 2005)

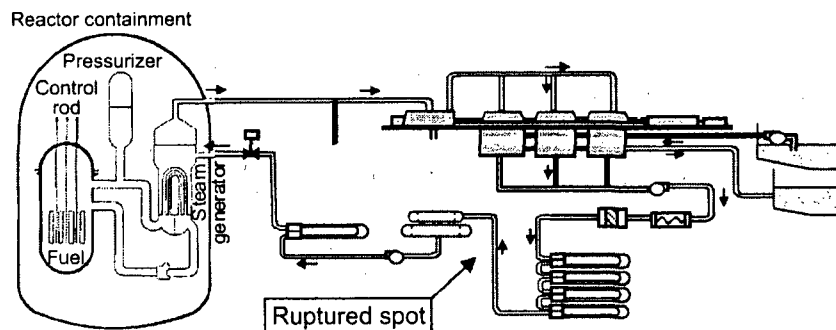
Figure 1. Major systems of PWR and the ruptured spot

The operator made an inspection in the turbine building and confirmed a ruptured opening in an A-loop condensate pipe at 17:30 on August 9, 2004, which was the feed water line from the 4th feed water heater² to the deaerator³ running near the ceiling on the deaerator side at the 2nd floor of the turbine building. After that, the nuclear safety inspector also confirmed the same situation.

The portion where a rupture was confirmed was in a condensate pipe of the A-loop, one of the two loops of condensate piping going from the 4th low-pressure feed water heater to the deaerator near the ceiling on the deaerator side on the 2nd floor of the turbine building, and was near the downstream of the orifice⁴ for measuring the condensate flow rate of the A-loop.

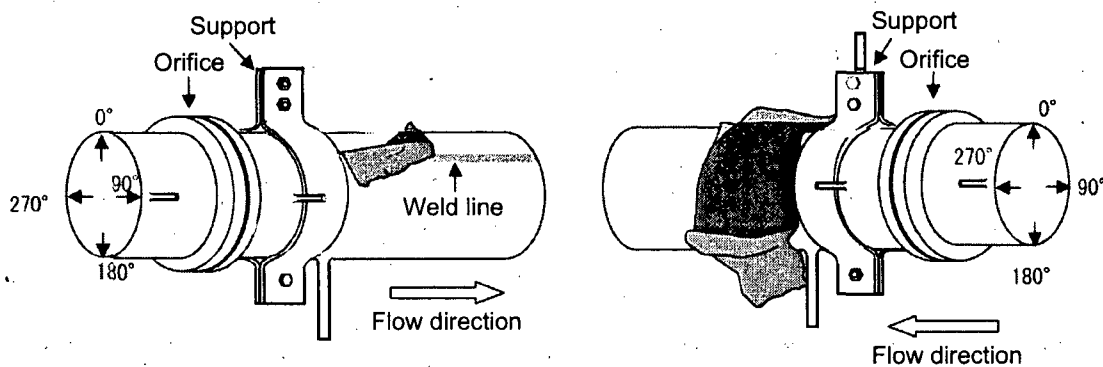
Figure 2. Ruptured condition of pipe

A joint team of NISA and JNES conducted an on-the-spot inspection, and as a result confirmed a fracture opening in the ruptured portion, which extended a maximum of about 515 mm in the axial direction and about 930 mm in the circumferential direction of the pipe. KEPCO measured the pipe in the presence of the police authority, and the result was 0.4 mm at the thinnest portion of the pipe, whereas it must be 4.7 mm or over⁵ according to the technical standards. As shown in Appendix 2, the thinning was striking in the upper part of the pipe.

The A-loop pipe was cut out, including the ruptured portion, and examined at JAERI. As a result, a portion was found out downstream of the vent hole of the orifice⁶ where pipe wall thinning reached to the flange for the orifice support.

The inner surface of the pipe was observed using a digital microscope, and it exhibited a fish scale-like pattern, which is characteristic of so-called erosion/corrosion⁷, downstream of the orifice and over the entire surface except the bottom (180°) of the pipe. At the bottom (180°) of the pipe, a portion of almost nominal wall thickness existed where thick surface film (about 0.5 mm) existed, and a fish scale-like pattern was not seen on the inner surface of the pipe.

The insulation material attached to the pipe was scattered around.

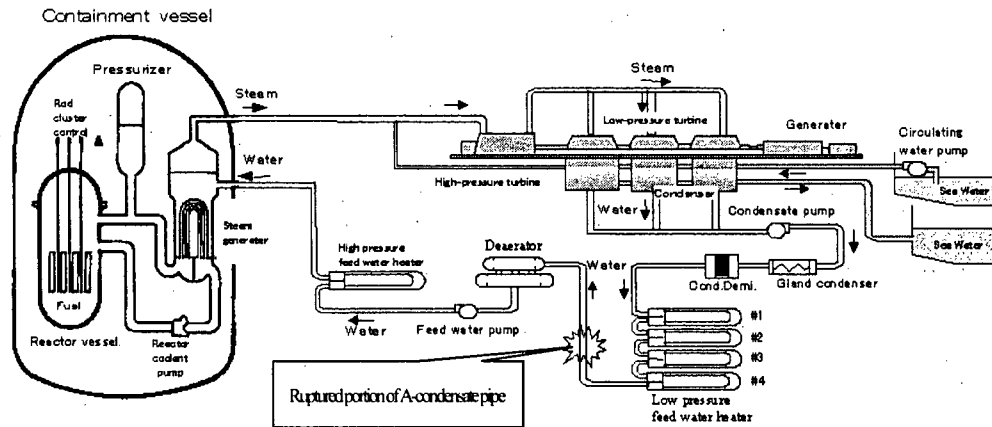
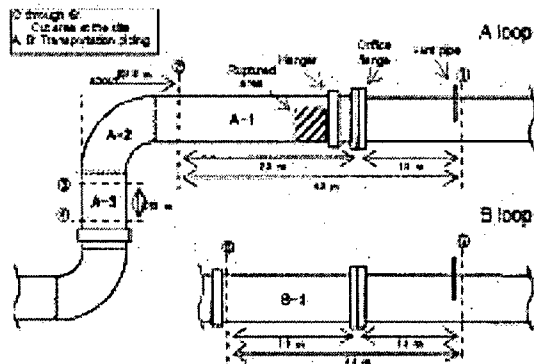
Ruptured condition of secondary piping at Mihama Power Station, Unit 3

- (1) Piping downstream of the orifice; Material: JIS G SB42, Diameter (hereinafter referred to as D): approximately 560 mm, Initial thickness: approximately 10 mm
- (2) Flow condition during operation; Flow rate: approximately 1,700 t/h, Pressure in use: approximately 0.93 MPa, Temperature: 142 degrees Celsius, Flow velocity: approximately 2.2 m/sec
- (3) Operation time; approximately 185,700 hours
- (4) Water quality; pH: 8.6 to 9.3, Dissolved oxygen concentration: less than 5 ppb

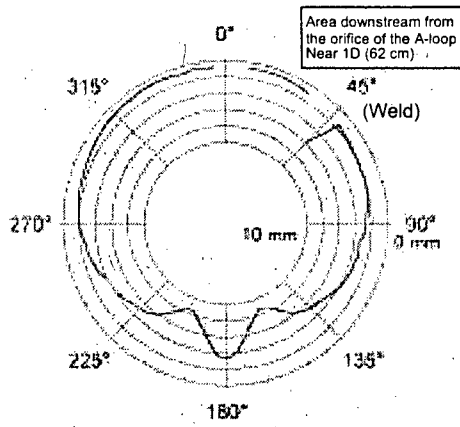
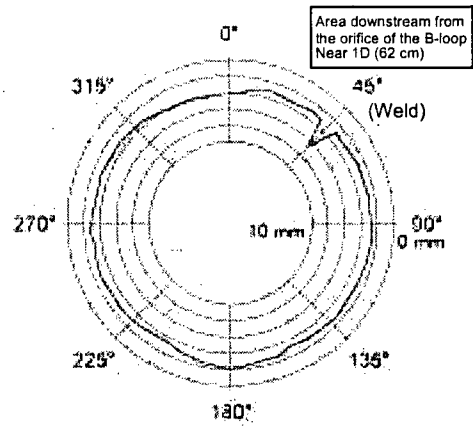
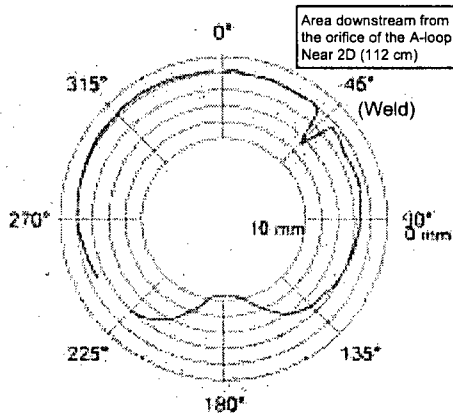
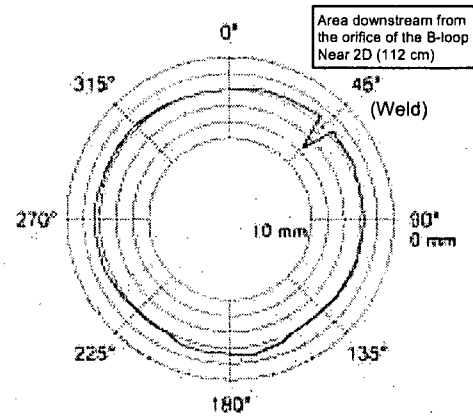
As a result, a thinning tendency was observed over almost the entire surface downstream of the orifice as shown in Appendix 2. Pipe wall thinning was observed downstream of the vent hole in the orifice. Upstream of the orifice, however, no significant thinning tendency was observed. At the thinnest portion of the wall, the thickness was 1.8 mm.

Near 1D from the downstream end of the orifice

Near 2D from the downstream end of the orifice

Situation of reduced thickness at the downstream orifice of A-piping

Situation of reduced thickness at the downstream orifice of B-piping

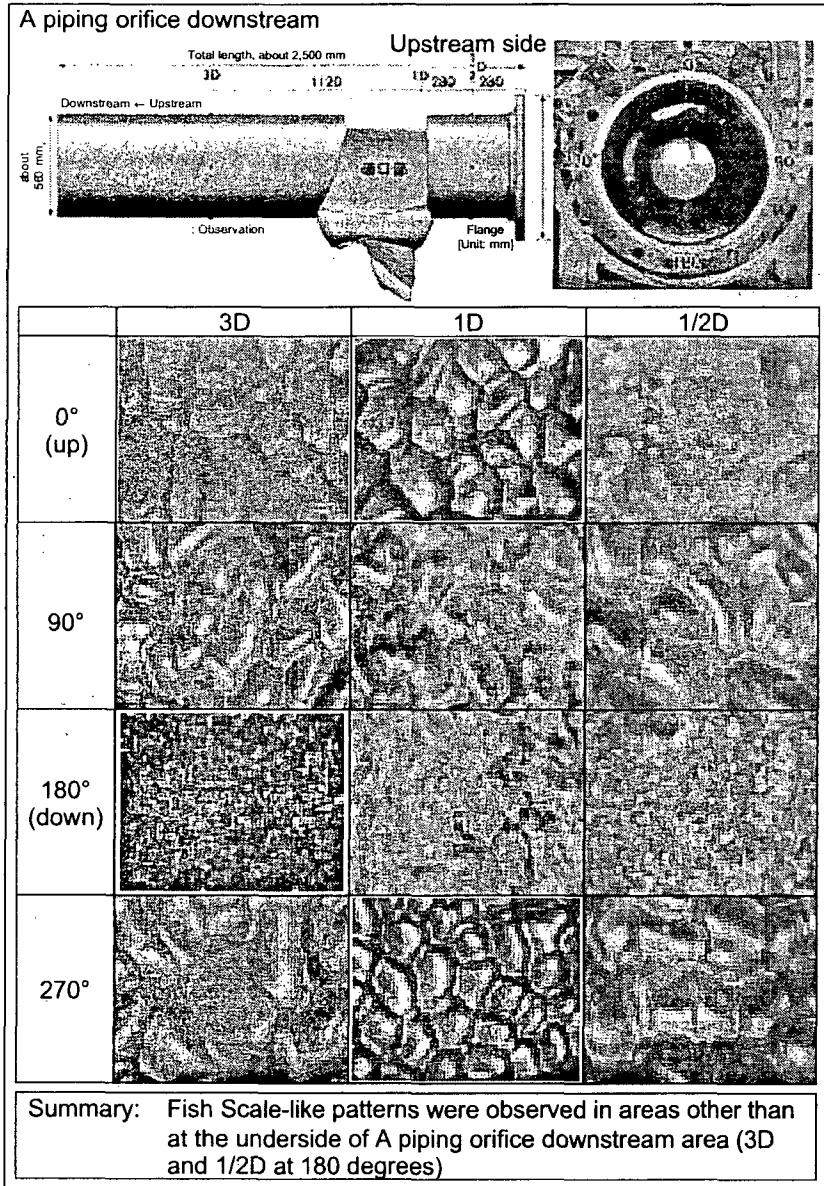
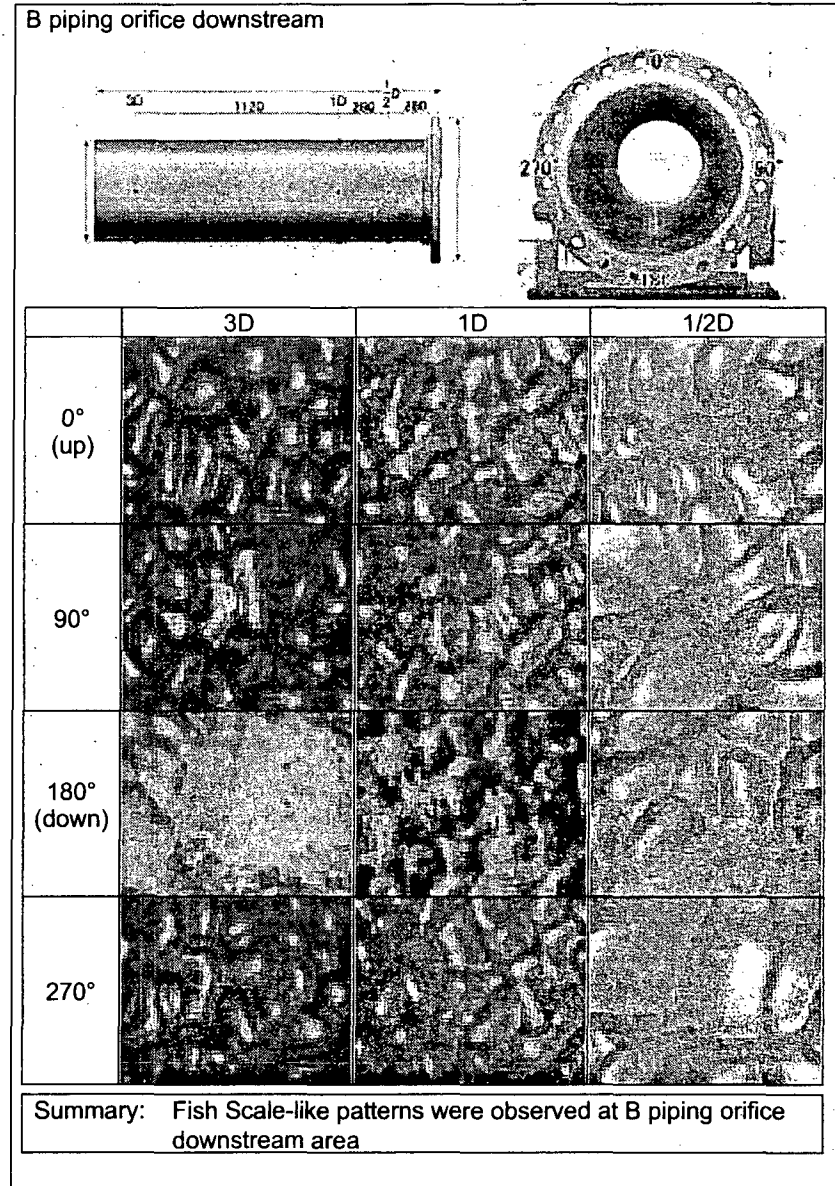
3. Observation results of the inner surfaces of the piping

The inner surface of the pipe was observed using a digital microscope, and the result was that it exhibited a fish scale-like pattern over almost the entire surface, which is characteristic of so-called erosion/corrosion.

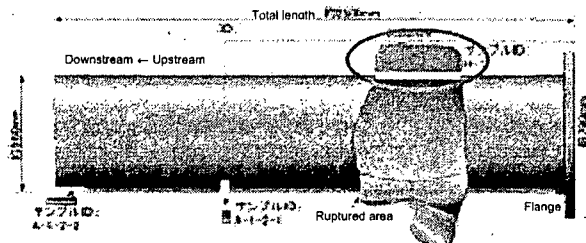
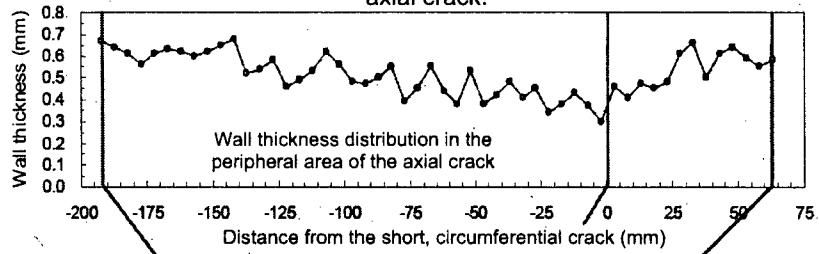
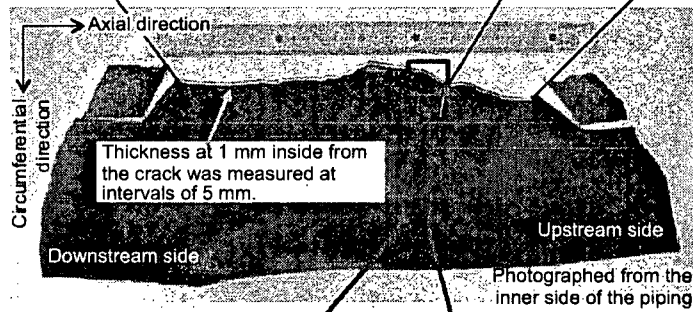
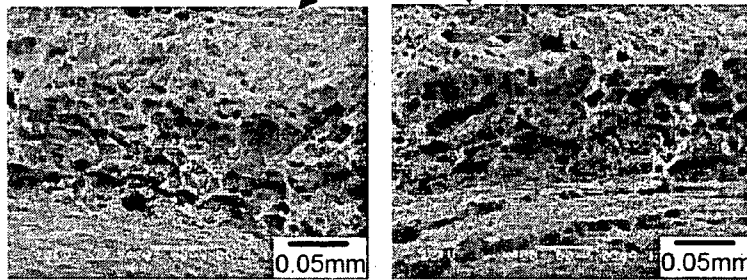
Figure 1 Condition of the fracture surface and wall thickness distribution in the vicinity of the crack at the ruptured opening

By using a scanning electron microscope (SEM), the fracture surface of the ruptured opening was observed with emphasis on the vicinity of the thinnest area. In each SEM photograph, there were dimples (small depressed areas formed on a fracture surface at the time of the occurrence of ductile fracture) on the fracture surface. In addition, in comparison with the hardness in the areas other than the ruptured opening, the hardness in the vicinity of the ruptured opening had a tendency to increase toward the edge of the ruptured opening. Therefore, it is considered that plastic deformation occurred at the time of the occurrence of the fracture. For these reasons, it was proved that the fracture mode was ductile fracture.

The thinnest wall thickness was 0.3 to 0.4 mm in the vicinity of the axial crack.

Dimples, which indicated ductile fracture, were found on the fracture surface.

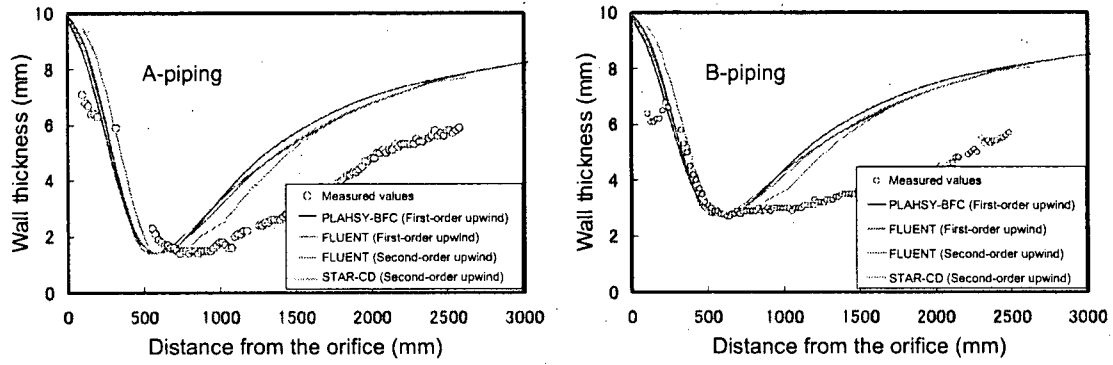
Figure 1 Comparison between the thinning amounts predicted by near-wall turbulence energy and the measured values (at 270 degrees clockwise as seen from the upstream side)

The straight pipes on both sides of the orifice of the secondary piping were investigated by a 3-dimensional turbulent flow analysis. Then the predicted distribution of the thinning amounts obtained by conversion from the maximum value of near-wall turbulence energy was compared with the measured values of the actual equipment. According to the comparison, an abrupt thinning tendency at the orifice downstream and the position where the thinning amount became maximum (at a distance of approximately 1.2 times the diameter of the pipe downstream from the orifice: approximately 700 mm) was reproduced well by the calculation. Incidentally, the thinning amount predicted by the calculation at downstream area from the maximum thinning position was smaller than the measured value. Therefore, the pipe wall thinning area was underestimated. It is considered that the reason is the effects of other parameters related to thinning phenomena other than near-wall turbulence energy.

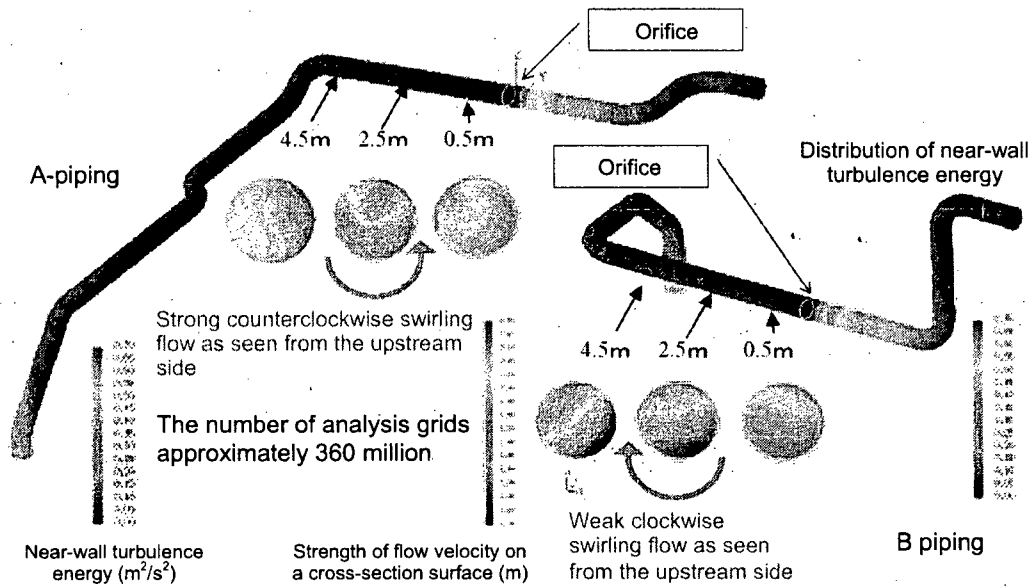
Figure 2 Analysis results based on the simulation of the actual piping

In order to analyze the difference of circumferential thinning tendencies between the A and B piping, a 3-dimensional turbulent flow analysis was conducted for the entire piping. In the flow velocity distribution at the orifice inlet, a strong counterclockwise swirling flow as seen from the upstream side was confirmed for the A piping, and a weak clockwise swirling flow as seen from the upstream side was confirmed for the B piping. It is considered that the difference has an effect on the difference of the pipe wall thinning behaviors in the circumferential direction between the A and B piping. These swirling flows occur when a flow into a branch pipe from the header of a main condensate pipe reaches the first elbow. Because the directions of the elbows differ by 180 degrees each other, the direction of a swirling flow in the A piping is opposite to that in the B piping. In addition, because swirling strength depends on the degree of eccentricity of a flow into an elbow, the A piping, whose eccentricity is high, is higher in swirling strength than the B piping, whose eccentricity is low.

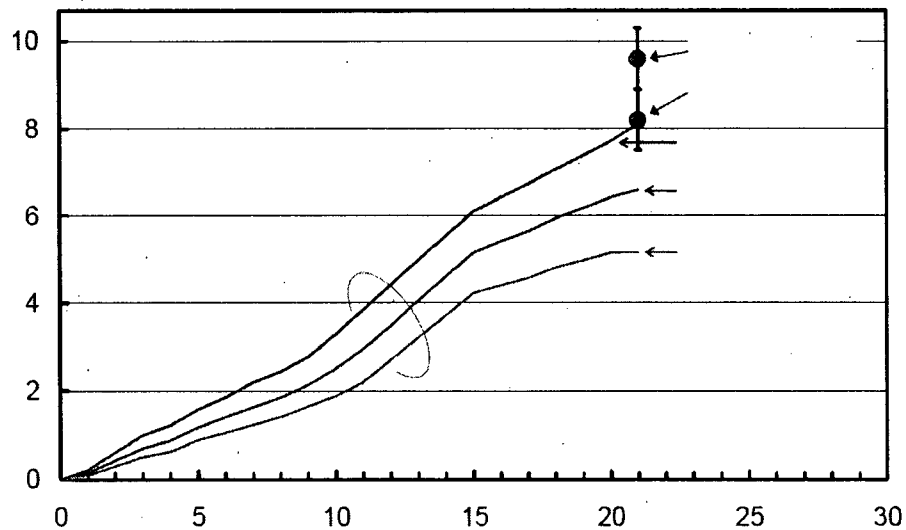
Figure 1 Analysis results of thinning progress based on actual water environment data, etc.
 Analysis conditions: Flow velocity = 2.2 m/s,
 Water temperature = 146

Regarding the thinning amounts, by using PASCAL-EC, the thinning amounts of carbon steel tube caused by erosion-corrosion (E/C) in single-phase water flow were calculated on the basis of the prediction formula given by Kastner et al. The figure below shows the analysis results related to the wall thinning behaviors by using the actual water environment and material data. In the figure, the maximum thinning amounts of the A and B loop piping in Mihama Power Station, Unit 3, are also shown. In addition, the maximum thinning amount is calculated on the assumption that the initial wall thickness is 10 mm, and error bars are shown in consideration of 0.7mm tolerance of wall thickness. The measured maximum thinning amounts of A and B-loop piping were somewhat larger in comparison with the analysis results as shown in the figure below. In consideration of existing knowledge regarding the prediction accuracy of thinning amounts, it is concluded that the thinning amount of A-loop piping is within the range of predictable variations.

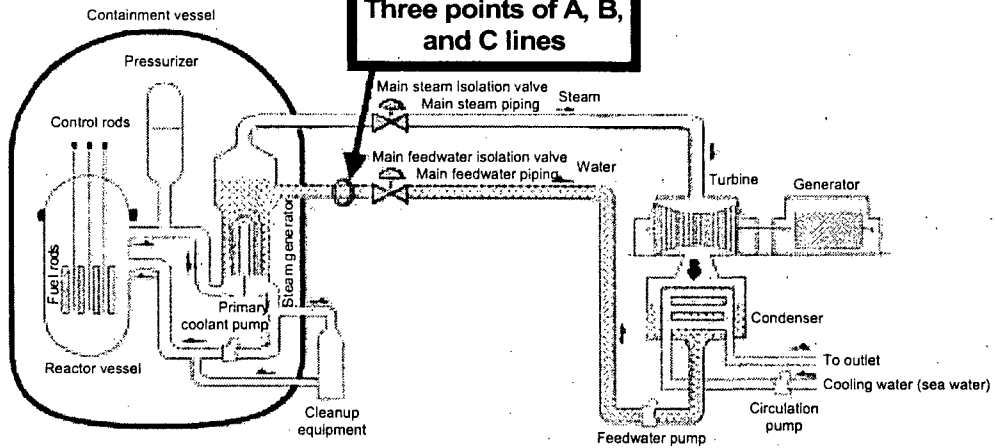
System outline diagram

This thinned area belongs to the water piping operated at 230°C, so it is classified into "other systems" in the PWR Management Guidelines. "Other systems" require inspection on a sampling basis. The thinning phenomenon causes a need to review the PWR Management Guidelines regarding whether the sampling inspection requirement is adequate for "other systems" and how to manage the D system, because no significant thinning was detected in the D system, which has the same structure and environment as the area concerned.

**Thinned area
Three points of A, B,
and C lines**

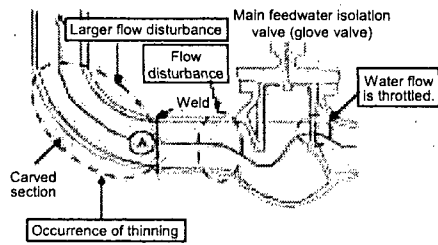
Thinning mechanism

It was confirmed that the flow disturbance that occurred at the inside of the main feedwater isolation valve (glove valve) was further intensified at the piping curved section to potentially cause erosion/corrosion.

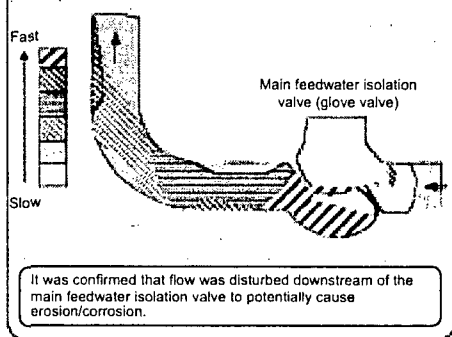
Flow pattern analysis

It was confirmed that flow was disturbed downstream of the main feedwater isolation valve to potentially cause erosion/corrosion.

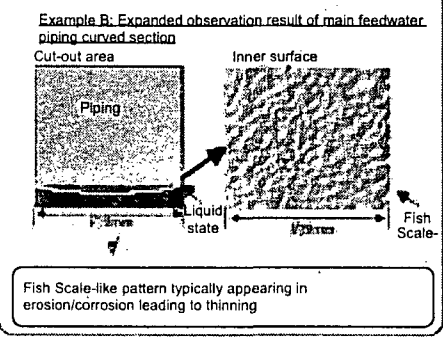
Enlarged view of "A" area

Fish Scale-like pattern typically appearing in erosion/corrosion leading to thinning
