Subject: **Docket No. 50-361**
Licensee Event Report No. 2008-006
San Onofre Nuclear Generating Station, Unit 2

4. TITLE
Loose connection bolting results in Inoperable Battery and TS violation

Plant: San Onofre Nuclear Generating Station (SONGS) Unit 2
 Event Date: March 25, 2008
 Reactor Vendor: Combustion Engineering
 Mode: Mode 1- Power
 Power: 100 percent

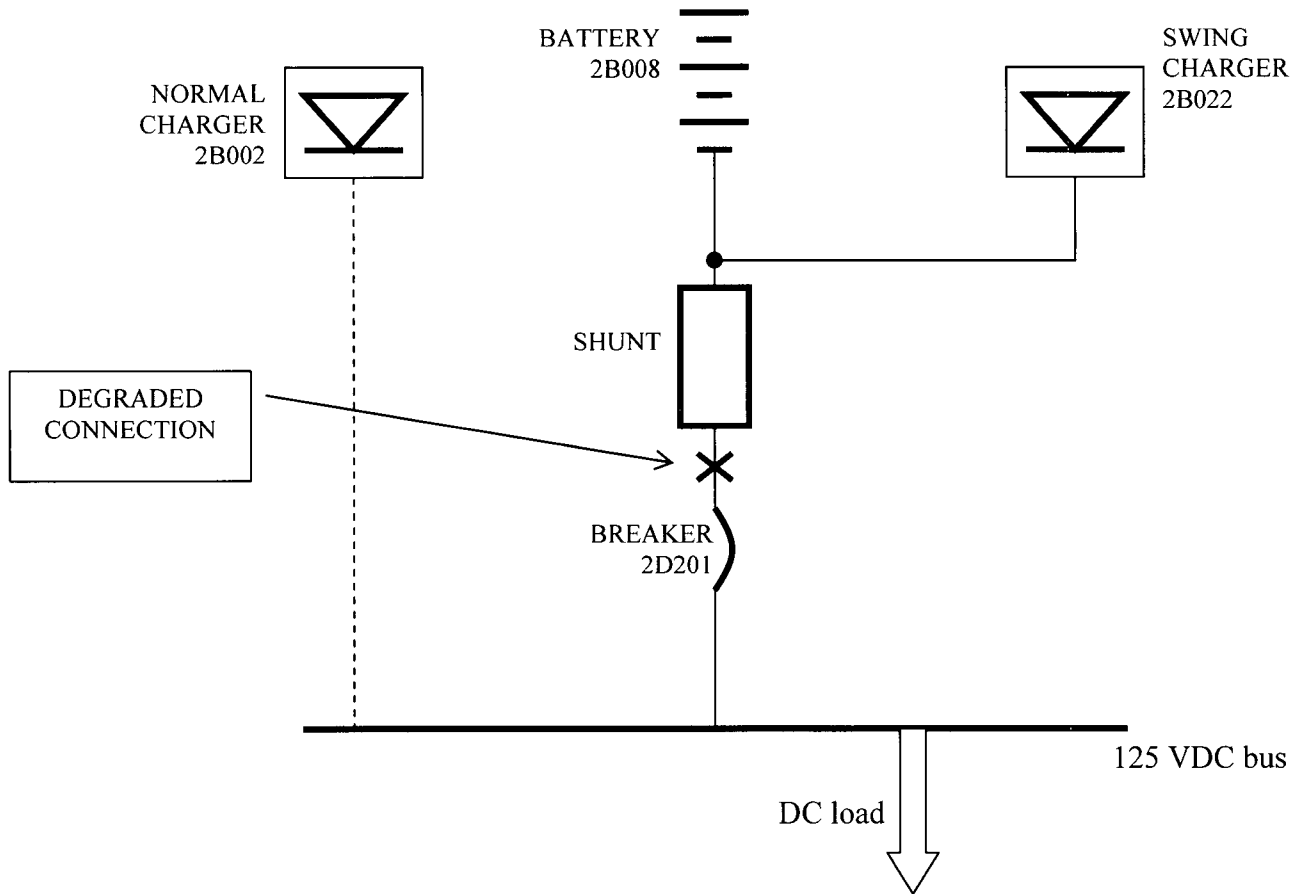
Figure: DC System Configuration

Technical Specification 3.8.4 requires Trains A, B, C and D electrical power subsystems to be operable in Modes 1 through 4. If one electrical subsystem is inoperable, Action A.1 requires restoration of the DC electrical power subsystem to operable status within 2 hours. If not completed within 2 hours, Action B requires Operators to place the plant in Mode 3 within 6 hours and Mode 5 within 36 hours. TS Surveillance Requirement 3.8.4.1 requires SCE to verify battery voltage is greater than or equal to 129 VDC once every 7 days. Technical Specification (TS) Surveillance Requirement (SR) 3.8.4.6 requires verification of each battery charger capability every 24 months. During this surveillance a swing charger is connected at the battery and supplies the DC bus through the same DC breaker. This allows isolation of the normal charger for testing (See attached figure).

On March 25, 2008 (Discovery Date), with Unit 2 at approximately 100 percent power, plant personnel began performance of the weekly surveillance (SR 3.8.4.1) of the Train B battery (2B008). The SR requires battery voltage to be greater than or equal to 129 VDC at the battery terminals. At about 0415 PDT, plant personnel discovered the battery voltage below the required value. Subsequently, while attempting to verify the low battery voltage reading, indications of a loose connection were observed on the bolt on the battery side of the breaker (2D201) that connects the battery to its DC bus (2D2) (See attached figure).
