UNITED STATES
NUCLEAR REGULATORY COMMISSION
OFFICE OF NUCLEAR REACTOR REGULATION
WASHINGTON, D.C. 20555

September 16, 1987

NRC INFORMATION NOTICE NO. 87-44: THIMBLE TUBE THINNING IN WESTINGHOUSE
REACTORS

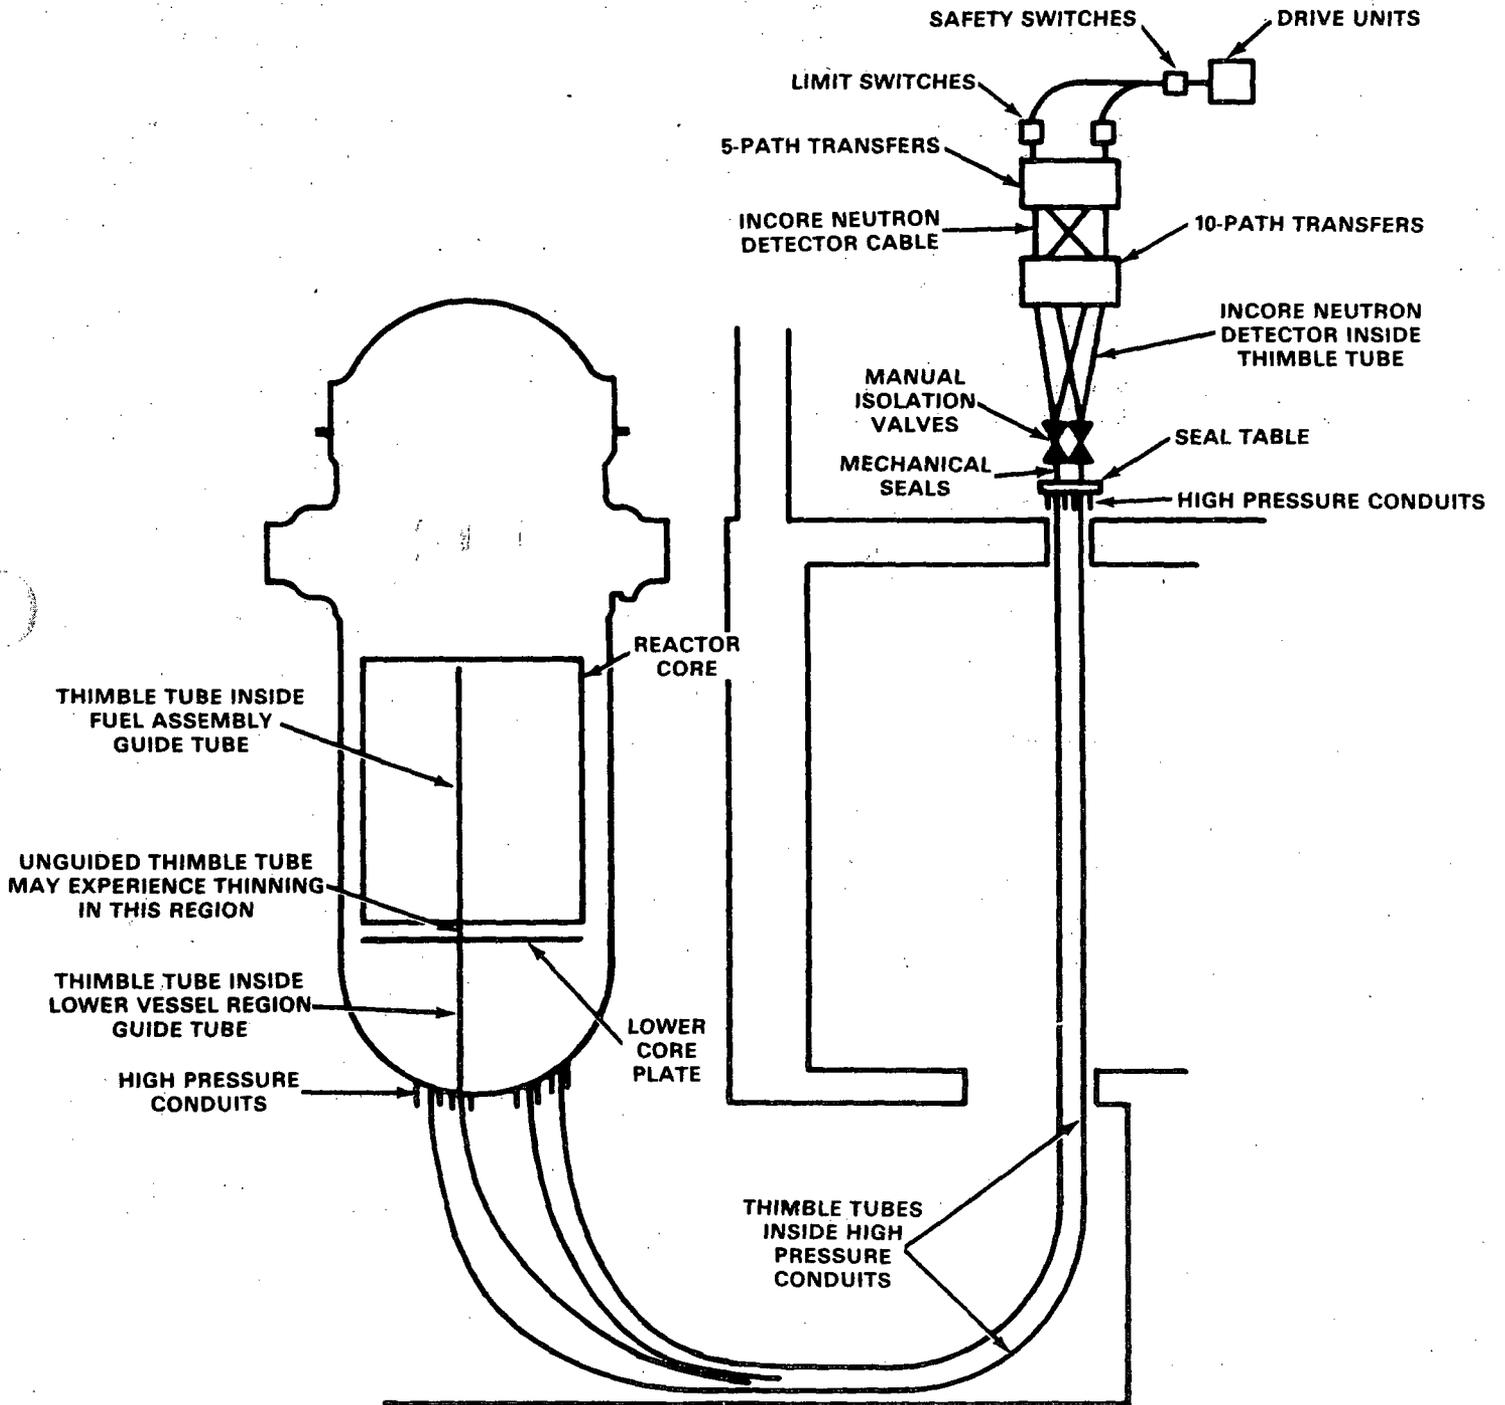
TYPICAL WESTINGHOUSE INCORE NEUTRON MONITORING SYSTEM

The movable incore neutron detectors travel within retractable thimble tubes. The thimble tubes normally extend (as indicated in Attachment 1) from a 10-path transfer device, through the seal table, through the bottom of the reactor vessel, and into selected fuel assemblies. The thimble tubes are supported by guide tubes within the lower vessel region and the fuel assemblies, and by high-pressure conduits between the reactor vessel and the seal table.

As indicated, the thimble tubes are supported over most of their length. However, a small portion of the thimble tube is directly exposed to RCS flow. This exposed portion is between the top of the lower core plate and the bottom of the fuel assembly. This region is approximately 18.4 to 34.8 mm in length, depending on the reactor type. It is believed that flow-induced vibration on this exposed portion causes fretting at the adjacent guide tubes.

At North Anna Unit 1, the proposed corrective action was to retract selected thimble tubes approximately 2 inches. This would move the thinned area out of the region of high turbulence. In addition, the thimble tube that experienced the most degradation will be taken out of service by closing the corresponding isolation valve.
