**SUBJECT: COMANCHE PEAK STEAM ELECTRIC STATION (CPSES) UNIT 2 TENTH
REFUELING OUTAGE (2RF10) STEAM GENERATOR 180 DAY REPORT**

Enclosure - SG-CDME-08-28, Rev 1 - Steam Generator Condition Monitoring and Operational Assessment for Comanche Peak Unit 2 April 2008 Outage (2RF10)

**Steam Generator Condition Monitoring and
Operational Assessment for
Comanche Peak Unit 2 April 2008 Outage (2RF10)**

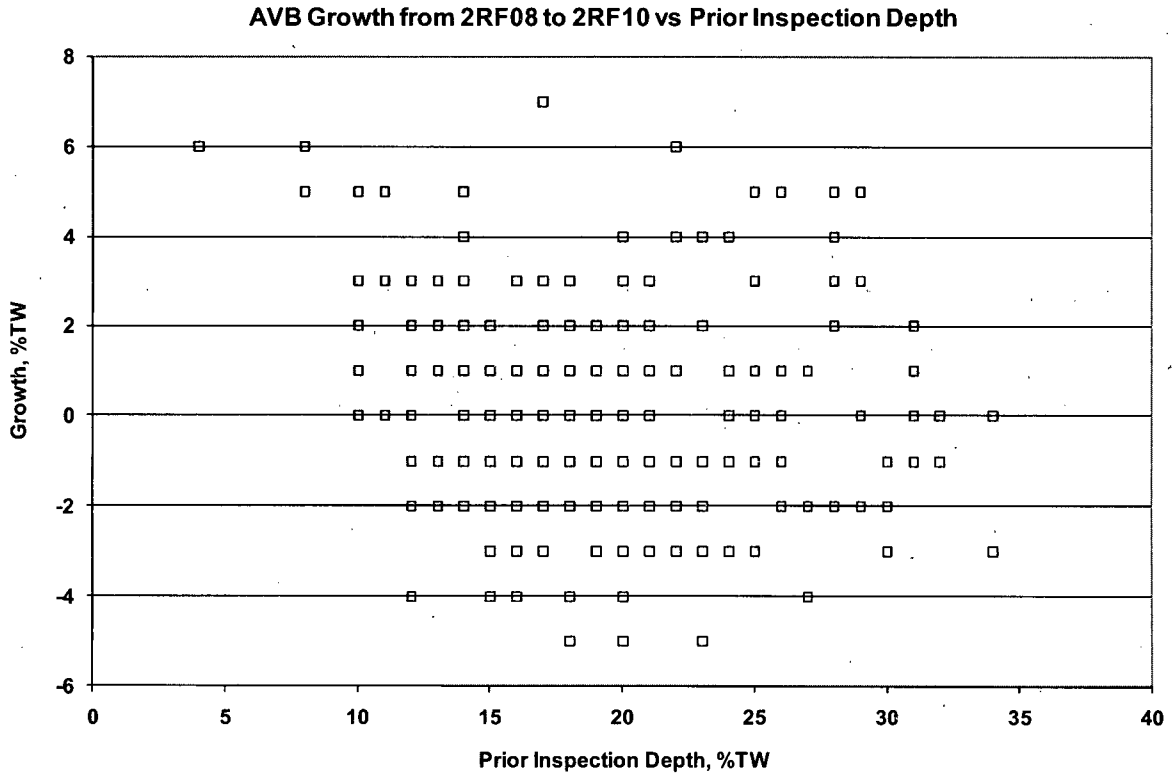
Figure 4-1. Growth rate of AVB wear indications in Cycles 9 and 10

The growth rate of AVB indications is very low. Figure 4-1 shows the growth rate distribution as a function of the indicated depth at the beginning of the period. It may be noted that the growth rate is independent of the initial wear depth. There are a large number of negative values, which reflect the NDE uncertainty. The average growth of the AVB indications in the last two cycles was 0.18% TW, with a standard deviation of 2.17% TW. Since the combined operating length of cycles 9 and 10 was 2.839 EFPY, the average growth per EFPY was 0.06% with a standard deviation of 0.76%/EFPY. The growth rate at 95% probability and 50% confidence is 1.32%/EFPY. A histogram and a cumulative probability distribution of the growth rates during Cycles 9 and 10 are shown in Figure 4-2. The average and maximum growth rates for the last few cycles are listed in Table 4-2. This table also shows the growth rates at 95% cumulative probability and the 95% probability value at 95% confidence. The latter two values are both equal to 1.41%/EFPY. The combined length of the next two fuel cycles is 2.86 EFPY. Hence using the 95/95 growth rate and the cycle lengths, the projected growth during the next two cycles is 4.03% TW.

Applying this growth rate, a 34% indication (largest indication left in service after 2RF10) will grow to 40% TW at 2RF12. As noted in the degradation assessment, the structural limit for AVB wear is 78% and the condition monitoring limit is 60%. Hence there remains considerable margin from condition monitoring limit. Thus the AVB wear indications will meet the performance criteria during the next two operating cycles.
