TENNESSEE VALLEY AUTHORITY

NUCLEAR SAFETY REVIEW STAFF

NSRS INVESTIGATION REPORT NO. I-85-776-SQN

SUBJECT: SOCKET WELDS NOT INSPECTED

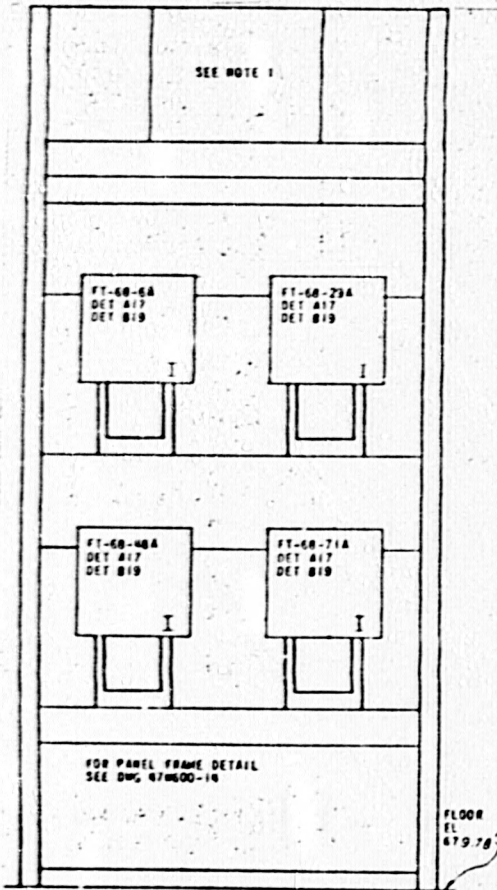
PANEL 1-L-226
PANEL 2-L-224

The concern of record was substantiated. Several sense lines for the reactor coolant system flow transmitters were found to have slope conditions that are not presently in accordance with stated requirements. However, a review of operational histories for these instruments does not indicate SQN has experienced significant problems with air entrapment in their sense lines. Air entrapment in instrument sense lines is generally detectable during operation, and its removal can be accomplished with existing plant procedures.

Because of the demonstrated generic effects of WBN NCR 6172 (ref. 23) to SQN on improper instrument sense line slope, the WBN construction NCR should be sent through design to SQN and to the other TVA plants for a generic review for applicability in accordance with Office of Engineering Procedure OEP-17 (ref. 24). [P2]

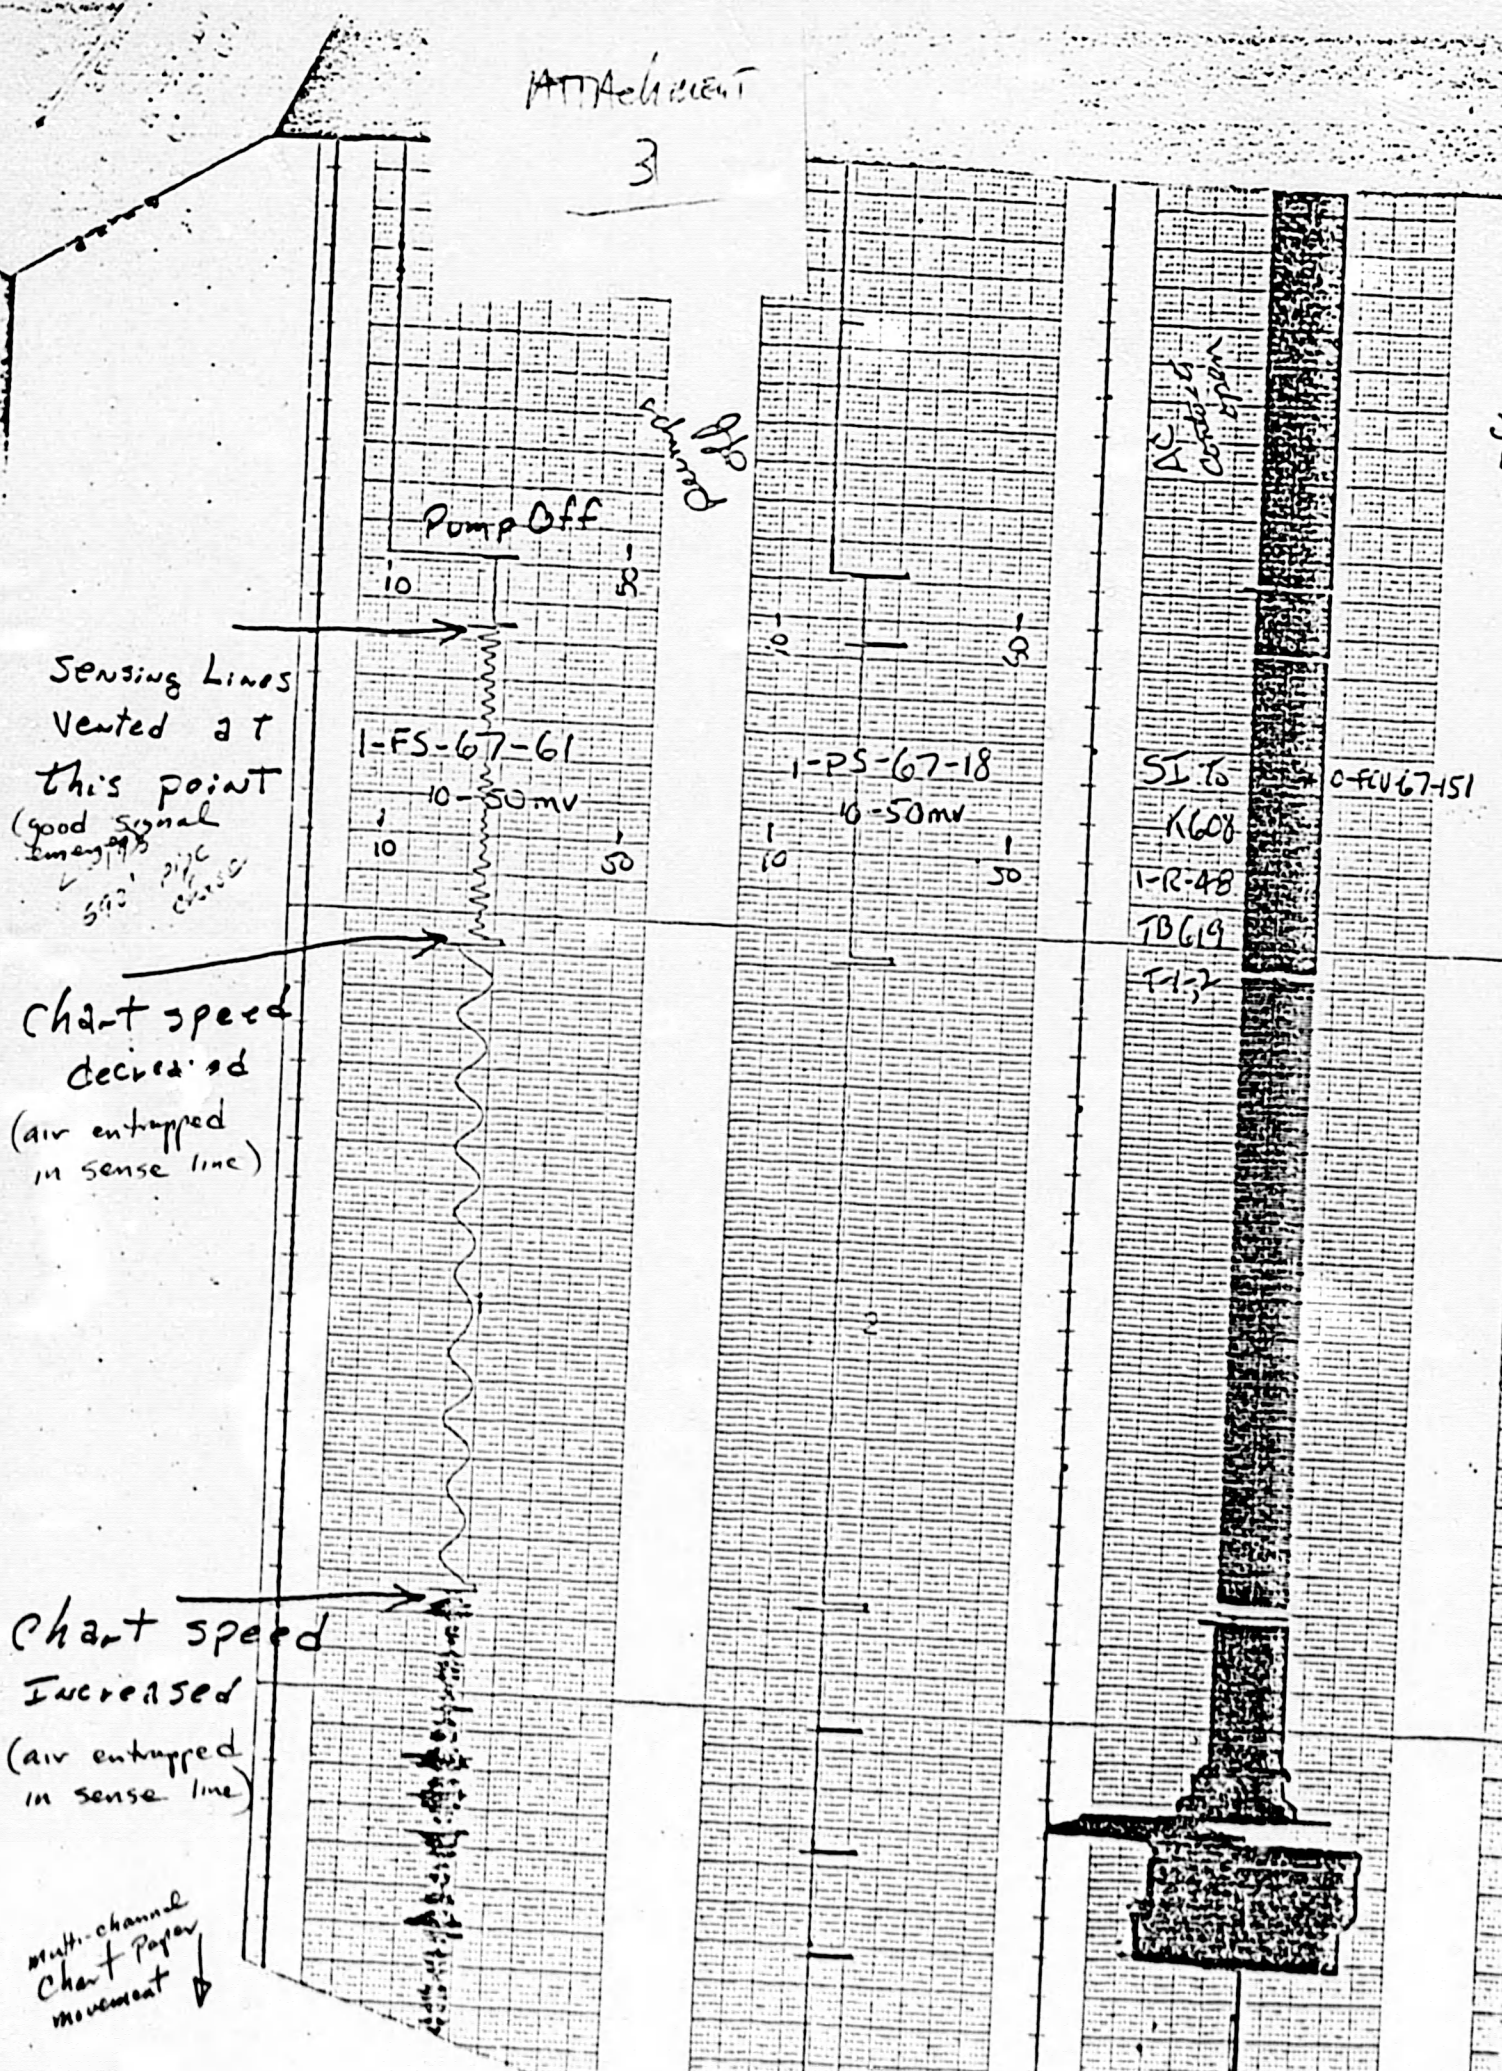
measurements such as RCS flow. This is due to the low pressures applied to the transmitter. Attachment 3 shows a strip chart recording of a typical erratic flow signal (not RCS flow) caused by air entrapped in the sense line and then subsequently removed. Although it is possible that a large air bubble in a vertical section of sense line may cause a zero shift upscale or downscale depending on which line contains the bubble, it would also be characterized by an erratic transmitter output signal similar to that shown on Attachment 3. This erratic signal can be detected by observing flow indicators or recorders and comparing redundant flow channels during periodic channel checks.
