WATTS BAR NUCLEAR PLANT (WBN) – DAM SAFETY INSPECTION RESULTS AND FUTURE SCHEDULING UPDATE

Watts Bar Nuclear Plant
Dam Safety Inspection Report

**Dam Safety Inspection Report - Class A
Watts Bar Hydro Plant
Special, Nuclear Yard Drainage Holding Pond**

Date of Inspection: 07/18/08

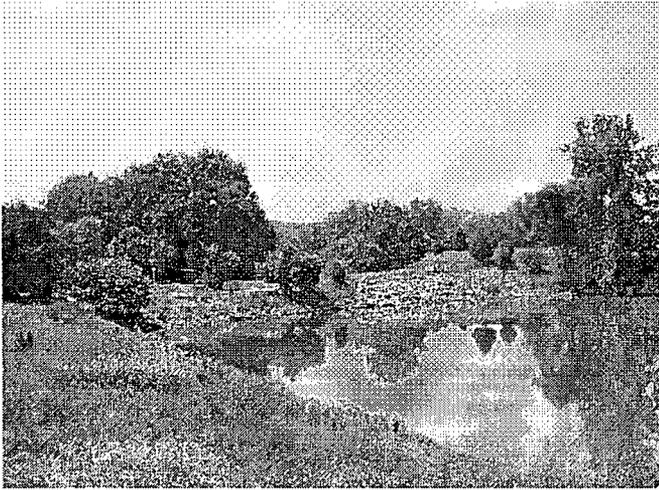
The embankment dam is in satisfactory condition. Numerous trees will require removal per Dam Safety requirements. See Exhibit 1 for recommendations.

Figure 4:
View of upstream side of dam with the concrete spillway. Note numerous trees that will need to be removed.

1. PM – Remove the trees located on the upstream and downstream side of the small embankment dam and spillway. Include all trees within 20' of the toe and groin areas.
Responsible Organization: Facilities Maintenance, Darrel Reed
Estimated Cost: \$4,000.00
Estimated Completion Date: 3/30/09

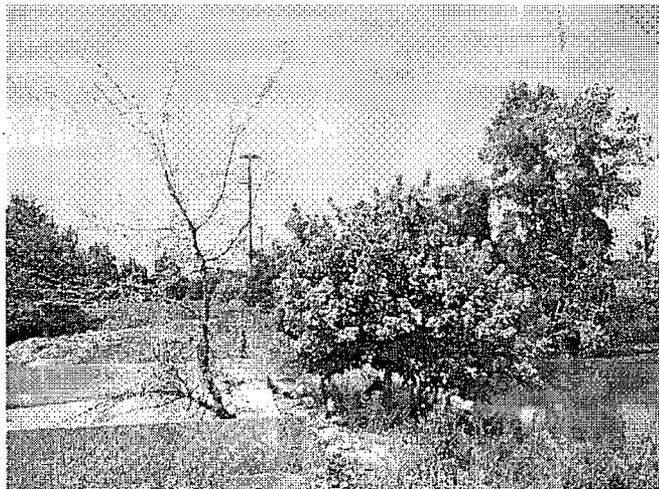
Figure 5:
View of crest of dam and upstream edge of concrete spillway. A weir for measuring flow is located on the upstream end of the spillway.

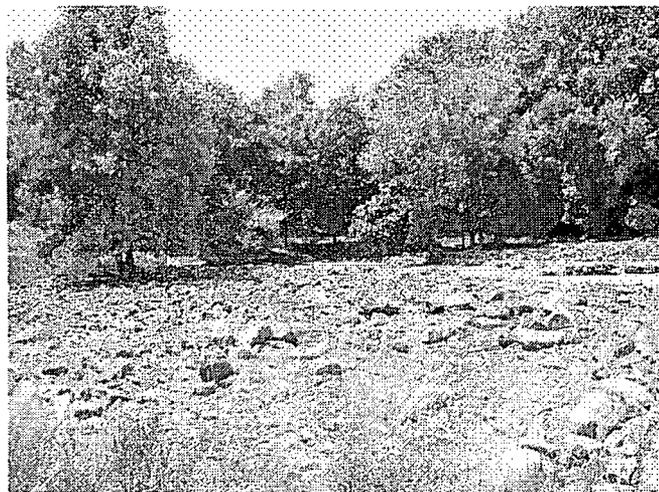
Figure 6:
View of downstream slope of dam, with concrete spillway slab. Note trees located along the toe which will require removal.

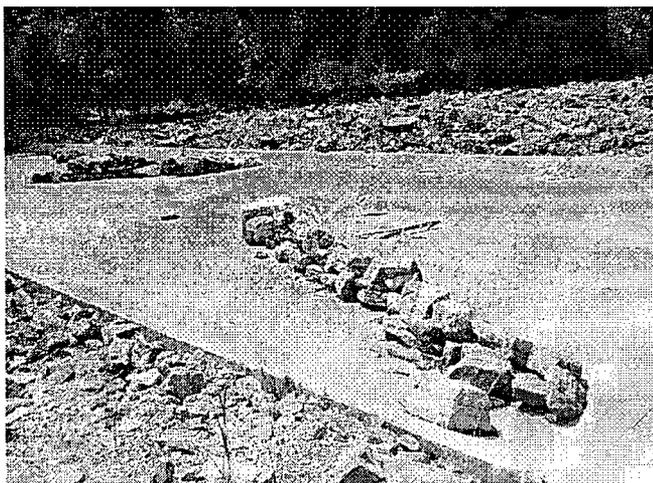
Figure 7:
View of concrete spillway slab on
downstream slope.

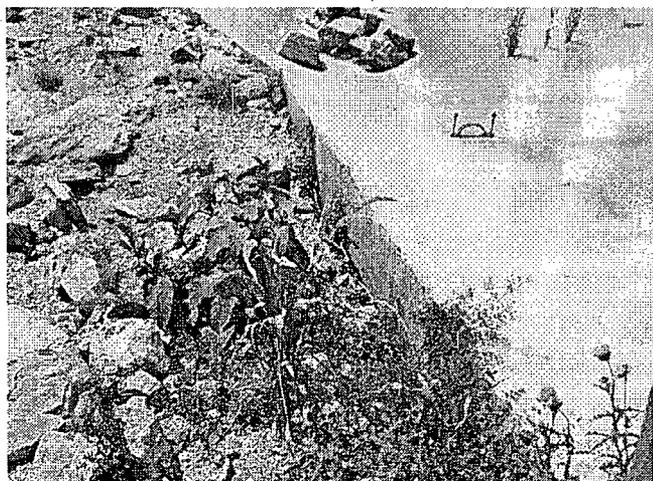
The spillway section is in satisfactory condition. A small undermined area is located on the left side of the spillway slab, which allows water to flow underneath the slab. This hole should be filled with small 1/2" stone. See Exhibit 1 for recommendations.

Figure 8:
View of a small hole that has undermined the
concrete spillway slab.

2. PM – Fill the small hole that is undermining the left side of the spillway slab just downstream from the crest of the dam with small 1/2" washed stone.
Responsible Organization: Facilities Maintenance, Darrel Reed
Estimated Cost: \$500.00
Estimated Completion Date: 3/30/09
