RE: Permit to Mine No. 633; Release of Solutions Report

**Power Resources, Inc  
Smith Ranch-Highland Uranium Project  
URANIUM IN SITU FLUID RELEASE REPORT**

**Production Fluids**

**MINE UNIT K  
BOOSTER 3, PUMP A  
SPILL 9-17-2008**

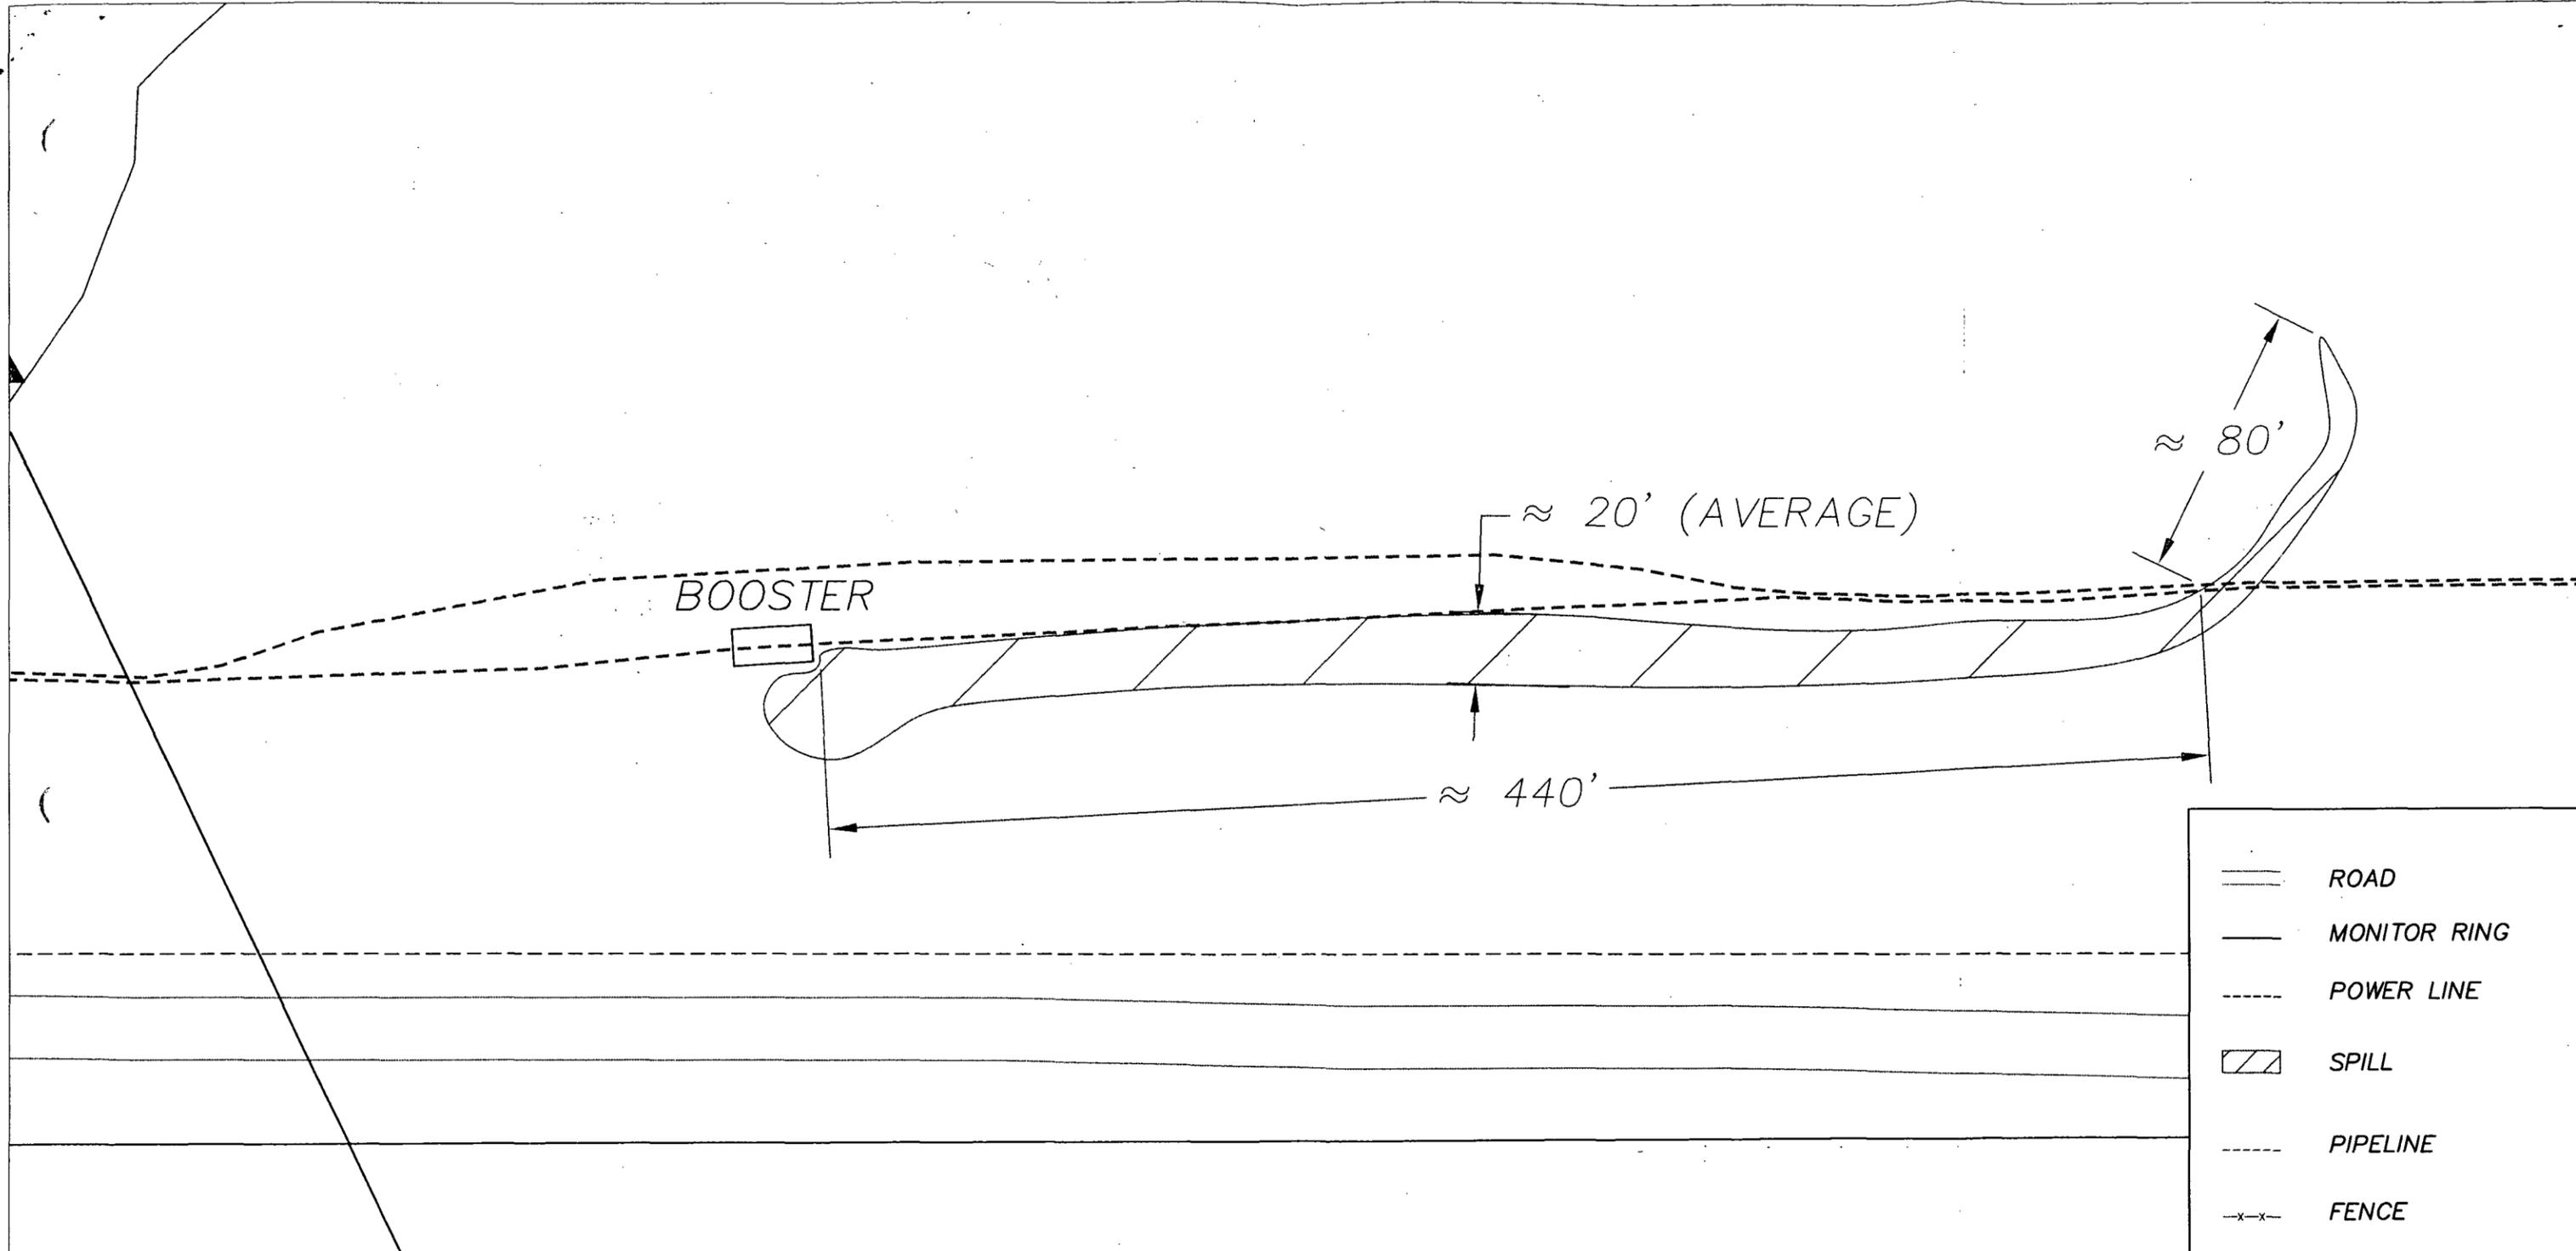
On 17 September 2008 at approximately 1:30 am, a Satellite Operator reported a release of production fluid at a Booster House #3 northeast of Wellfield K (see attached map). Upon discovery of the leak, the wellfield was immediately shut down to control further loss of solution.

The release occurred adjacent to and northeast of Wellfield K and affected approximately 0.4 acre.
