UNITED STATES
NUCLEAR REGULATORY COMMISSION
OFFICE OF NUCLEAR REACTOR REGULATION
WASHINGTON, D.C. 20555

December 18, 1991

NRC INFORMATION NOTICE 91-18, SUPPLEMENT 1: HIGH-ENERGY PIPING FAILURES CAUSED BY WALL THINNING

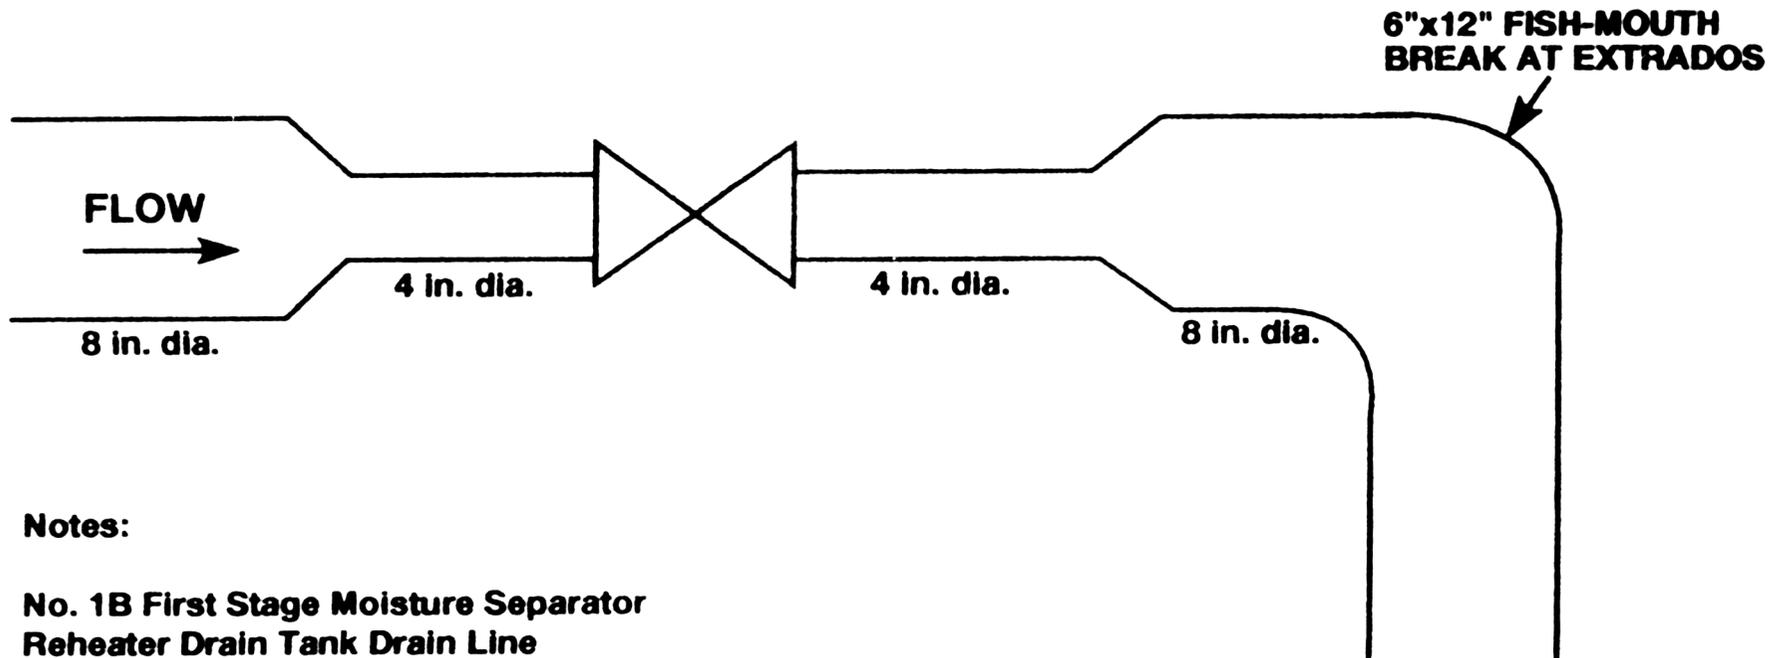
Figure 1. Rupture of Elbow in Secondary System at Millstone Unit 2 on November 6, 1991

At Millstone Unit 2, on November 6, 1991, while the licensee, the Northeast Nuclear Energy Company (NNECo), was operating the plant at 100 percent of full power, a rupture occurred in train B of the moisture separator reheater (MSR) system. An 8-inch elbow, located between the first stage MSR drain tank and the feedwater heater, ruptured at its extrados (Figure 1). The elbow was located downstream from a 4-inch flow control valve and a 4- to 8-inch expander. The high energy water in the pipe (approximately 463 F, 470 psig) flashed to steam, actuating portions of the turbine fire protection deluge system. The water level in the steam generator decreased slightly. The licensee had not selected the ruptured elbow for ultrasonic testing (UT) in its erosion/corrosion monitoring program.

The ruptured elbow was made of carbon steel with nominal wall thickness of 0.322 inch. Wall thickness at the failed area was eroded to 95 percent of the initial nominal value. Other areas, away from the failed area, showed a loss of 22 percent of the wall thickness. The identical elbow in the A train had a maximum wall loss of 34 percent of the initial nominal value.

In its response to GL 89-08, NNECo indicated that its Engineering Procedure EN-21153, "Thickness Testing of Secondary Piping," describes its monitoring program, established in accordance with EPRI guidelines and using the CHEC program to select for testing those areas of the piping systems with highest probabilities for wall thinning. The licensee also selects areas on the basis of plant experience. However, although the pipe wall thickness testing program was included in the licensee's procedures, the licensee had not implemented the methodology using the EPRI computer codes at Unit 2. This omission may account for the licensee not having tested previously the piping that ruptured on November 6, 1991.

The licensee did use an earlier version of the CHEC computer code in limited analyses at its other nuclear units. The licensee's program did not reflect the use of current versions of EPRI codes (either CHEC or CHECMATE). The Unit 3 rupture described in the March 12, 1991, issuance of this information notice prompted NNECo to commit to perform CHEC or CHECMATE analyses at all its units by December 31, 1991. However, at the time of the second rupture on November 6, 1991, the licensee was implementing this program at its corporate engineering office and not at Unit 2. The Unit 2 personnel were consequently relying on inspection procedures that did not possess the benefit of the EPRI's methodology for selecting areas of piping for UT inspection. After November 6, 1991, NNECo performed a CHECMATE analysis that did identify this portion of the MSR system as highly susceptible to erosion or corrosion and thus as a candidate for UT inspection.

**No. 1B First Stage Moisture Separator
Reheater Drain Tank Drain Line**

**Pipe: Carbon Steel
No Chromium Content**

**Fluid: H₂O @ 470 psig, 463°F
pH: 8.2 → 8.7
O₂: <?ppb**
