Palo Verde Nuclear
Generating Station

**Subject: Palo Verde Nuclear Generating Station (PVNGS)
Unit 2
Docket No. STN 50-529
License No. NPF 51
Licensee Event Report 2007-005-00**

LICENSEE EVENT REPORT (LER)

4. TITLE
Emergency Diesel Generator Inoperability Resulting from a Degraded Speed Control Actuator

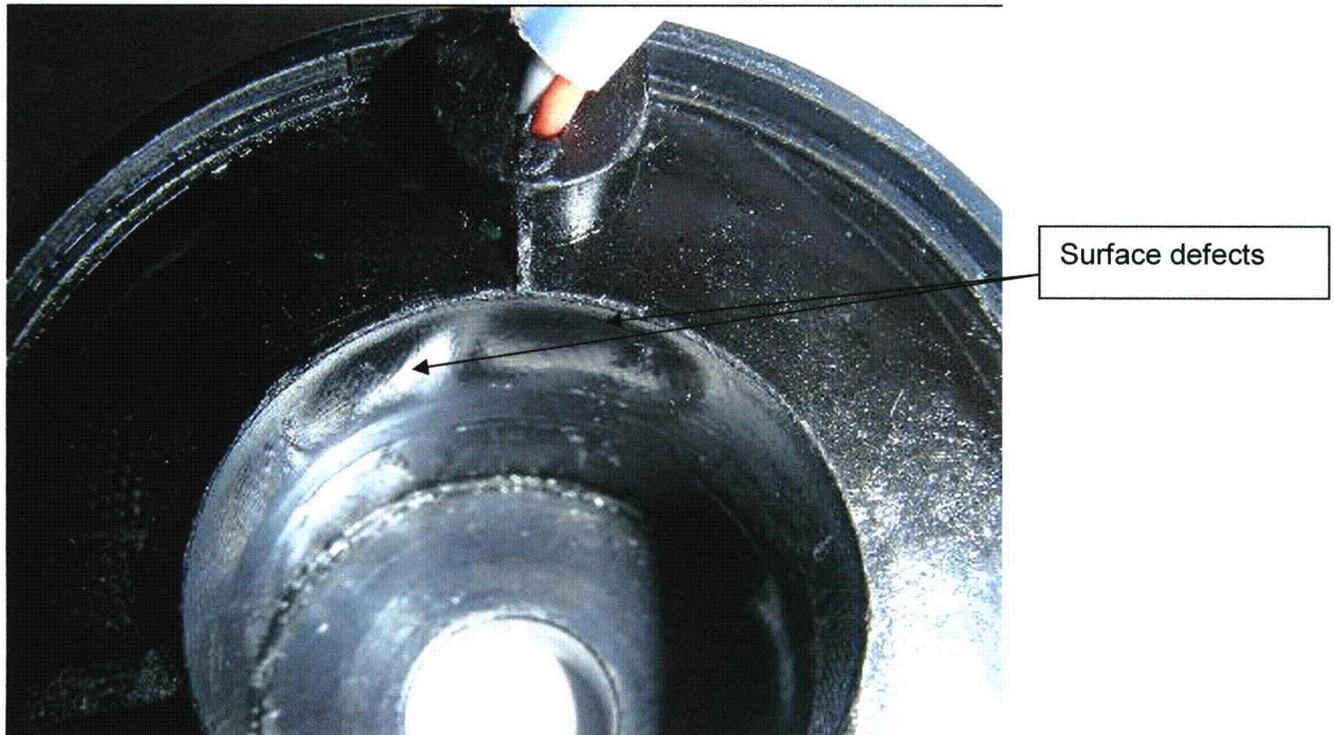
FIGURE 1

The direct cause of the frequency oscillation was a degraded component within the Woodward® EGB50-PLS hydraulic actuator. Specifically, the transducer assembly, two electrical coils fabricated as an assembly, degraded over time. Surface defects appeared on the inside diameter of the potting material that surrounds the coils (see Figure 1 at the end of this report). These defects protruded far enough into the inside diameter to cause friction with a positioning magnet. Frequency oscillation occurred as the magnet would stick and the electronic 2301 governor controls would continue to change voltage until the friction was overcome. The sudden release of friction would cause the magnet to overshoot. This cycle of being stuck and then released occurred repeatedly resulting in the oscillation.

The root cause of the frequency oscillation was the surface defects growth as a result of a wicking action that drew small amounts of oil into the transducer after the EDG was shutdown and the actuator slowly cooled to ambient temperature. When the EDG was subsequently started, the actuator would heat up and the ingested oil was essentially trapped within the transducer. Thermal expansion of the oil would exert pressure on the potting material, distorting the shape, causing surface defect growth.

Picture showing some of the potting material surface defects discovered during investigation.

The positioning magnet (not shown) sits inside the transducer. Friction between the potting material and the positioning magnet occurred when the surface defects grew.

The root cause will be corrected by the completion of a modification to upgrade the governor and the actuator. Three EDGs have already been upgraded and the other three EDGs (1A, 1B & 3A) will receive the upgrade during their next respective refueling outages. Note: It has been determined that the new actuator could be susceptible to the same defect over time. However, the defective actuator in 2A EDG had been in service since initial plant operation indicating that the defect develops slowly.

Purchase Order instructions for future refurbishments of the new EGB50-P hydraulic actuators, which contain a similar transducer, will be revised to require specific inspections for potting material surface defects.
