**Report No. 10CFR21-0095**

**10CFR21 REPORTING OF DEFECTS  
AND NON-COMPLIANCE**

COMPONENT: Ingersoll-Rand series 89 air start motors  
P/N 8367694-ESI

SYSTEM: Emergency Diesel Generator – air starting system

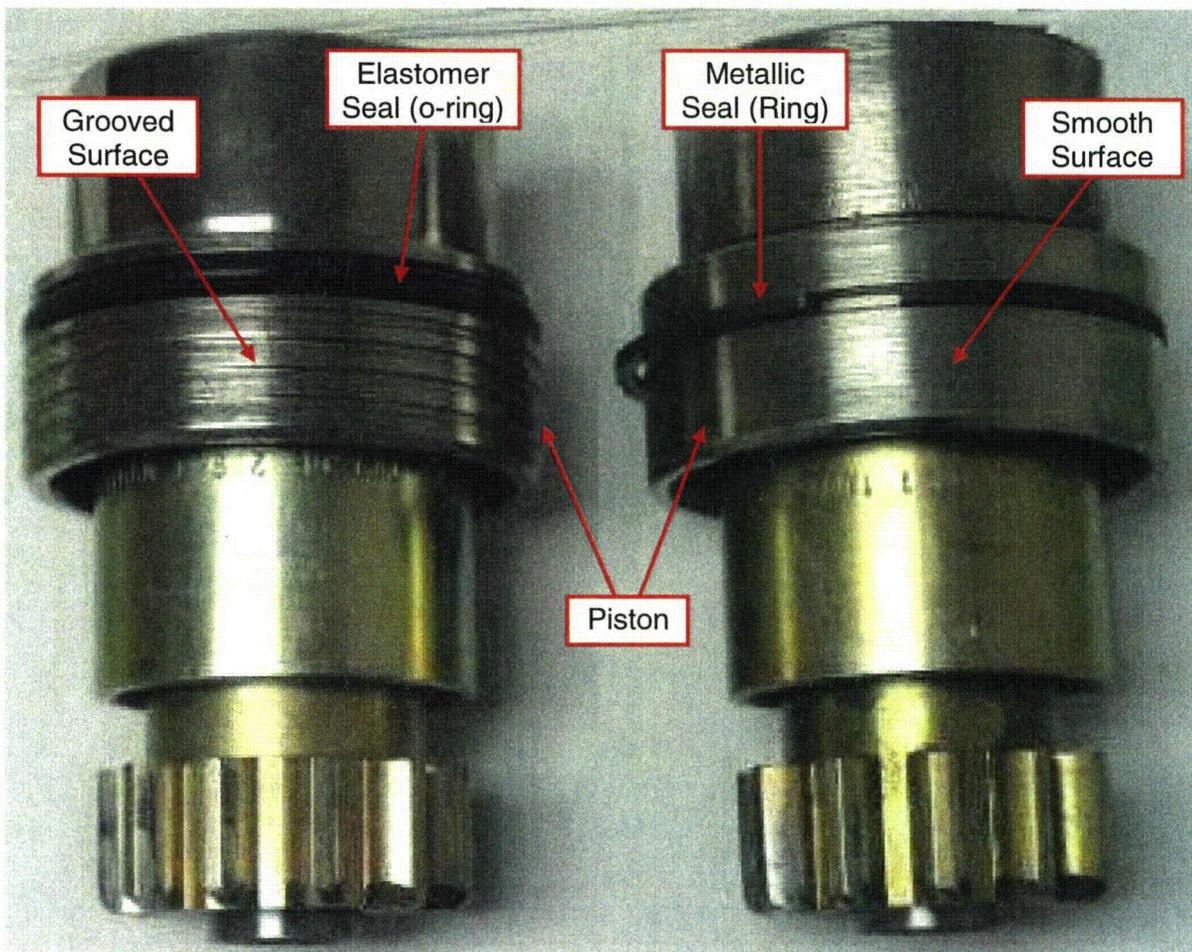
ESI inspection determined that Ingersoll-Rand used the wrong pinion engagement piston during assembly of the air motors. A new style piston with an elastomer seal ring (used in I-R's series 88 air starters) was incorrectly installed in the drive housing instead of the required piston with a metallic seal ring (required for the series 89 motor).

**Series 88 Drive Pinion**  
***INCORRECT***

**Series 89 Drive Pinion**  
***CORRECT***

- (1) the elastomer seal is located further away from the drive gear on the piston; this requires increased travel of the piston to port air from the pinion outlet port. During abutment of the starter drive gear with the engine ring gear, air will not port from the starter to activate the main air start valve and thus engine cranking will not occur.
- (2) the elastomer seal can be cut by the pinion outlet port hole in the starter drive housing after a number of starter engagements. This could cause binding of the piston within the drive housing and or excessive air leakage past the seal. Both conditions could increase the time required for the pinion to engage with the engine flywheel and thus compromise the fast start capability of the engine.

1. ESI has contacted all affected customers that were shipped the incorrectly assembled starters. All starters have been returned to ESI.
2. ESI has added verification of correct pinion piston and seal assembly to the critical characteristic inspection activity for future starter shipments.
3. If desired, users can inspect other starters in their inventory to verify correct assembly of the pinion piston and seal. An inspection procedure is provided on the following page.

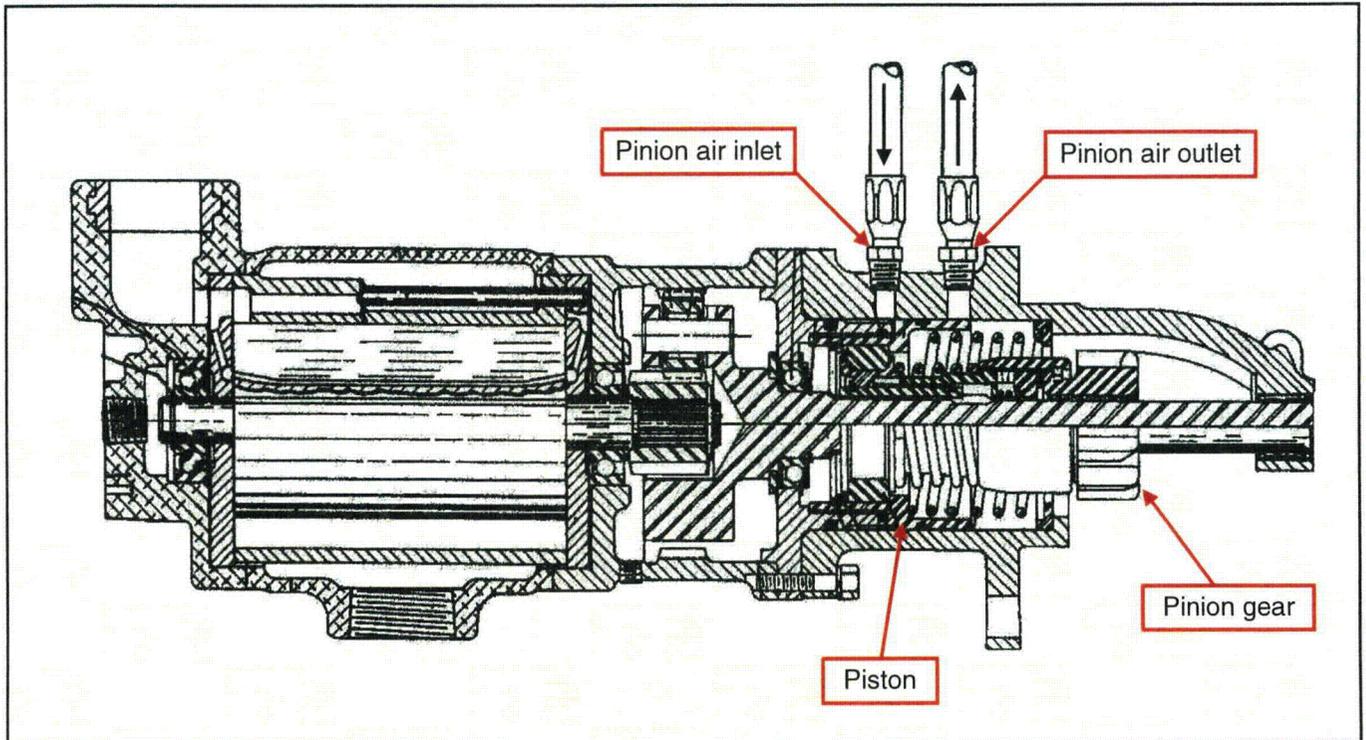
**AIR START MOTOR CROSS-SECTION**

Installation of the elastomer seal and piston within the series 89 starter could impact starting reliability of the diesel engine for the following reasons:

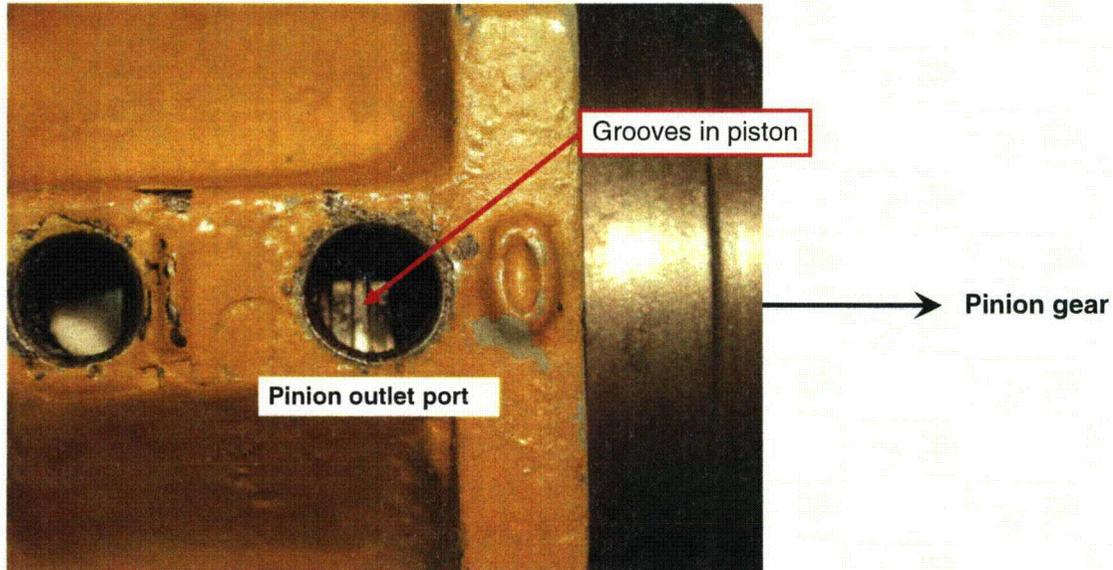
The pinion piston can be viewed through the pinion air outlet port to determine proper configuration. Refer to photos below.

***INCORRECT***

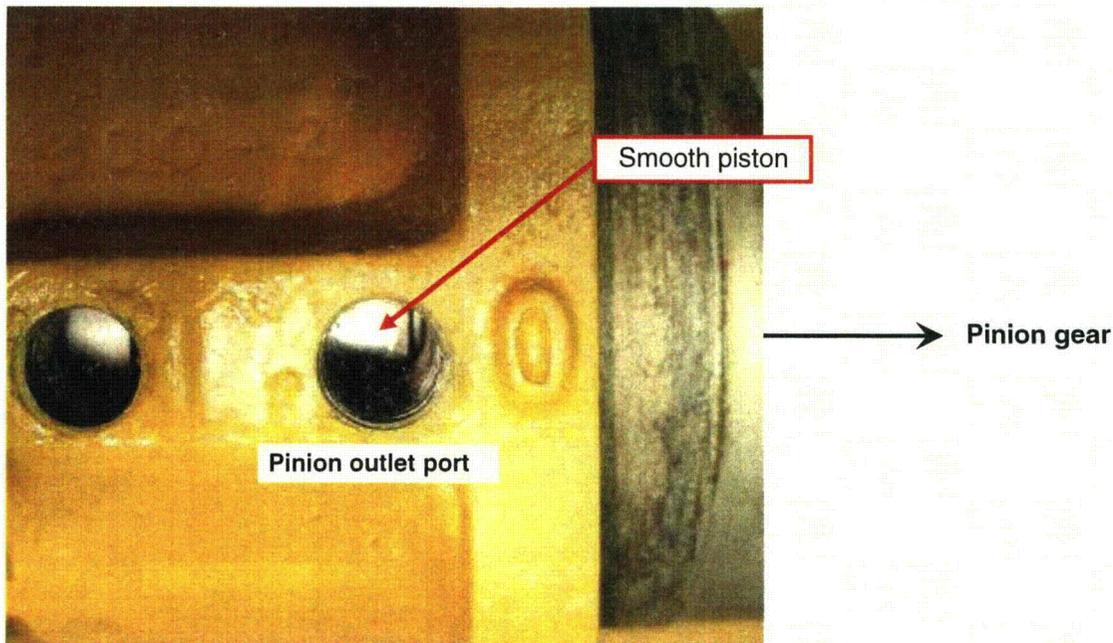
***CORRECT***
