SUBJECT: INSPECTION 03036239/2003001, CFC LOGISTICS, INC., QUAKERTOWN,  
PENNSYLVANIA

INSPECTION REPORT

Inspection No. 03036239/2003001  
Docket No. 03036239  
Licensee: CFC Logistics, Inc.  
Location: 4000 AM Drive  
Quakertown, PA 18951  
Inspection Dates: February 13, 2003 through August 6, 2003

**CFC Logistics, Inc.  
NRC Inspection Report No. 03036239/2003001**

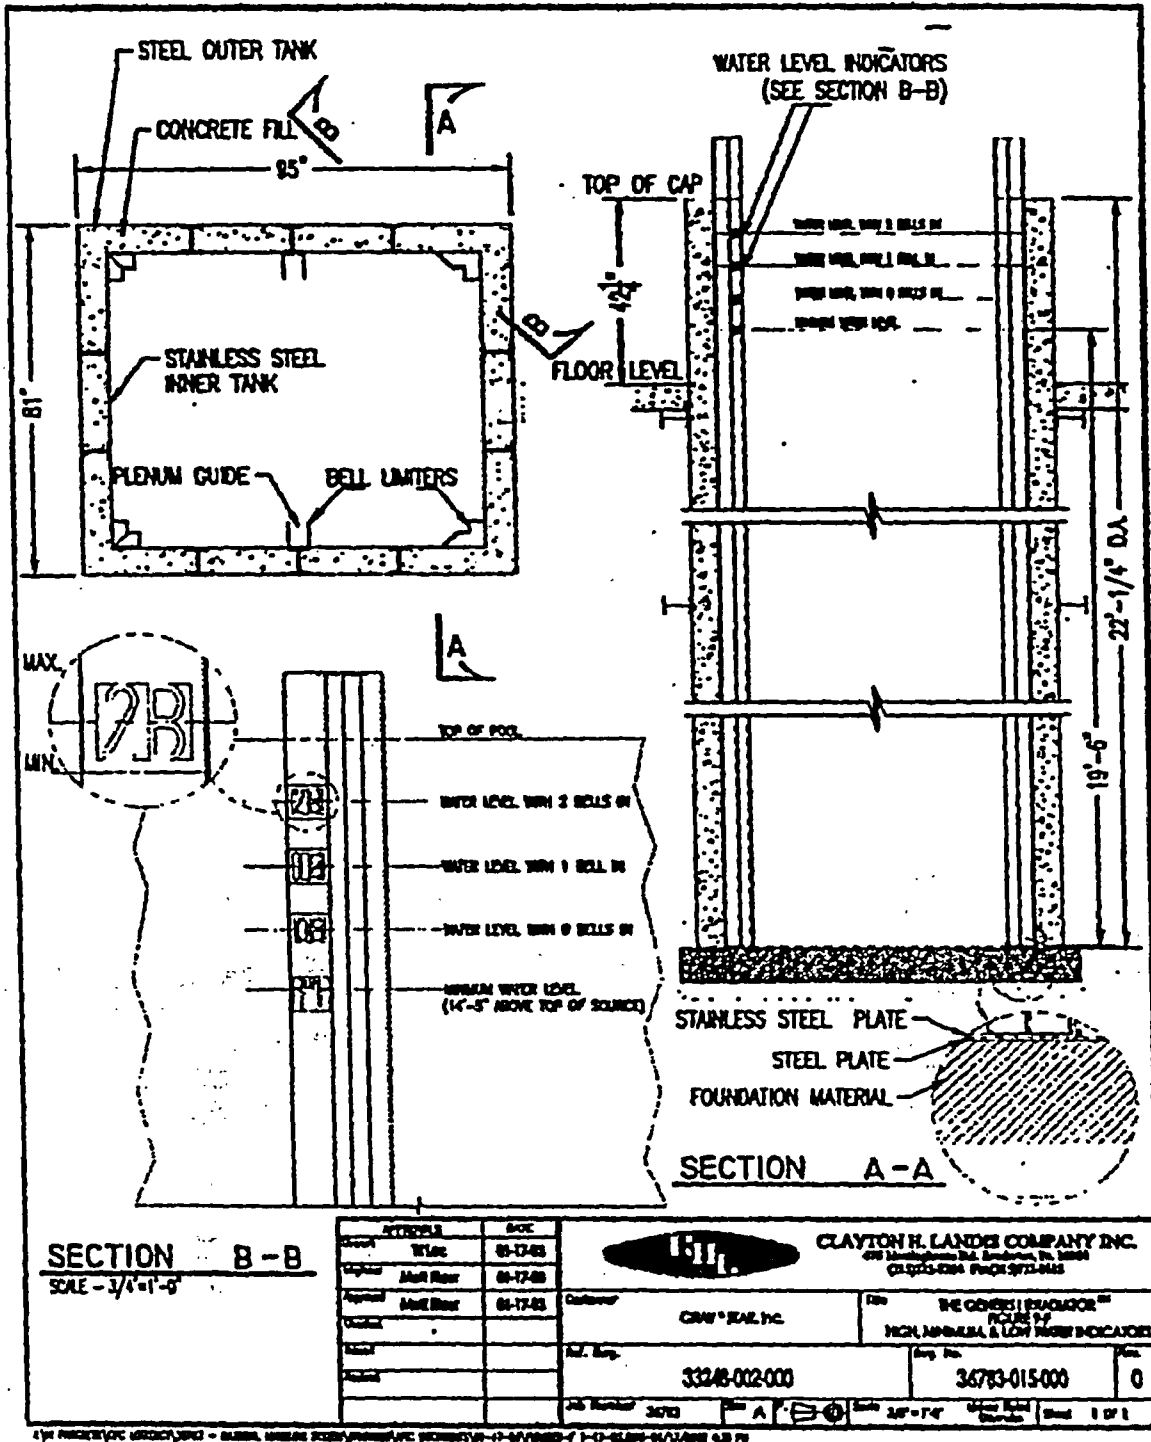
FIGURE 1

The pool is a double-walled rectangular box prefabricated at CHL Engineering facilities. The application includes a diagram of the pool on page 47, and a copy of the diagram is shown in Figure 1 (also at ML03161087) of this report. The inner walls are made of 1/4 inch thick stainless steel and the outer walls are made of 1/4 inch thick carbon steel. The inner and outer walls are 6 inches apart and on each side of the pool structure the walls are joined by two 6-inch steel "I" beams welded lengthwise between them. The 6-inch wide space between the inner and outer walls was filled with concrete after the pool was placed on the concrete foundation. Within the emplacement at the site, the outer walls of the pool are surrounded by cement grout. The open edge of the pool is 42 inches above the floor which provides a barrier to prevent personnel from inadvertently falling into the pool. The main pool is connected to a smaller pool to hold water displaced by the product bells when they are lowered into the main pool.

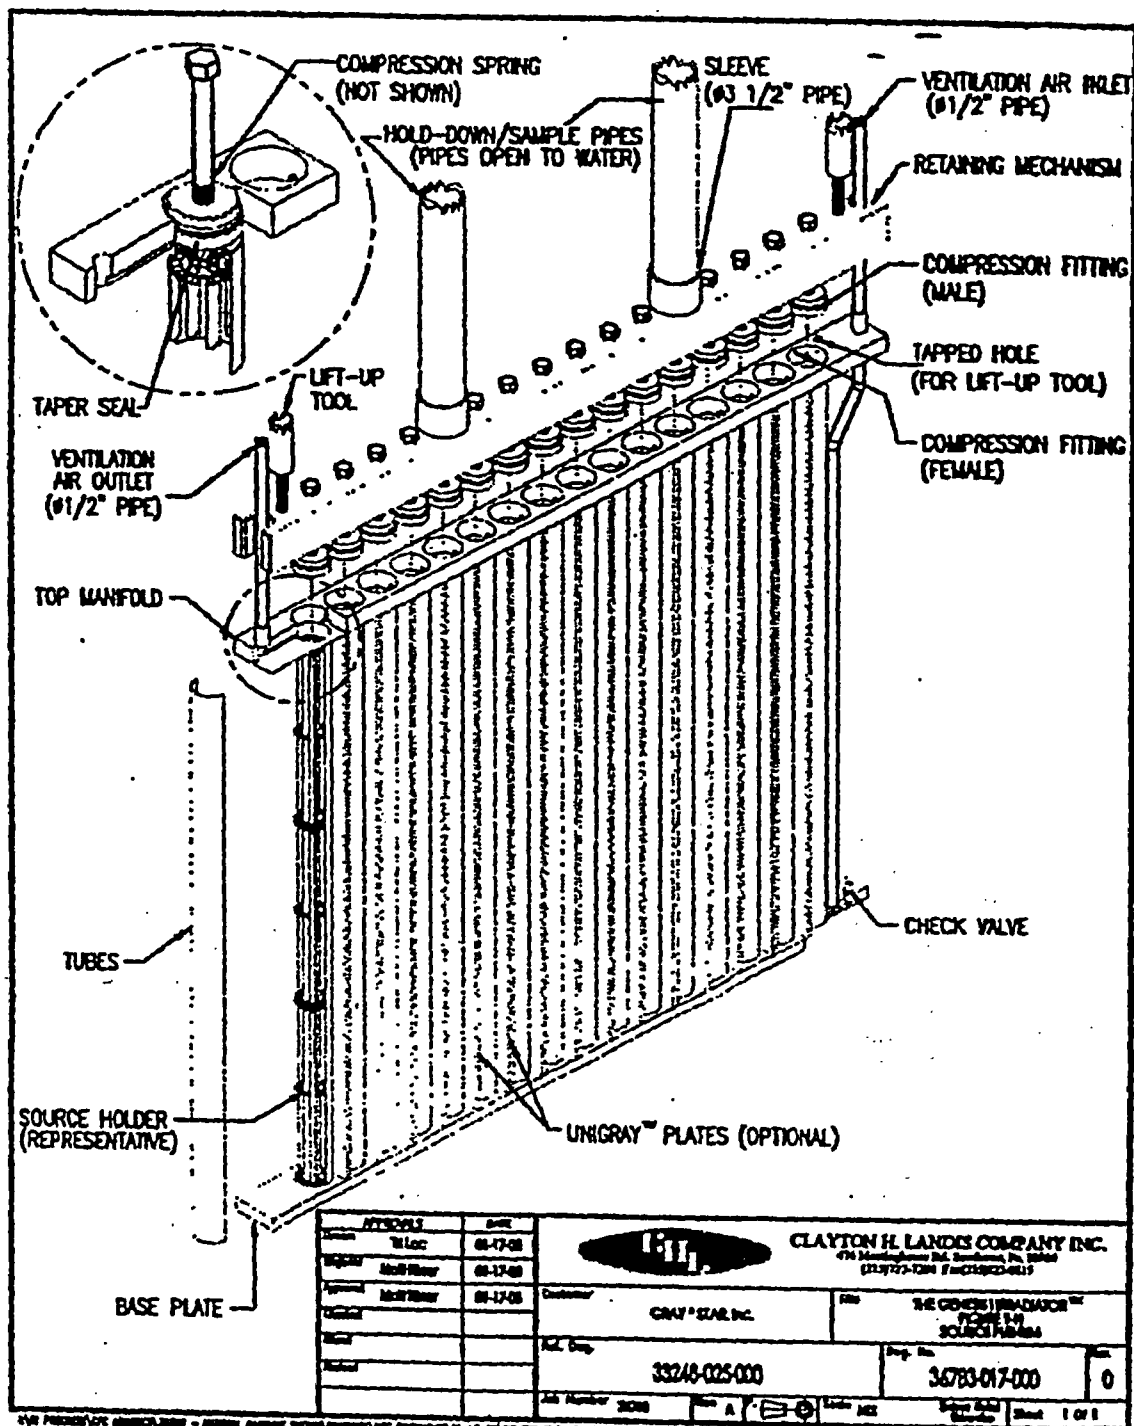
FIGURE 2

A diagram of the plenum is provided on page 49 of the application and Figure 2 (also at ML031610287) of this report. The plenum consists of 16-3 inch diameter vertical stainless steel tubes arranged in a vertical plane. Holders or racks containing the sources are inserted into these tubes. After loading, each tube is closed and sealed with a plug, and water is pushed from the tubes using compressed air, so that the sources are not in contact with pool water during operation. Then a pump continuously circulates air through the plenum tubes and a high efficiency particulate air (HEPA) filter. A radiation detector continuously monitors the air filter for radioactivity thereby providing a means to check for a leaking source. Another radiation detector monitors the radiation dose rate at the surface of the pool. The tubes that carry the air from the surface to the plenum and back to the surface are configured in such a way that there is no direct path for radiation from the sources to the surface. CFC plans to give particular attention to these tubes during the radiation survey after the sources are loaded.

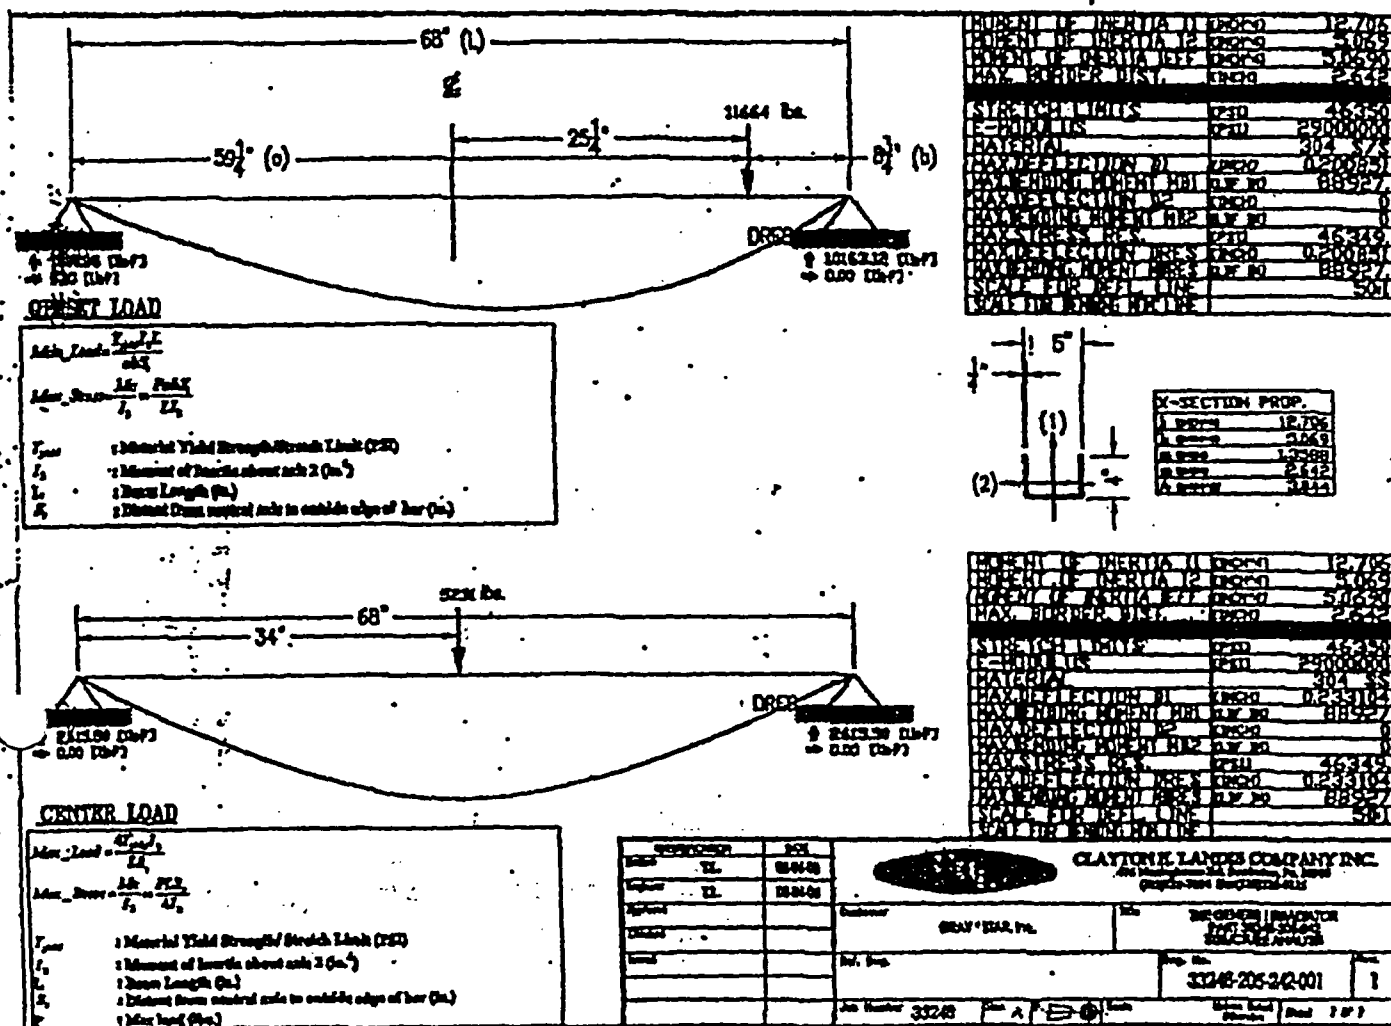
### FIGURE 3

**Scenario (3):** Under the scenario, a dropped bell would impact on the locking bar that sits on top of the pool. The bar is made of 1/4 inch thick stainless steel plate formed to a 5 inch wide channel shape with 3.5 inch high edges spanning a pool inner width of 68 inches. Downward deformation of the lock bar approximately ½ inch would result in contact with other structural members in the pool effectively reducing the span distance to 58 inches. The lock bar is bolted to the pool edges at both ends by ¾ inch diameter F593C-TME bolts and is boxed in at both ends by bolted stainless steel components that also provides support to bell guides. The span of the lock bar between the boxed in areas is 50.5 inches. This results in the lock bar being fixed and strengthened at both ends such that it is much stronger than a simple 5x3.5 inch channel.

Only considering the vertical sides (2x3.5 inch) and 1 inch of the horizontal section of the lock bar, there is ( 8" length x 1/4" thickness) 2 square inches of loadable cross-section of stainless steel in the lock bar. Stainless steel has a strength of 75,000 psi minimum. Using a safety factor of 4, two square inches would support a load of 37,000 lbs in tension or 18,750 lbs in shear. This compares favorably to the total weight of a load bell and its maximum load which is approximately 7,500 lbs or a loading of approximately 3750 lbs with one cable remaining functional.

CHL drawing No. 33248-205-242-001, Rev 1, shown in Figure 3, presents a calculation of the strength of the lock bar showing vertical strengths of the lock bar to be 5231 lbs at its center line and 11664 lbs at 8.75 inches inside the inner pool edge. The vertical strength of the lock bar at its center line (5231 lbs) is less than the maximum weight (7,500 lbs) of a loaded bell. However, this is not of safety concern because if only one cable fails, the bell will swing and one of its lower edges will strike the lock bar at a point away from the center line. On the other hand, if both cables fail, the weight of the bell will be at the ends of the lock bar because the bell is open at the bottom. Furthermore, the lock bar also has extra support at each end that effectively reduces the "free" length of the bar to approximately 58 inches, which is less than the length of the bell (approximately 66 inches). Therefore the weight of a fallen bell will be on the sections of the lock bar that have additional support. Accordingly, the inspectors concluded that, under this scenario, damage to the pool liner resulting in loss of shielding or damage to the sources was not credible.
