SUBJECT: BROWNS FERRY NUCLEAR PLANT - CONFIDENTIAL EMPLOYEE CONCERN OVER OPERATING PRACTICES WHERE PROTECTIVE SYSTEM SIGNALS ARE BYPASSED

CONFIDENTIAL EMPLOYEE CONCERN - CASE NO. 79-10-01

Subject: TVA
Browns Ferry Nuclear Plant
Employee Concern Over Operating Practices
Where Protective System Signals are Bypassed

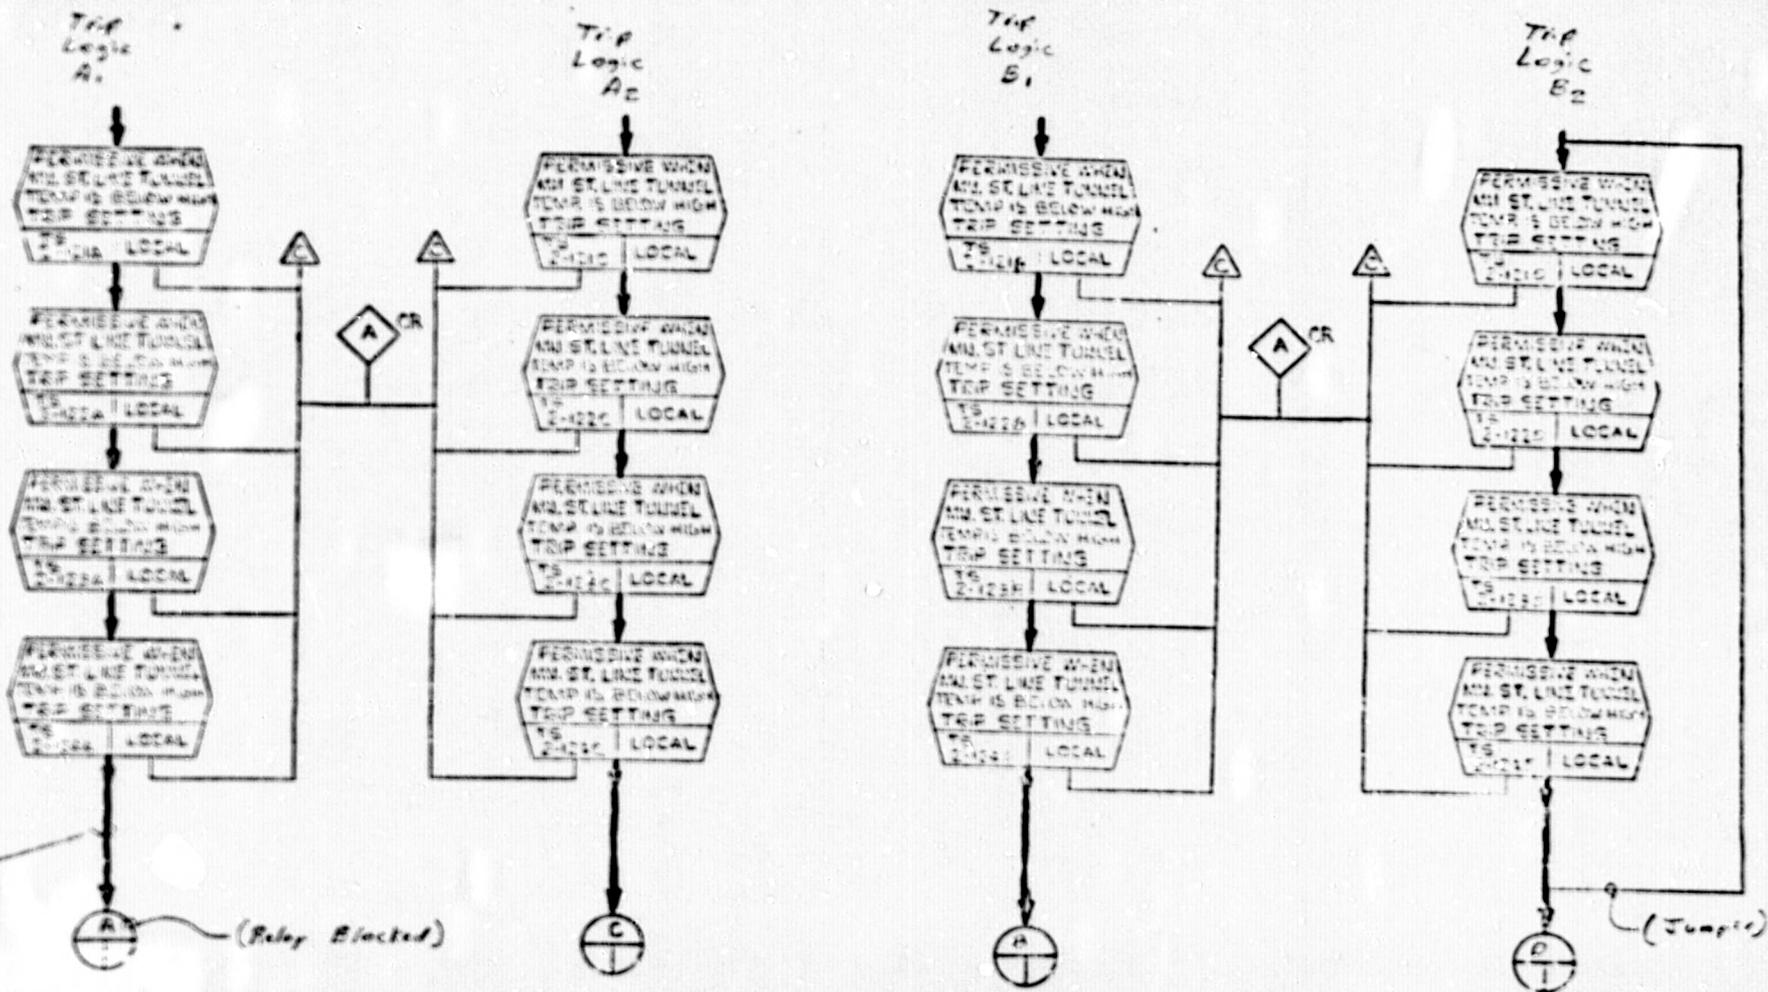
Figure 1

1. The sequence of events on September 26 relating to the employee concern that operating practices resulted in negating valid automatic isolation signals prior to unit 1 manual shutdown follows:
- a. Prior to 12 noon, unit 1 operating at approximately 1089 MWe.
 - b. 12 noon, received main steam half isolation signal due to steam line high temperature. Control room instrumentation and local inspection indicated that the main steam tunnel temperature was not high. Later investigation revealed that an open cable caused the half isolation signal.
- Note: The half isolation signal was from trip logic B₂. At this time, a half isolation signal from trip logic A₁ or A₂ would have automatically closed the main steam isolation valves (see figures 1 and 2).

MAIN STEAM LINE LEAK DETECTION
