SUBJECT: BROWN'S FERRY NUCLEAR PLANT - NSRS REVIEW REPORT NO. R-80-12-BFN

TENNESSEE VALLEY AUTHORITY
NUCLEAR SAFETY REVIEW STAFF
REVIEW
NSRS REPORT NO. R-80-12-BFN

Subject: Tennessee Valley Authority
Browns Ferry Nuclear Plant - Units 1, 2, and 3
Routine Review
(1) Old Items
(2) Potential New Concerns

SPECIAL REVIEW OF INCIDENTS AND ACTIVITIES CONDUCTED TO RESOLVE
DEFICIENCIES IN THE CONTROL ROD DRIVE SYSTEM PERFORMANCE

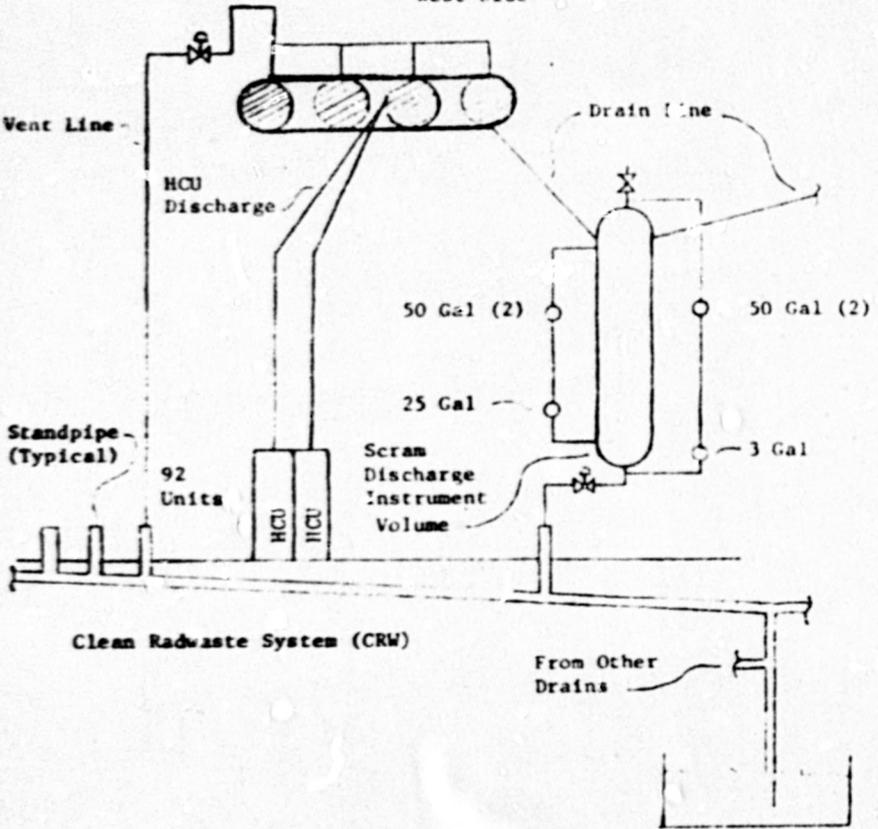
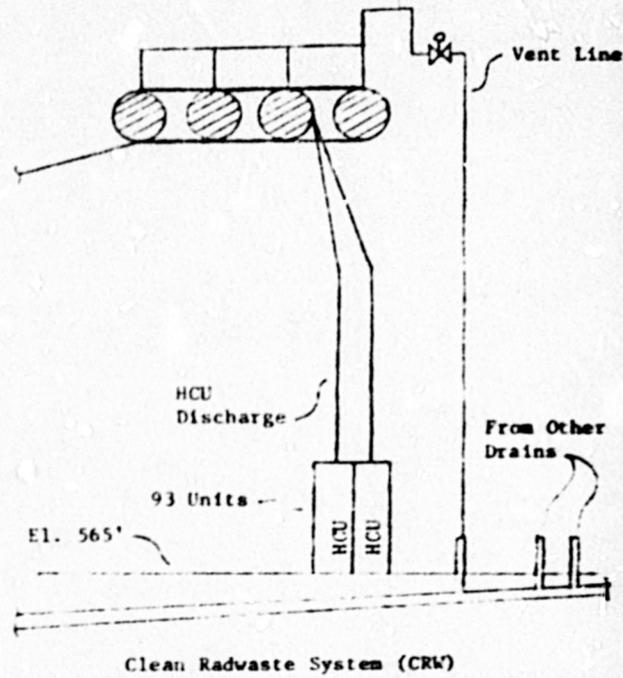
FIGURE 2 - MODIFIED CONTROL ROD DRIVE SYSTEM (NOT TO SCALE)

It has been concluded from this review that there should be an SDIV for each SDN, that the interconnection between the SDN and its SDIV should be of minimum length, and that the interconnection should be of the same size as the SDN so as to eliminate potential line restriction. With proper design, such a configuration would ensure that leakage will drain to the SDIV regardless of the availability of an external vent path.

NSRS recommends the following modifications to the vent/drain portions of the scum discharge volume (see figure 2):

In addition, MUC PR should consider a means to monitor SDIV drainage flow rate, such as by periodically closing the SDIV drain valve or monitoring sump fill rate in an independent tank such as the atmospheric sump tank recommended in III.D.3.

Besides ensuring scram discharge volume drainage independent of a functional vent path, these modifications will increase the capacity to handle and detect leakages into the SDM and decrease the post-scram drain time. These modifications should be accomplished in the time frame specified in item D.

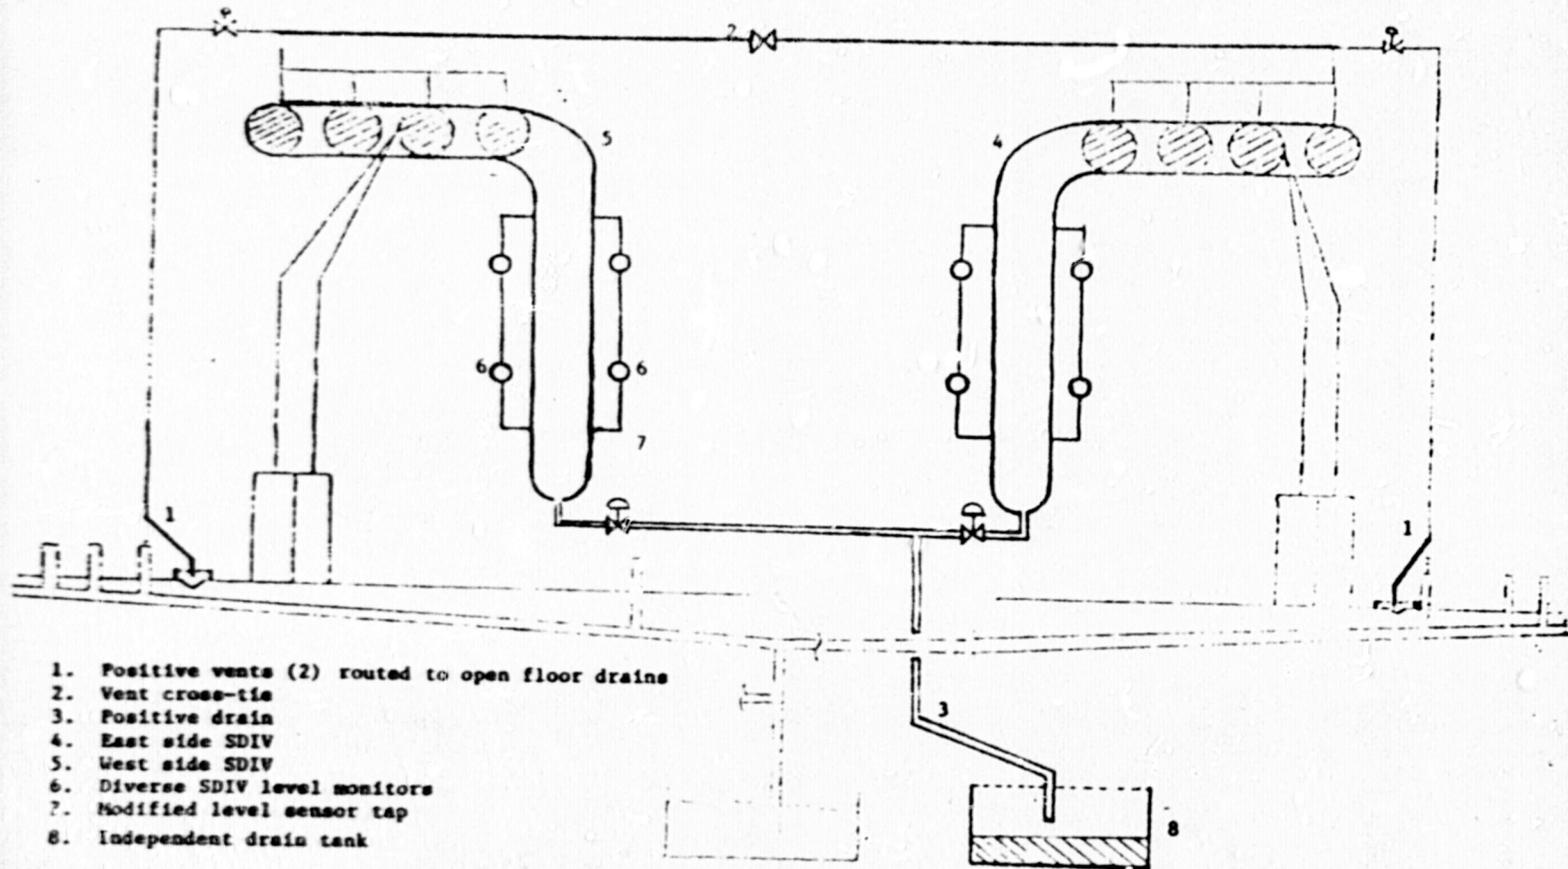
FIGURE 1- CONTROL ROD DRIVE SYSTEM (Not to Scale)

On July 25, 1980, an exit meeting was conducted by the NSRS representatives with those persons indicated in paragraph VI to summarize the purpose, scope, and findings of the special review. Except as noted below, the following findings were discussed and acknowledged by plant personnel as preliminary conclusions and recommendations at that time. NSRS' recommended modifications will provide corrective action to eliminate identified possible fundamental deficiencies in the present scram discharge headers (SDH)/scram discharge instrument volume (SDIV) arrangements. Figures 1 and 2 illustrate original and recommended configurations, respectively.

Results of performance tests and the Dresden unit 3 incident reported in IE Bulletin No. 80-17, supplement No. 2, have demonstrated an unacceptably long interval to drain the east-side SDH via its narrow bore, gently sloped, and extremely long drain connection to the SDIV. The BFN-3 tests also revealed that even under the best of conditions, east header drainage rate cannot result in an accumulation of water in the SDIV. With the east vent or drain line blocked, or for other causes (such as interactions of the CRW system), it is quite possible to have a nearly full east-side SDH with no indication of abnormality on the SDIV level monitoring system. Because of the near prohibition on shutting the SDIV drain valve for intervals in excess of one hour required by IE Bulletin No. 80-14, monitoring of scram discharge system leakage rate is not presently possible.
