D. Work Activities Related to the Thimble Tube Cleaning Prior to the Accident

1. Work Activities During the Evening of April 18 to Approximately 0830 on April 19

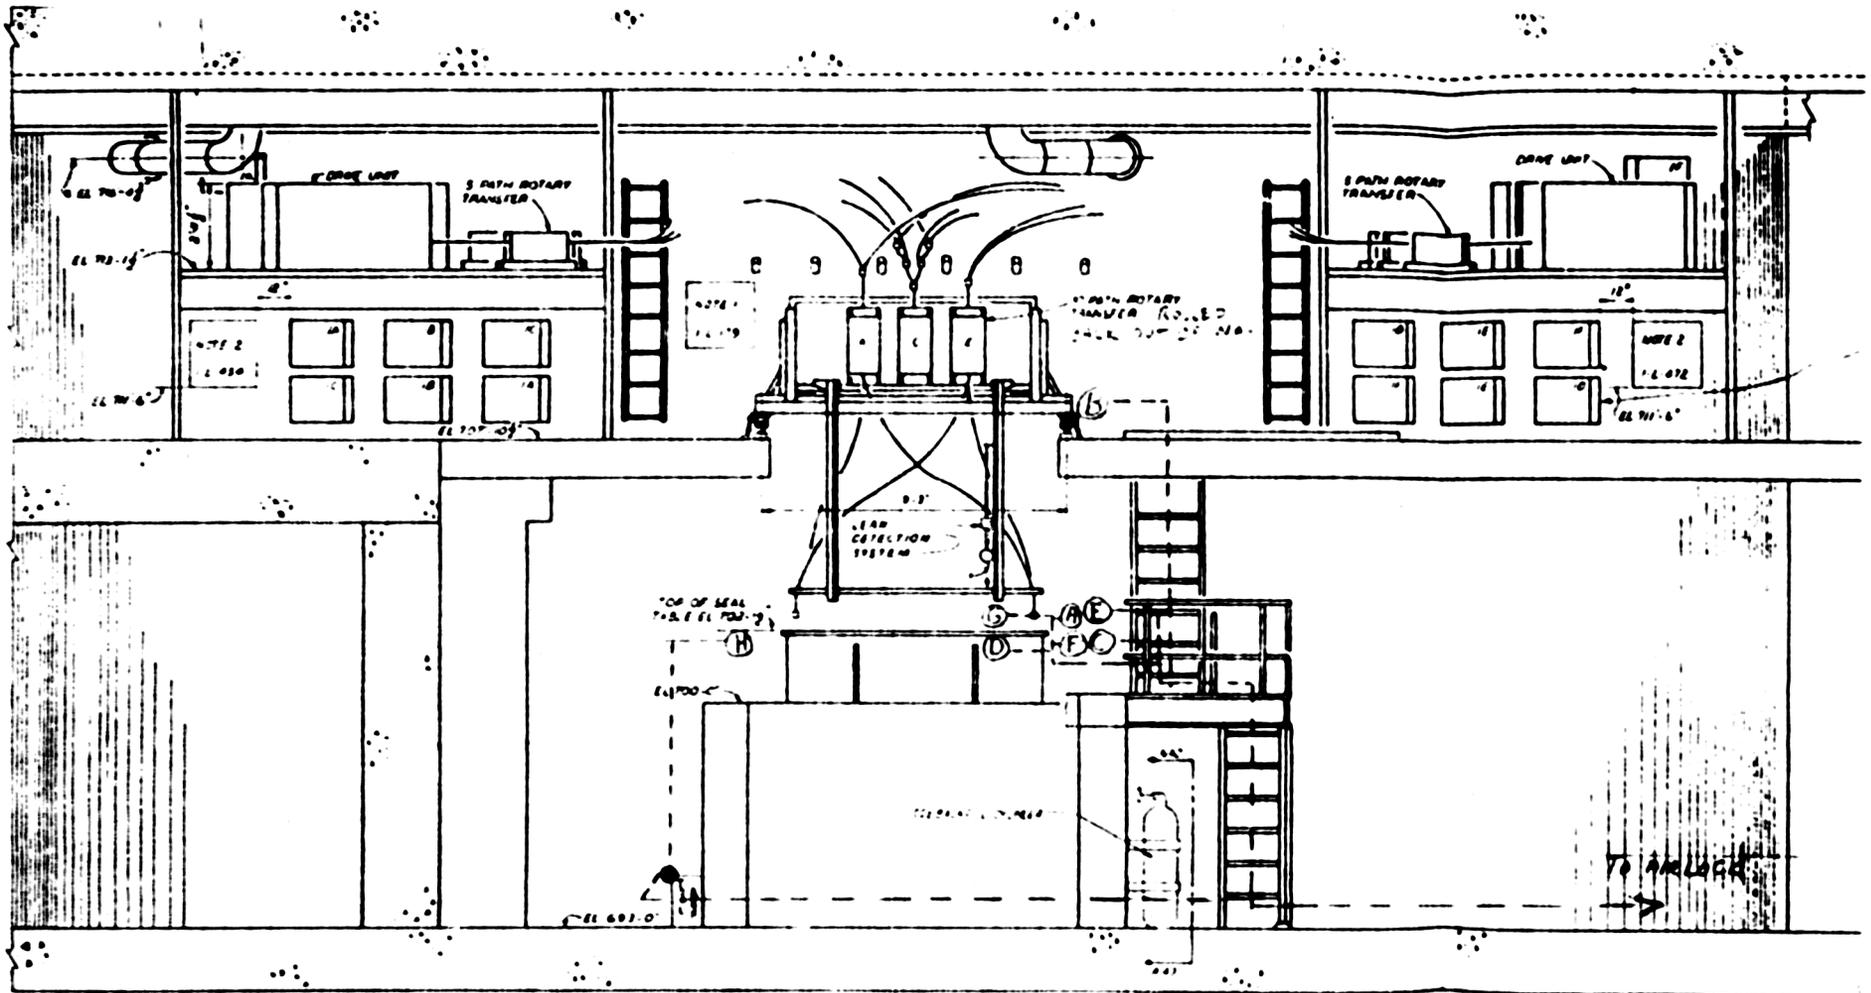
Workers (A), (C), (D), (E), (F) and (G) moved hurriedly onto the platform and started down the stairs. HP technician (G) noted HP technician (H) falling backwards towards the handrail. HP technician (H) dropped the teletector he was using to measure dose rates and fell over the handrail, hitting a toolbox on elevation 693. He started running toward the airlock.

NOTES (A) FLIPPED OR FELL OVER HANGRAIL, HIT TOOL BOX, AND RAN TO THE AIRLOCK

LOCATION OF WORKERS WHEN INCIDENT OCCURRED AND ESCAPE ROUTES
