D. Work Activities Related to the Thimble Tube Cleaning Prior to the Accident

E. The Accident

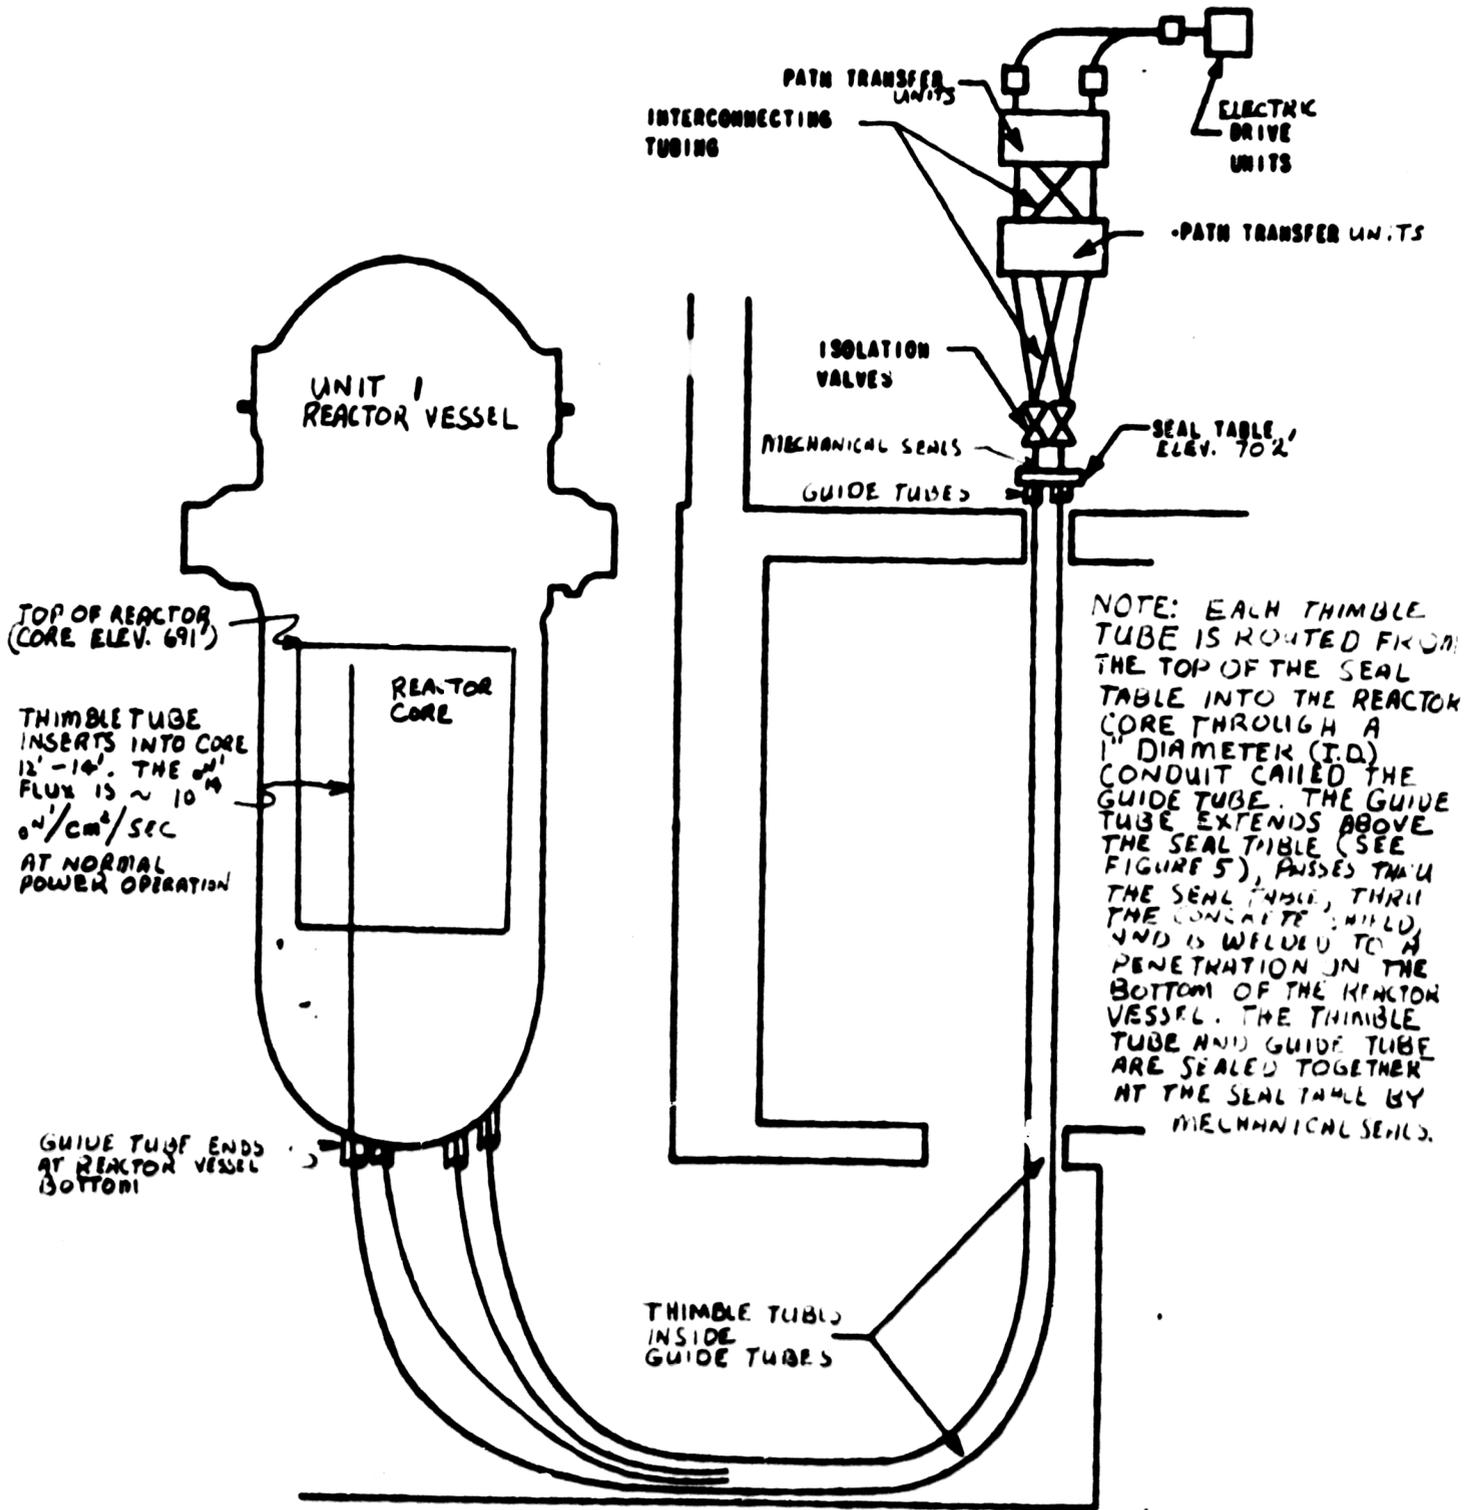
FIGURE 1 INCORE DETECTOR SYSTEM

NOTE: THIRIBLE TUBE EJECTION
OCCURRED FROM D-12 (31) LOCATION

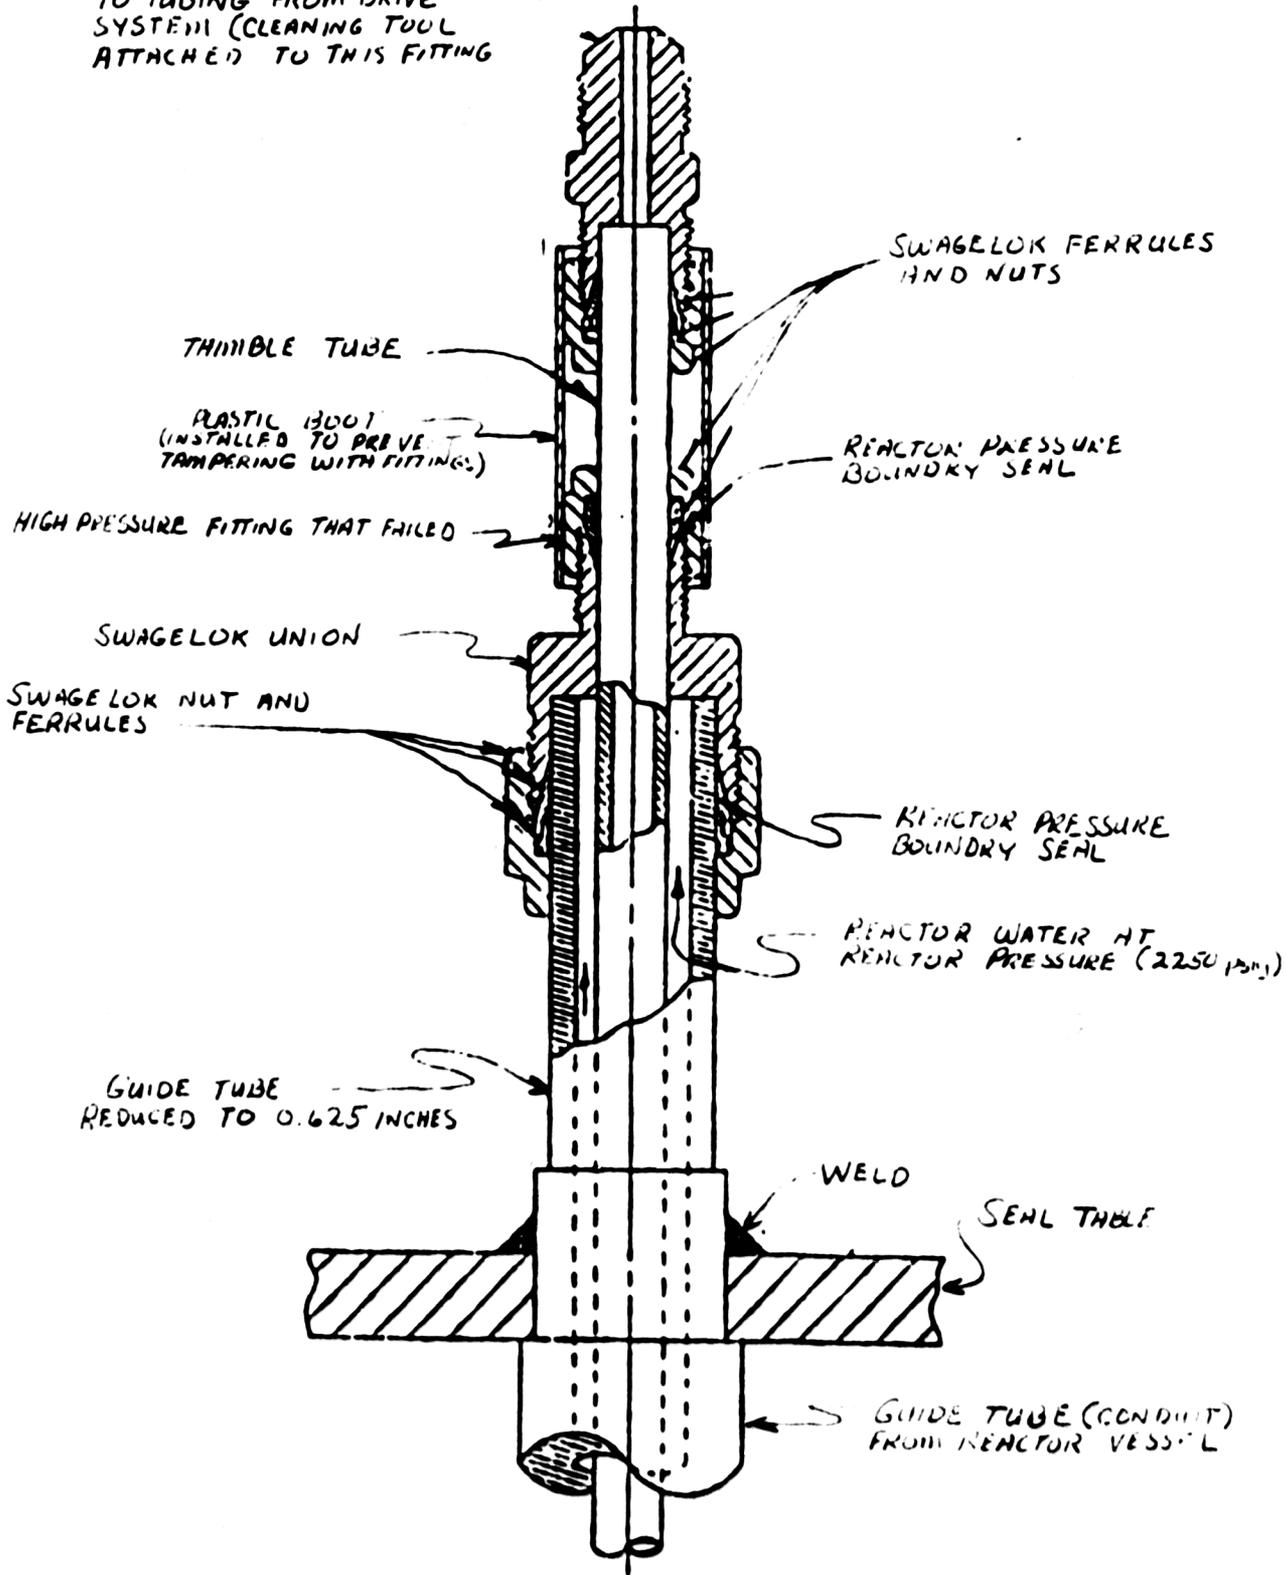
FIGURE 5

THIMBLE TUBE MECHANICAL SEALS

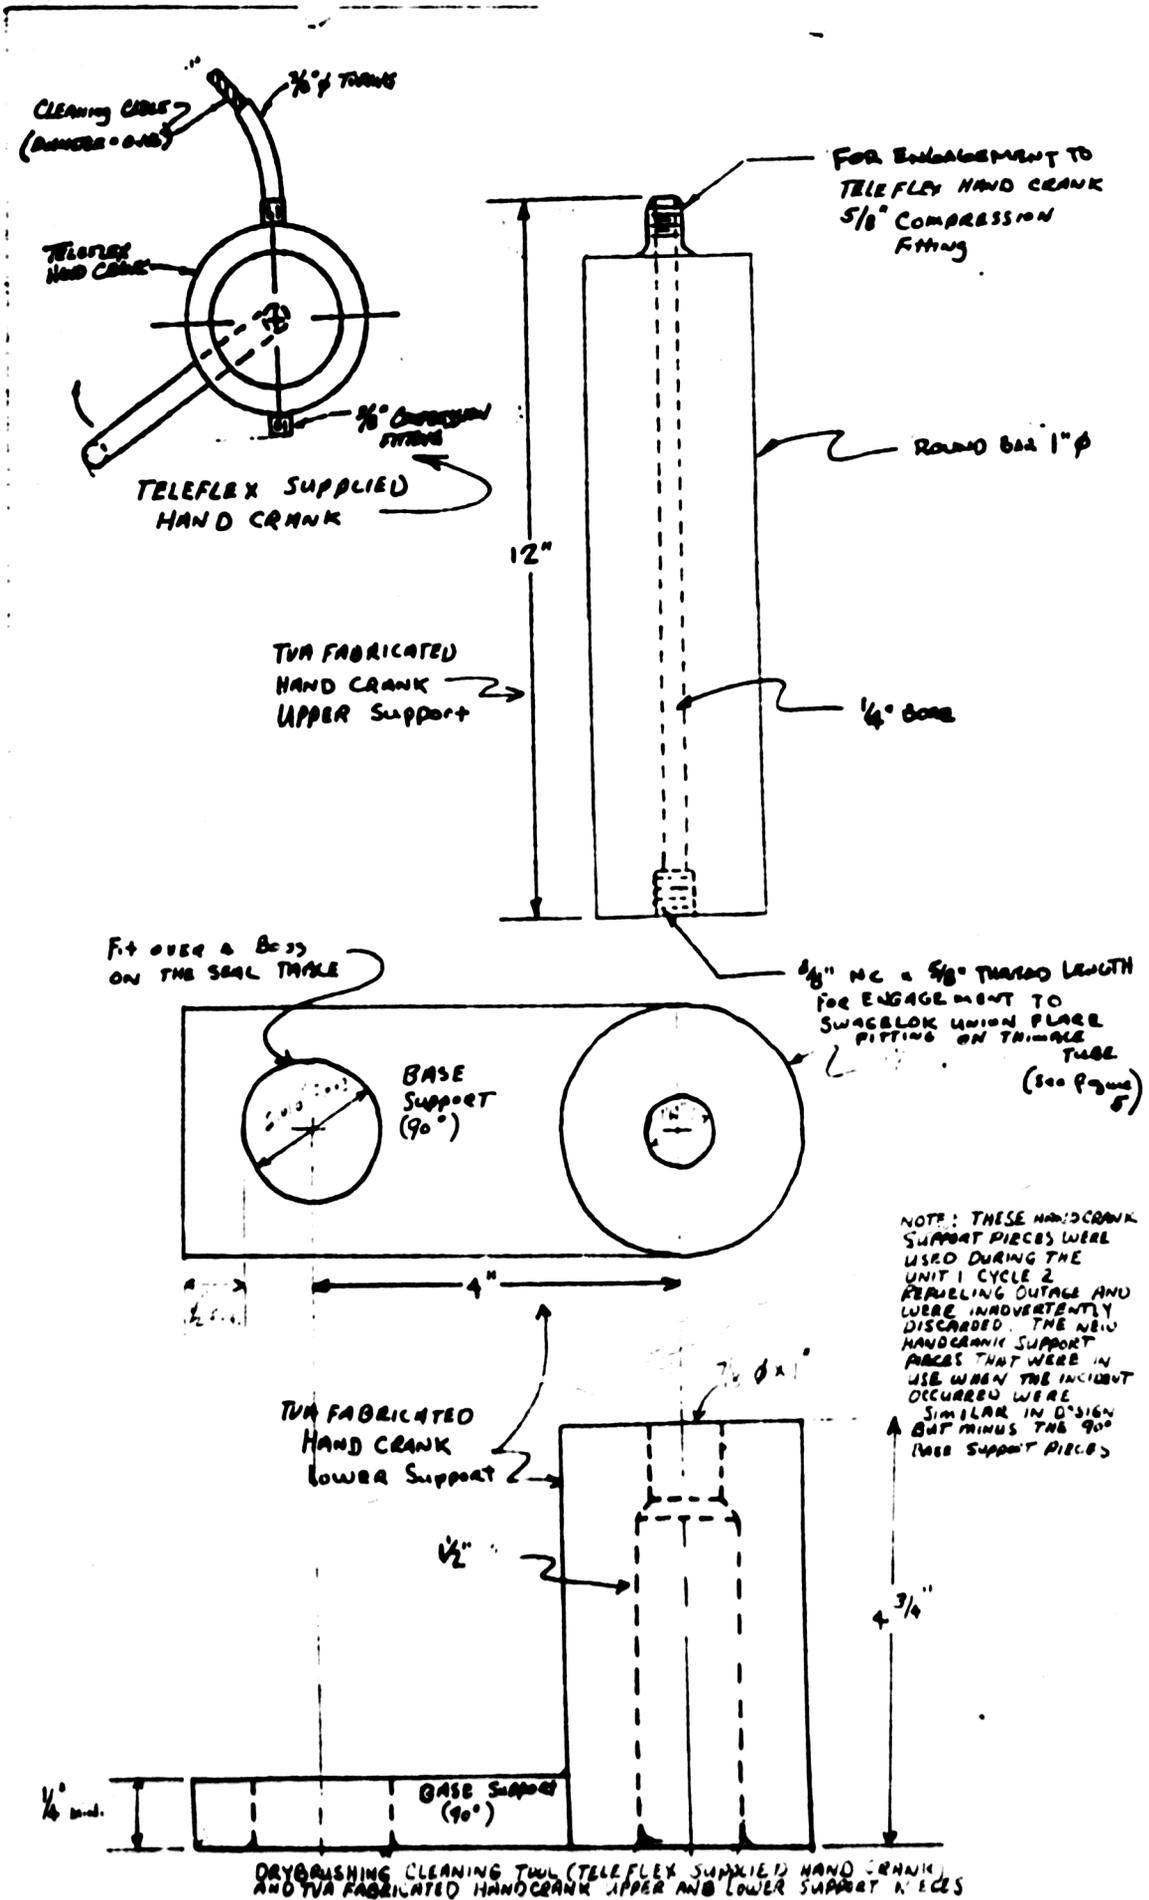
FIGURE 11A

The dry brushing tool (handcrank) and its support mechanism that had been used in past thimble tube dry brushing operations had been inadvertently discarded in radwaste. A handcrank device had been acquired from WBN. The support for the handcrank was not supplied from the vendor that supplied the dry brushing tool. The FSG second shift coordinator consulted with an FSG maintenance specialist who had been involved with prior thimble tube cleaning activities to determine what type of base support was needed for the new dry brushing tool. It was suggested that a new support device be fabricated somewhat differently than the one that had been used on previous cleanings. The change involved removing the right angle support on the base support (see figures 11A and 11B) to allow the base support to make better contact with the surface of the seal table. The problem with the old tool was that the support did not always fit up well with some of the "bosses" on the seal table and allowed the tool to move around during the turning of the handcrank. Figures 12A and 12B depict the tool and the base support in use when the accident occurred (part of the ejected thimble tube D12 is still attached to the upper portion in figure 12B).

The change to the tool base support was made without any technical evaluation of its effect on the mechanical seals. The new base support was not tested before use on the thimble tubes.

NOTE: THESE HANDCRANK SUPPORT PIECES WERE USED DURING THE UNIT 1 CYCLE 2 PERUELING OUTAGE AND WERE INADVERTENTLY DISCARDED. THE NEW HANDCRANK SUPPORT PIECES THAT WERE IN USE WHEN THE INCIDENT OCCURRED WERE SIMILAR IN DESIGN BUT MINUS THE 90° (SEE SUPPORT PIECES)

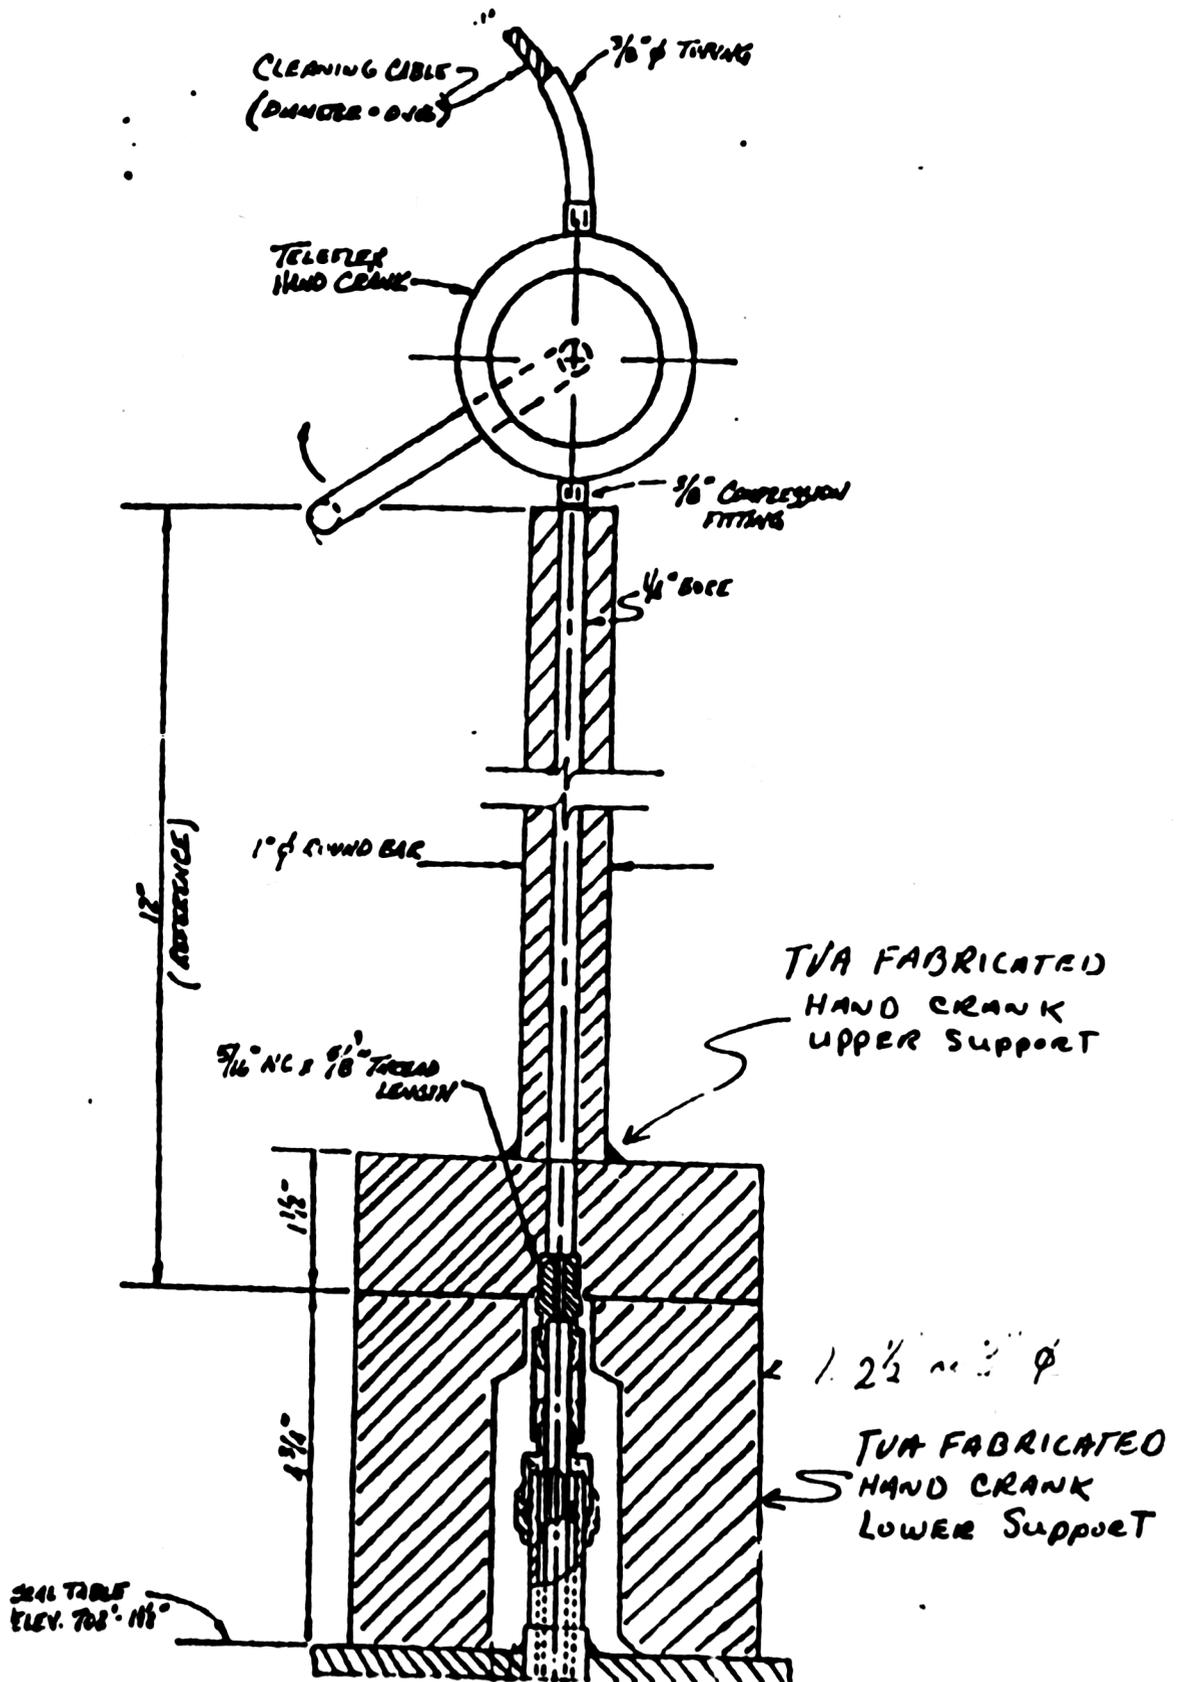
FIGURE 12 A

DRYBRUSHING CLEANING TOOL (TELEFLEX SUPPLIED HAND CRANK) AND T/A
 FABRICATED HANDCRANK UPPER AND LOWER SUPPORT PIPES IN USE WHEN THE
 THIMBLE TUBE WAS EJECTED

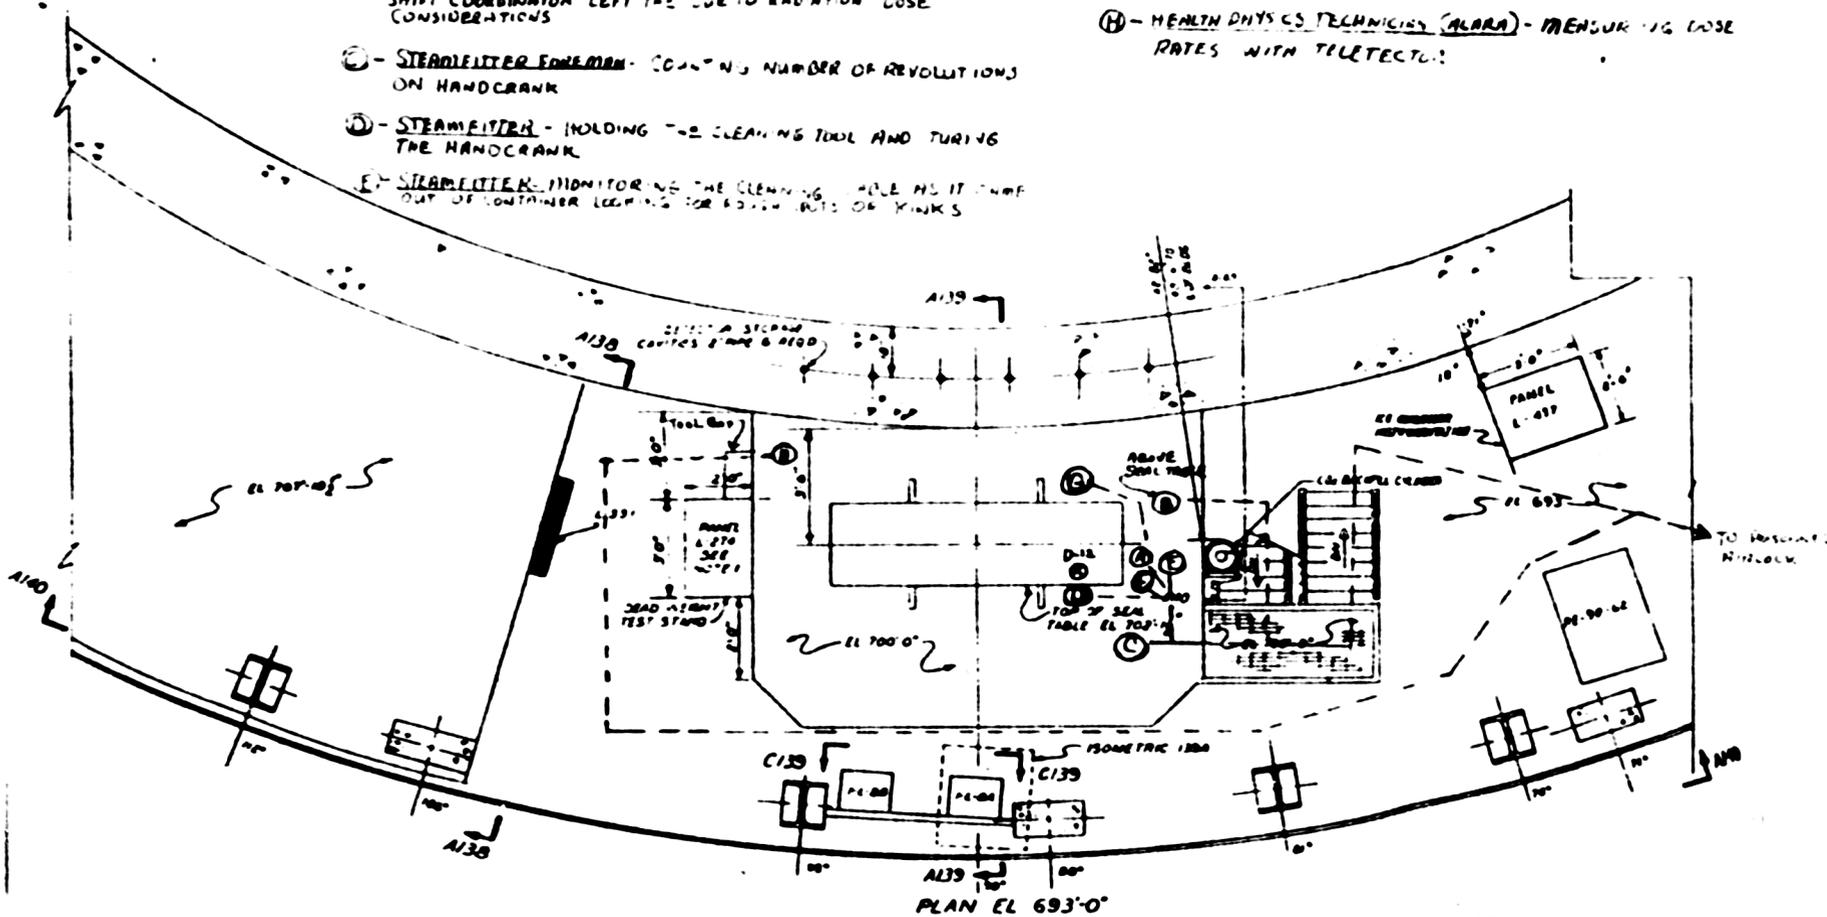
FIGURE 13A

The workers assembled around and above the seal table as depicted in figures 13A and 13B for performing their assigned tasks. The evening shift coordinator noted that the cleaning tool was on thimble tube D-12 which was not included on the list to be cleaned. The cable was inserted approximately 15 feet into the thimble tube. The coordinator decided that as long as they were connected to thimble tube D-12 they would go ahead and clean it one more time to make sure it was clean. Steamfitter (D) on the cleaning tool turned the handcrank one complete revolution. Coordinator (A) measured the length of insertion to verify that the insertion was 10 inches per one complete revolution. Steamfitter (D) continued to turn the crank and stopped at 50 revolutions and called out the number of revolutions. The number of cranks was verified by steamfitter foreman (C). Steamfitter (D) continued to crank the tool inserting the cable into tube D-12. At approximately 70 cranks a kink was noted in the cleaning cable coming out of the cable container. The workers stopped and examined the kink and decided to proceed. After a total of approximately 79 cranks the cleaning tool offered some resistance to being turned. As the crank started its upward stroke it was noted that additional effort was being required to turn the handcrank. Some movement of the cleaning tool was observed. At this moment the leak occurred spraying water at ambient temperature and slightly wet two of the workers. The cleaning tool pulled loose from the the grasp of steamfitter (D). He reached up, grabbed the tool and pitched it out of his way to the left so he could get out. The water by this time was blowing straight up at a significant rate and was described as hanging up in the overhead. Someone yelled "Let's go."

LOCATION OF WORKERS WHEN THE INCIDENT OCCURRED AND EGRESS ROUTES OUT OF THE INSTRUMENT ROOM

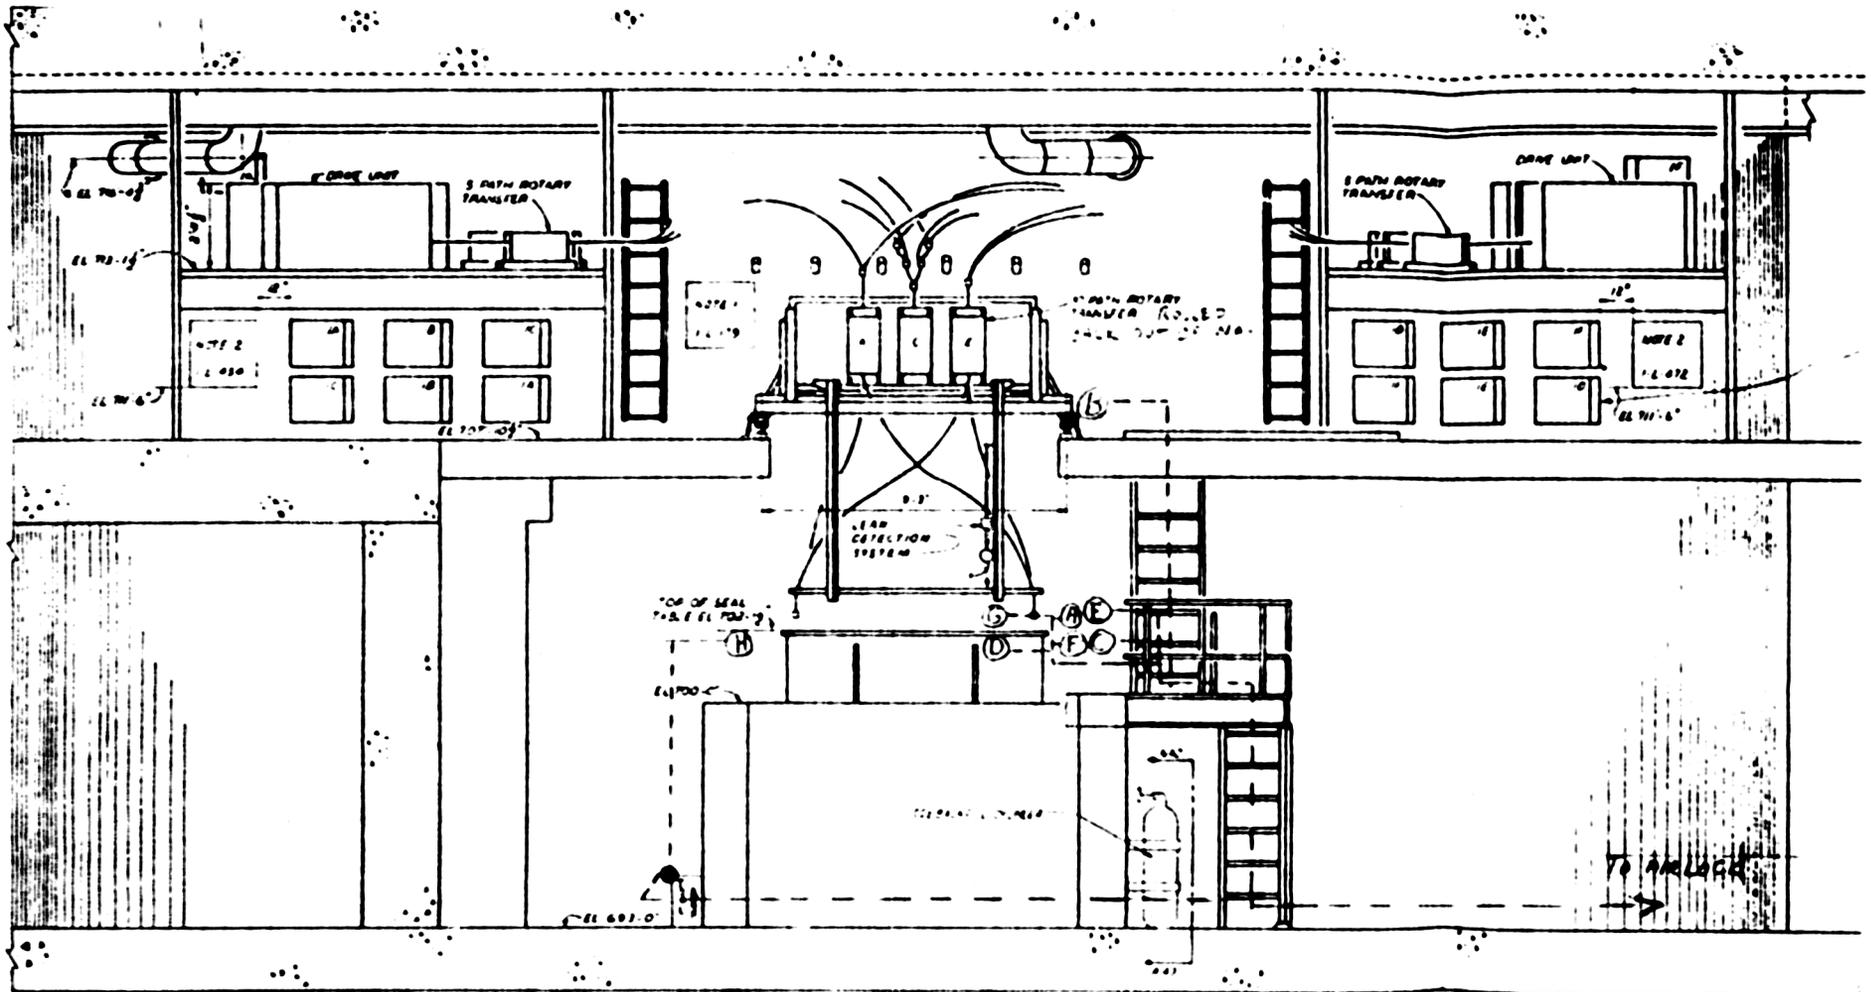
NOTES (A) FLIPPED OR FELL OVER
 HANGRAIL, HIT TOOL BOX, AND RAN
 TO THE AIRLOCK

LOCATION OF WORKERS WHEN INCIDENT
 OCCURRED AND ESCAPE ROUTES

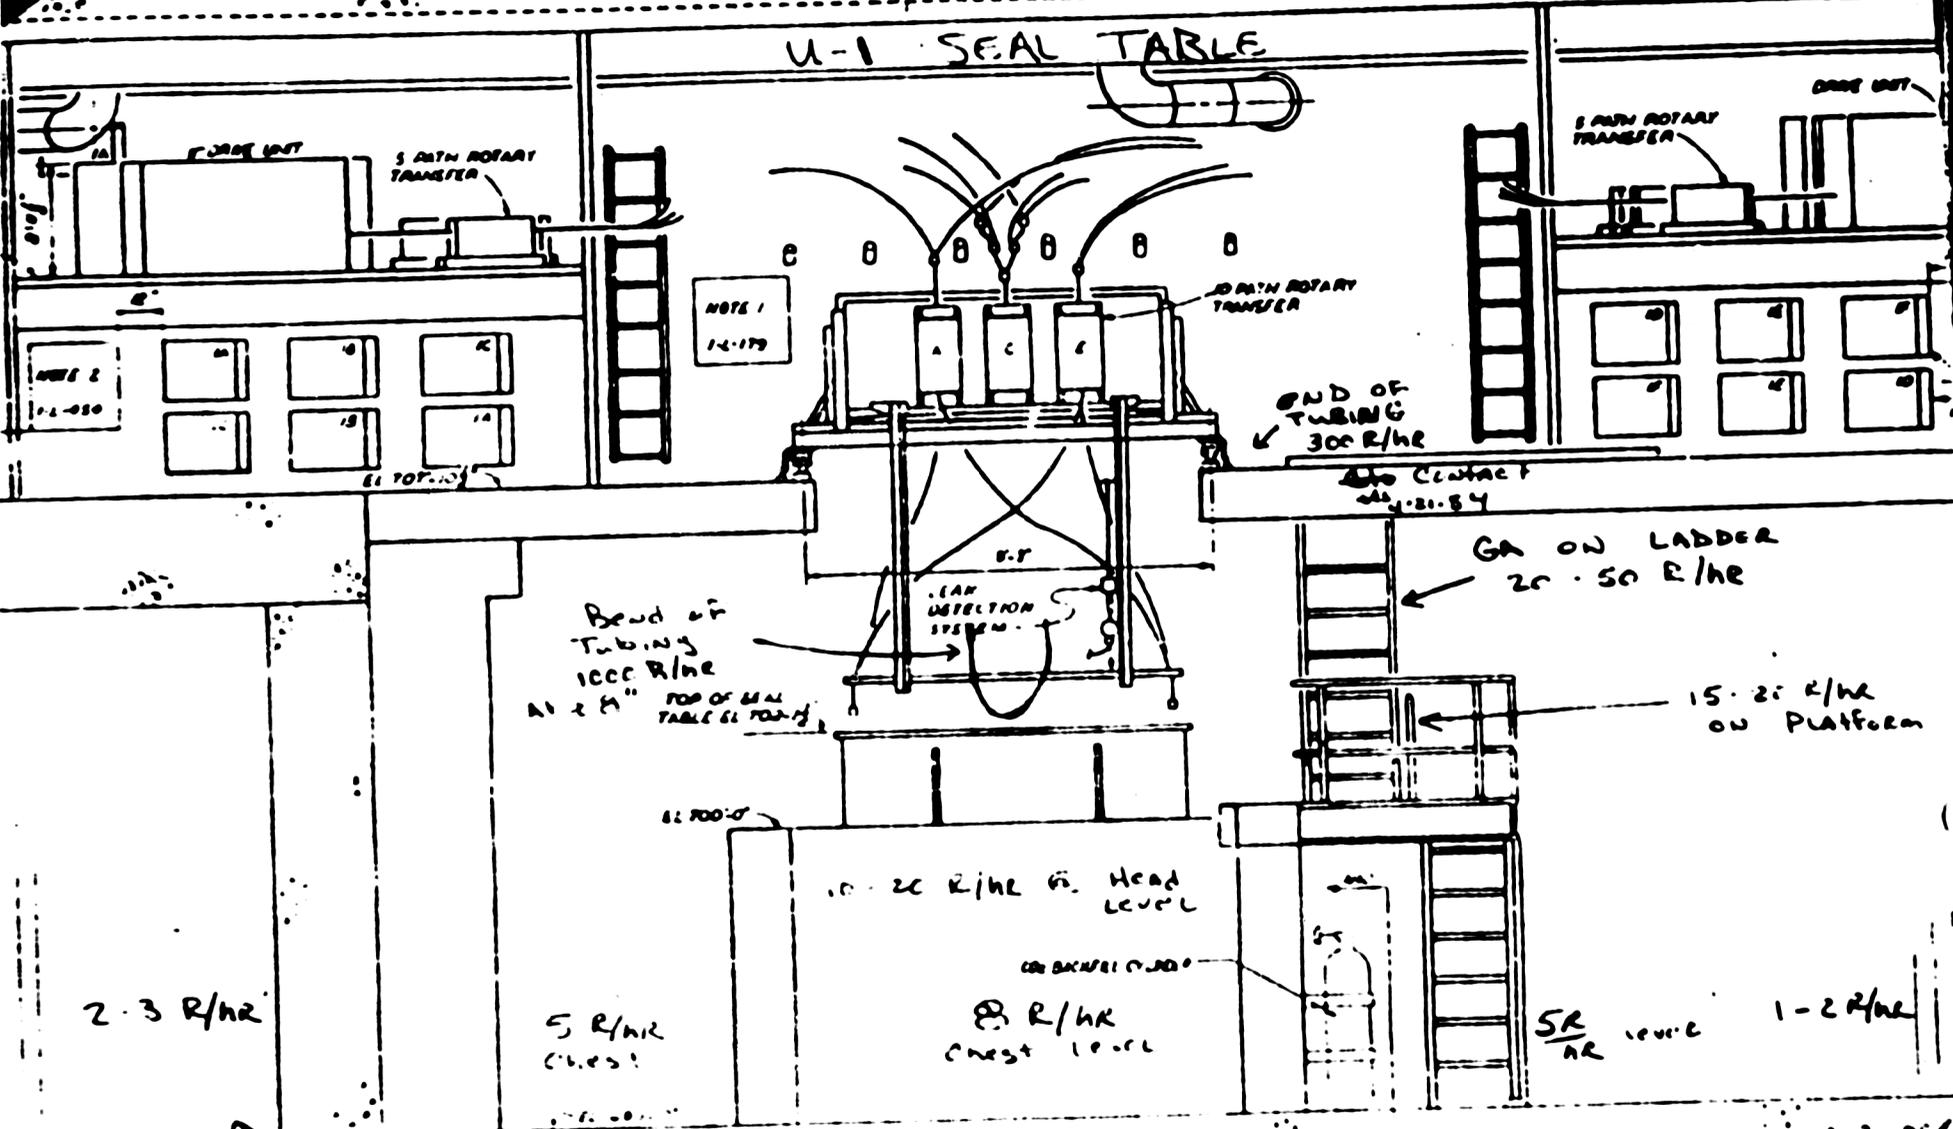
FIGURE 14

1) SMOG TAKEN ON 193'
FLOOR ≈ 60 R/hr
RADIATION DOSE RATES TAKEN ON
INITIAL ENTRY TO THE INSTRUMENT ASSY.
