SUBJECT: SPECIAL REVIEW OF NCR WBNSWP8303 RELATED TO MISSING PIPE SUPPORT CALCULATIONS - WATTS BAR NUCLEAR PLANT - UNITS 1 AND 2 - NUCLEAR SAFETY REVIEW STAFF REPORT NO. R-84-07-WBN

SUBJECT: WATTS BAR NUCLEAR PLANT - UNITS 1 AND 2 - SPECIAL
REVIEW OF NCR WBNSWP8303 RELATED TO MISSING PIPE
SUPPORT CALCULATIONS

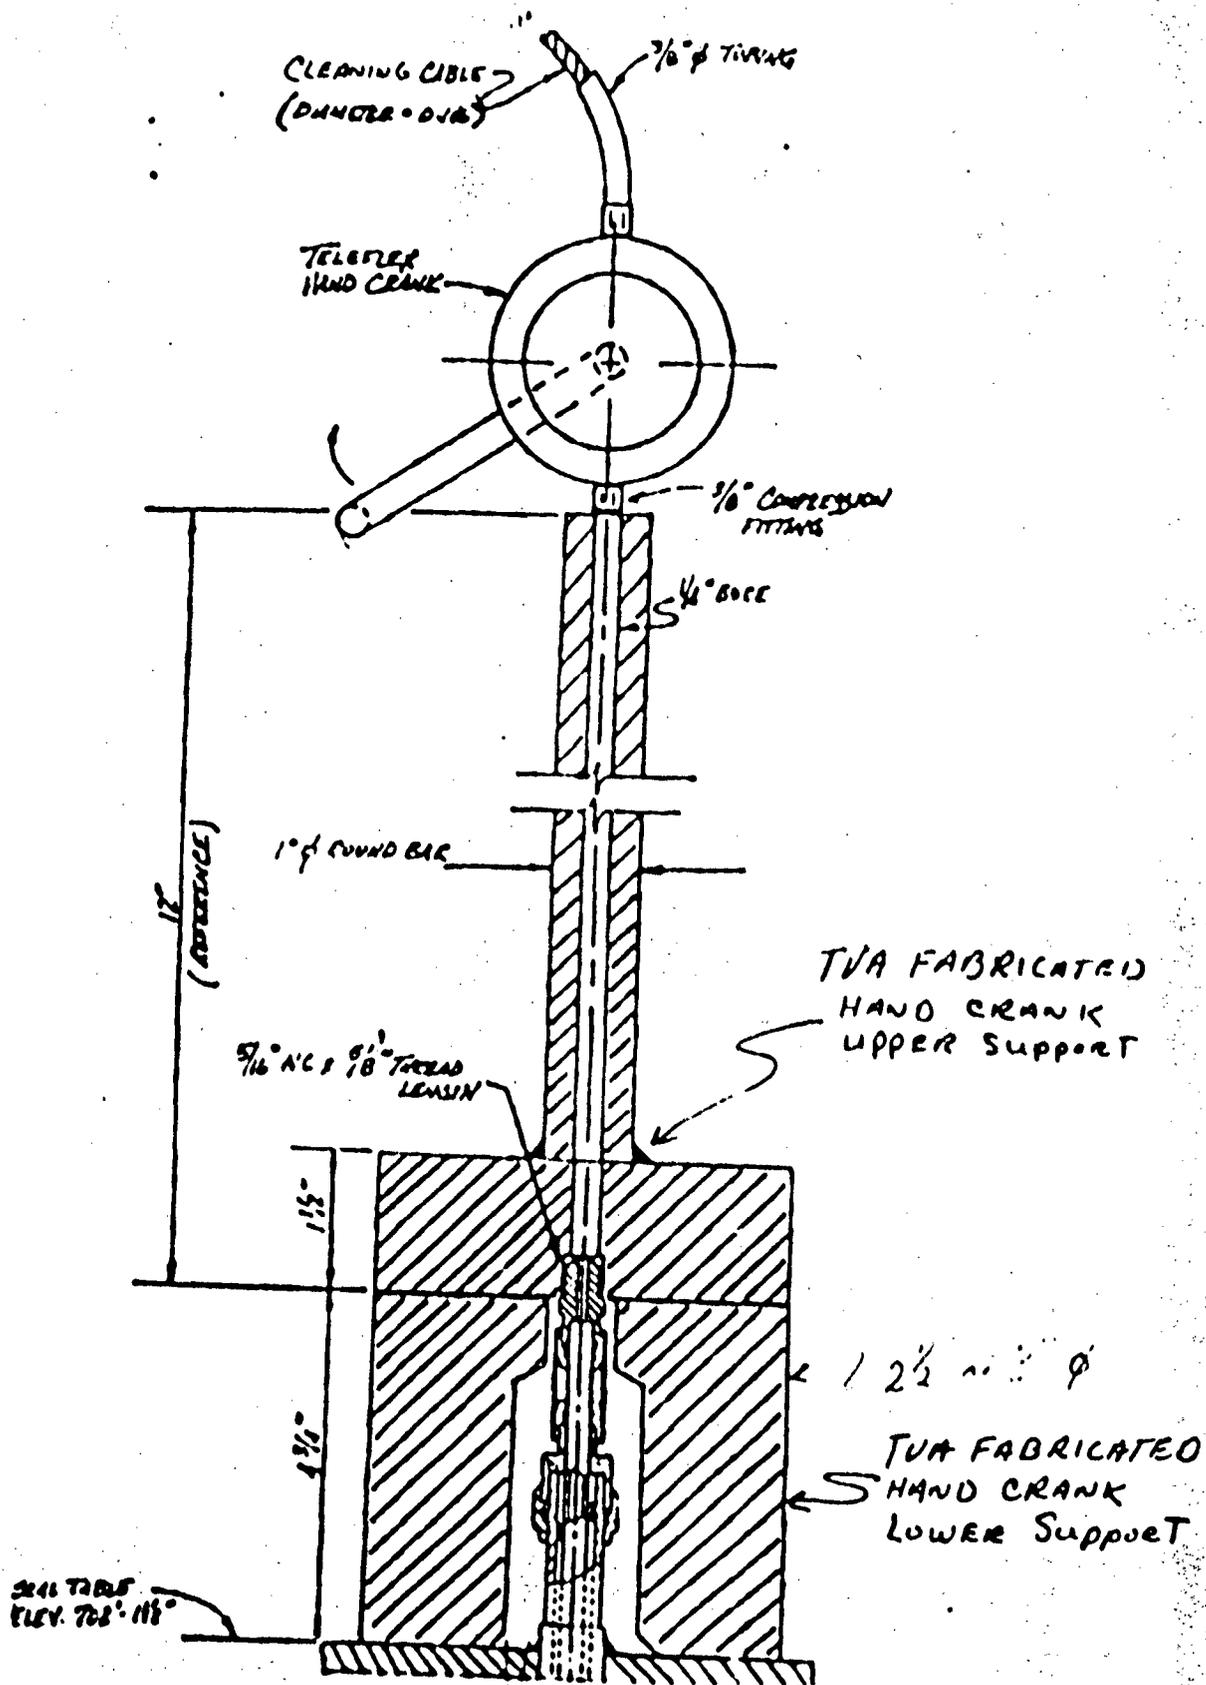
FIGURE 12 A

DRYBRUSHING CLEANING TOOL (TELEFLER SUPPLIED HAND CRANK) AND TVA FABRICATED HANDCRANK UPPER AND LOWER SUPPORT PIPES IN USE WHEN THE PIMBLE TUBE WAS EJECTED

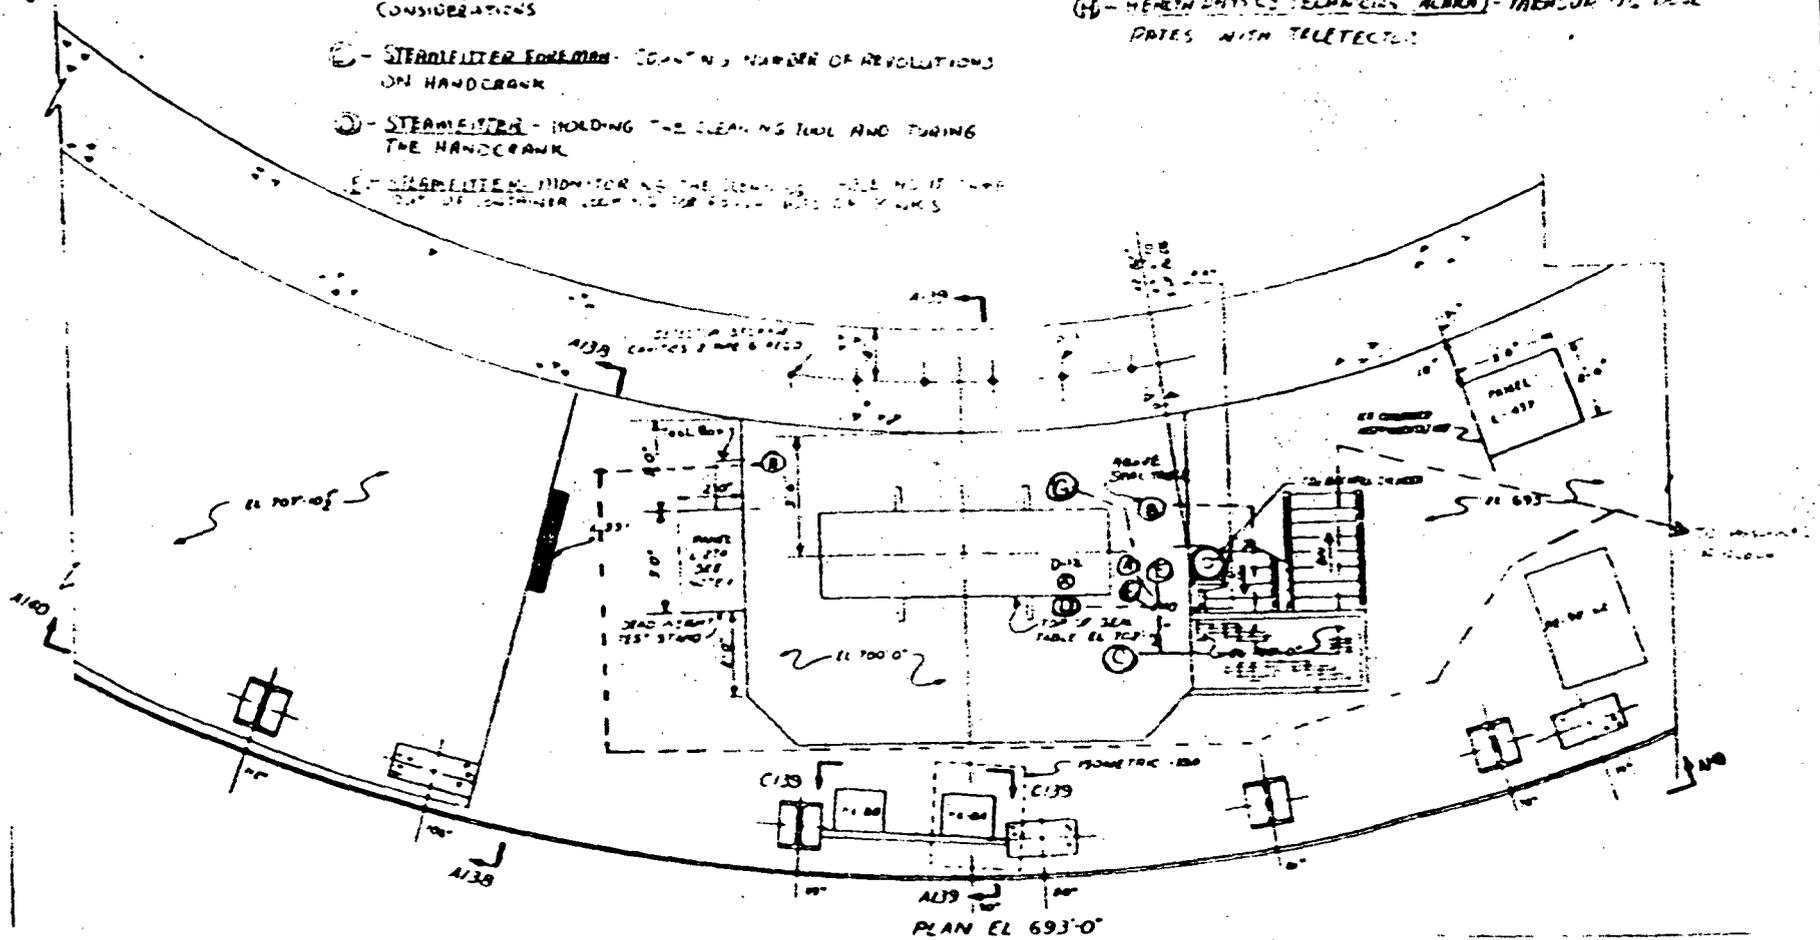
FIGURE 13A

LOCATION OF WORKERS WHEN THE INCIDENT OCCURRED AND ESSENTIAL ROOMS OUT OF THE INSTRUMENT ROOM

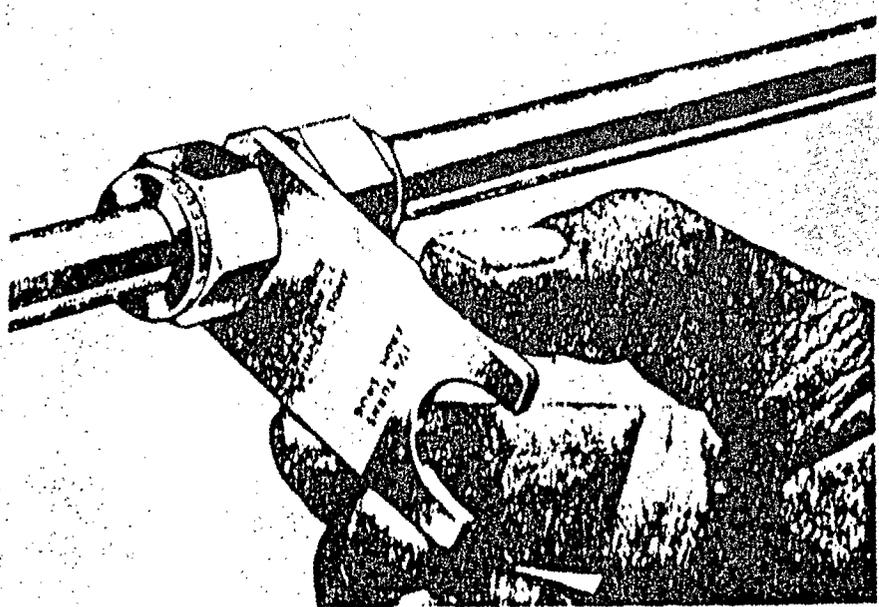
Gap Inspection Gage fits between nut and body hex. Fitting is not sufficiently tightened.
