Combined License Application

Part 11G: Site Area Paleoliquefaction And Surface Faulting Investigation Program

Revision 0
November 2008

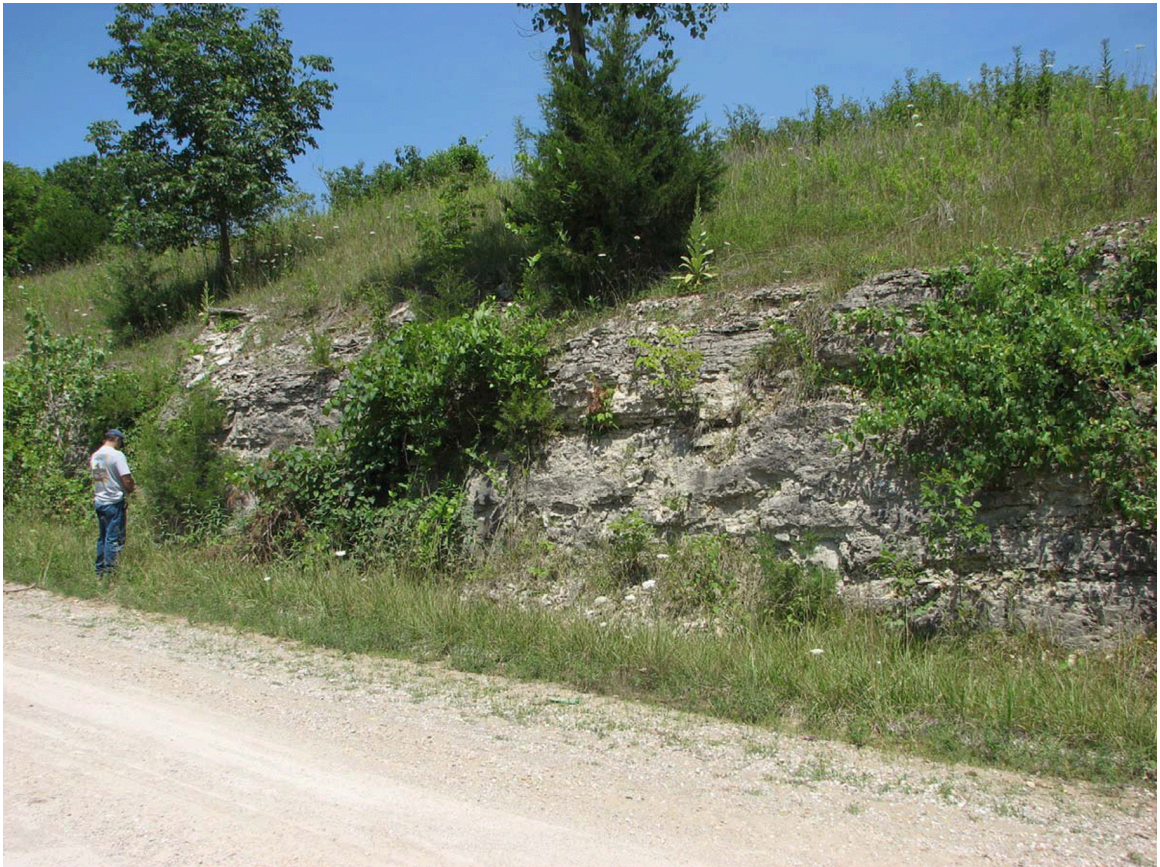
Figure No. 1—Deformation observed at Feature G24

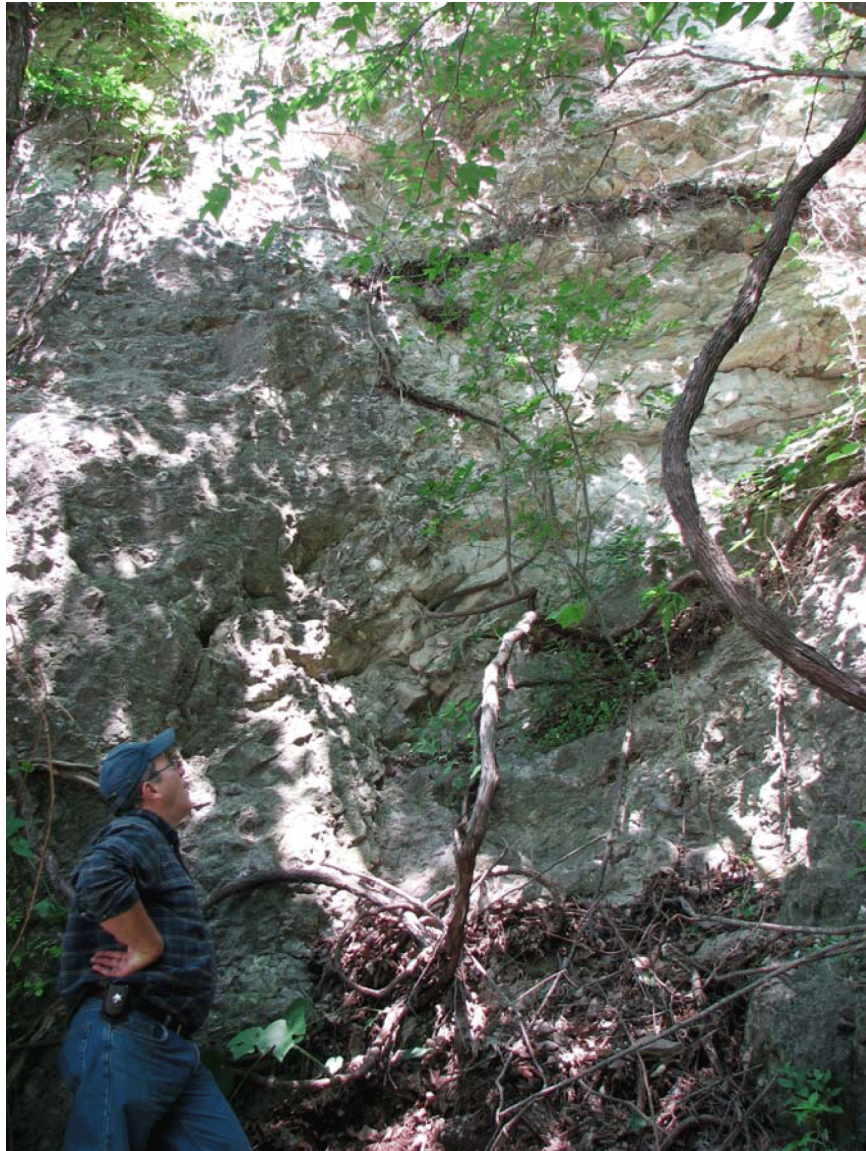
Figure No. 2—Deformation observed at Feature G39

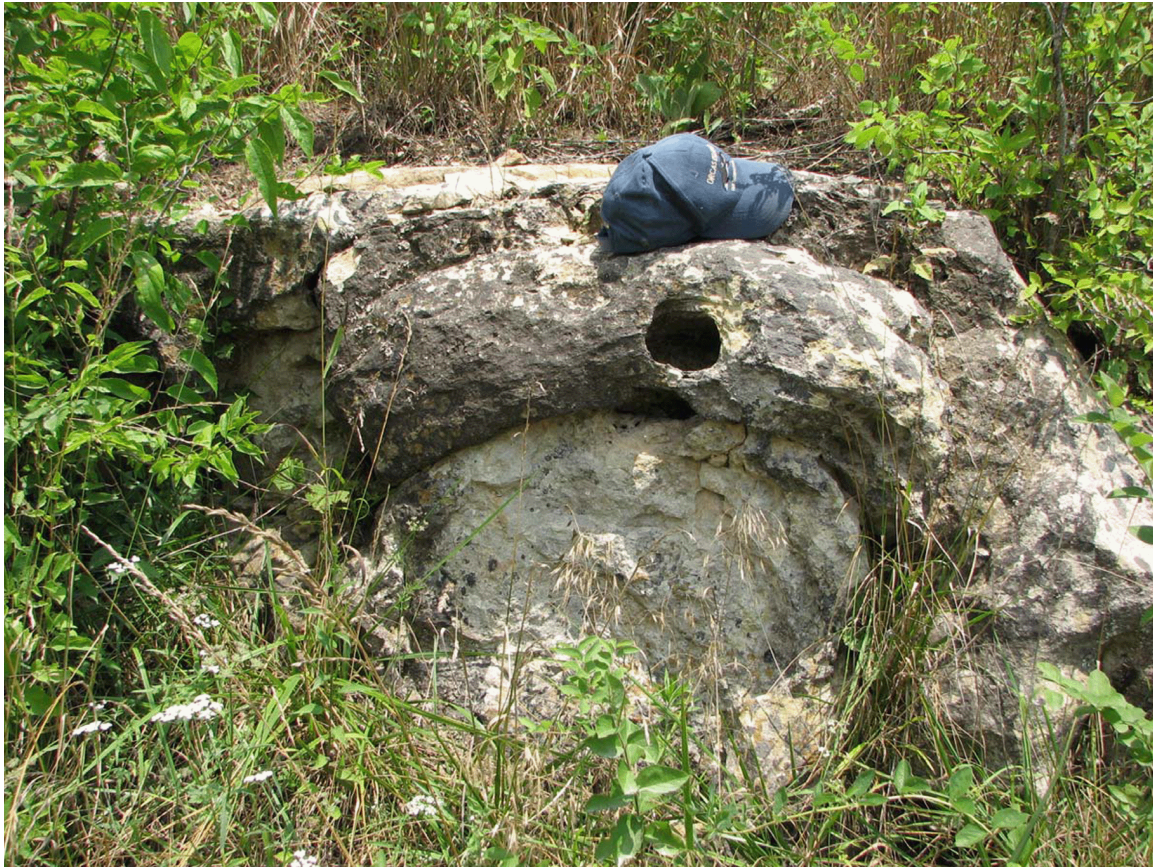
Figure No. 3—Deformation observed at Feature G43

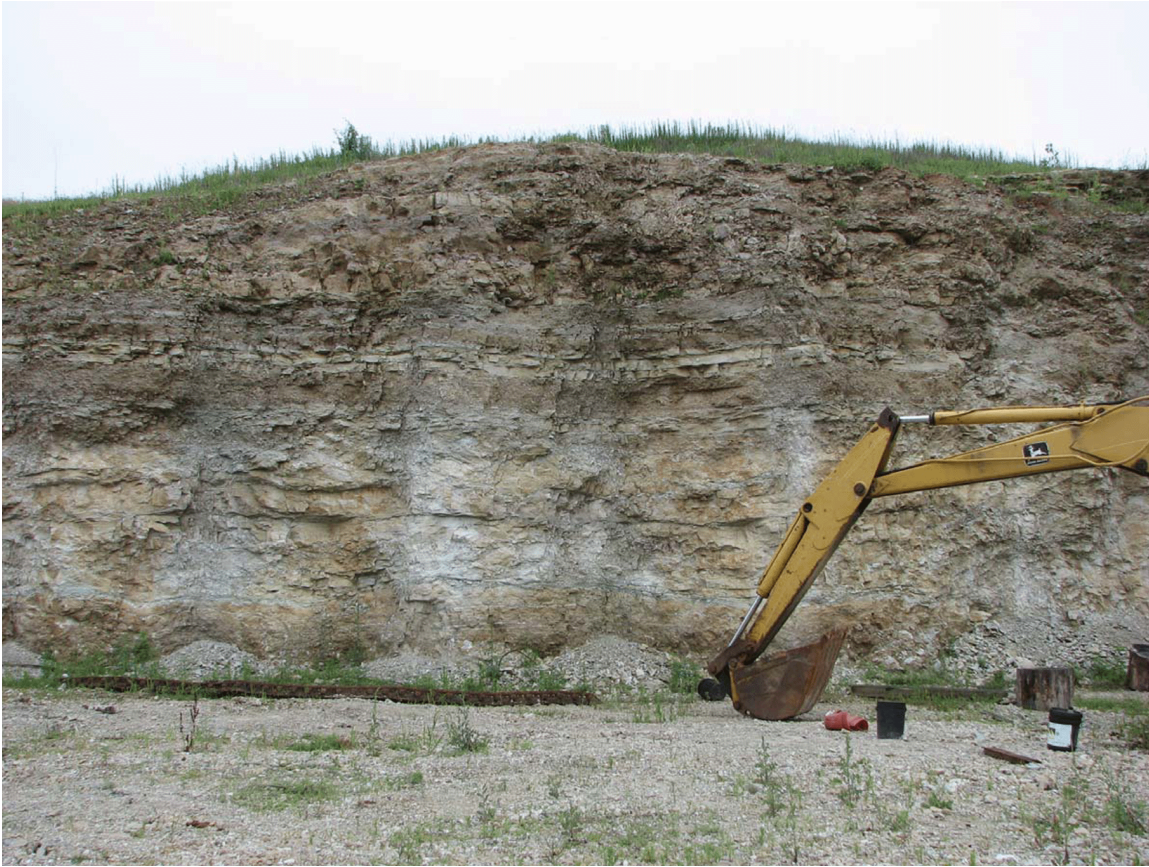
Figure No. 4— Rocks without deformation observed at Feature G9

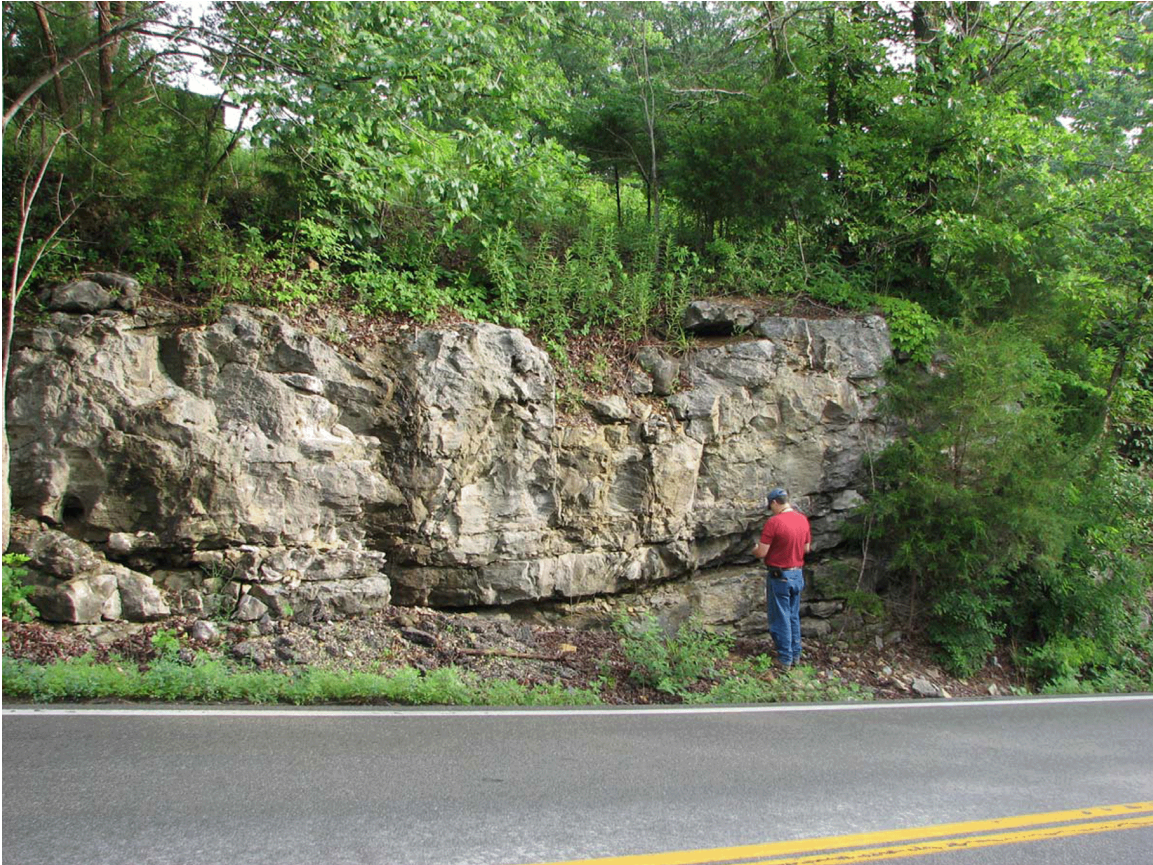
Figure No. 5— Rocks without deformation observed at Feature G11

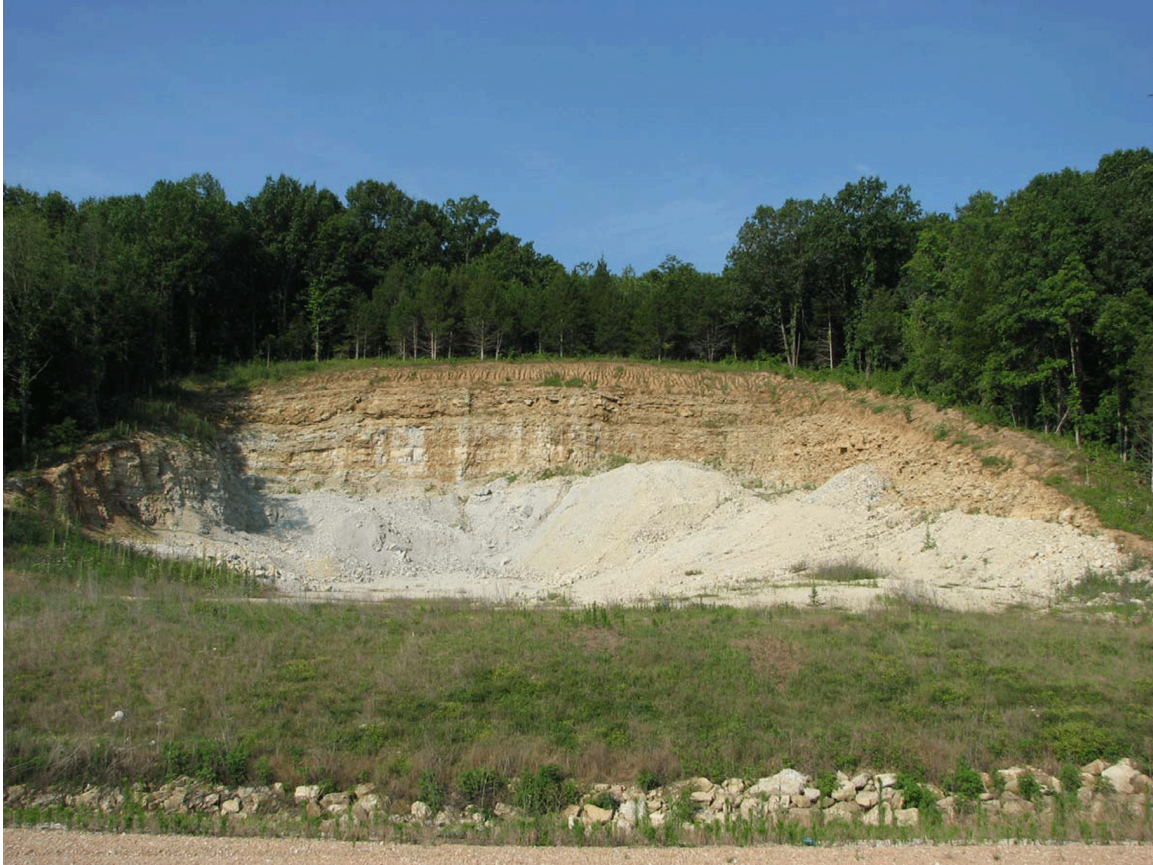
Figure No. 6— Rocks without deformation observed at Feature G30

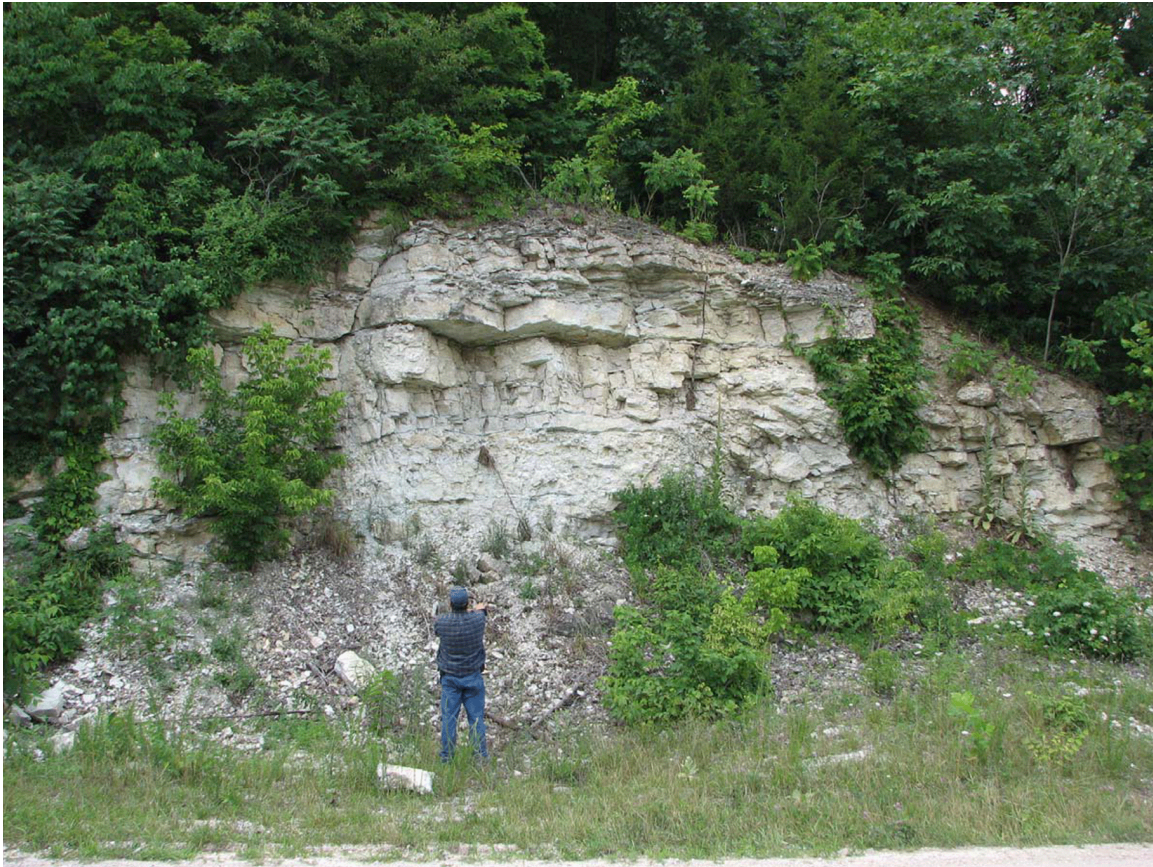
Figure No. 7— Rocks without deformation observed at Feature G41

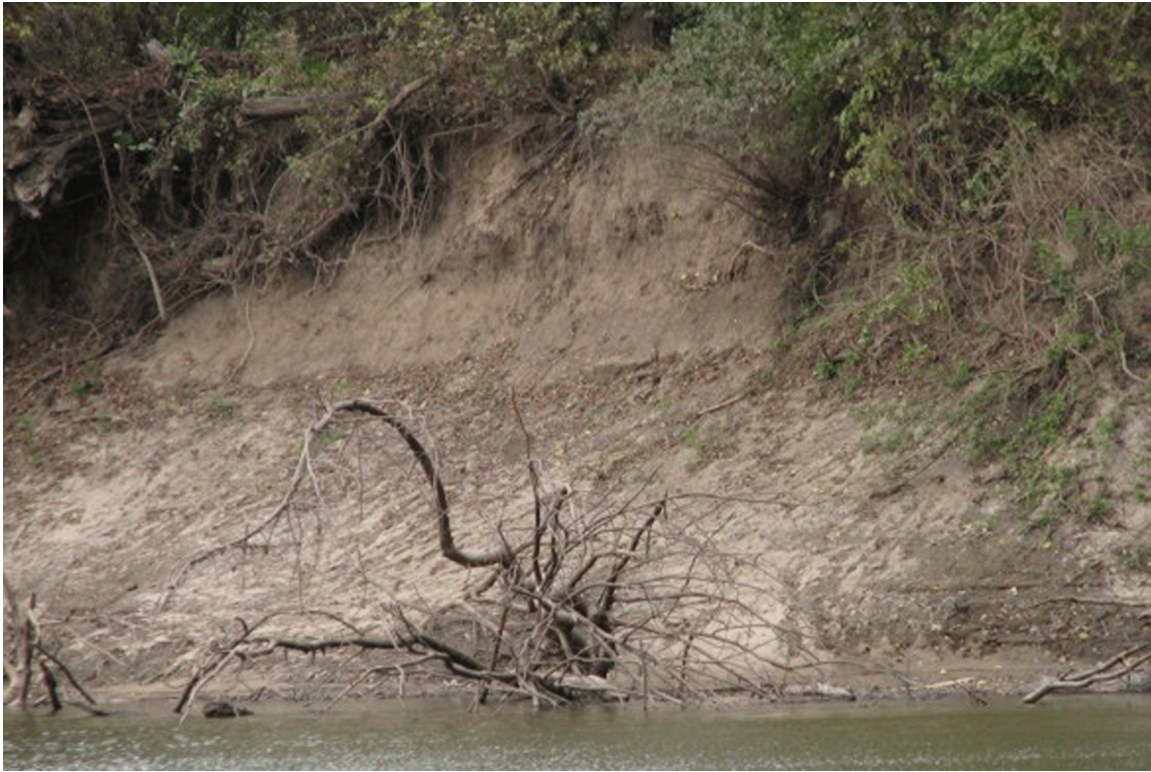
Figure No. 8—Non-Tectonic Deformation at Waypoint AV1

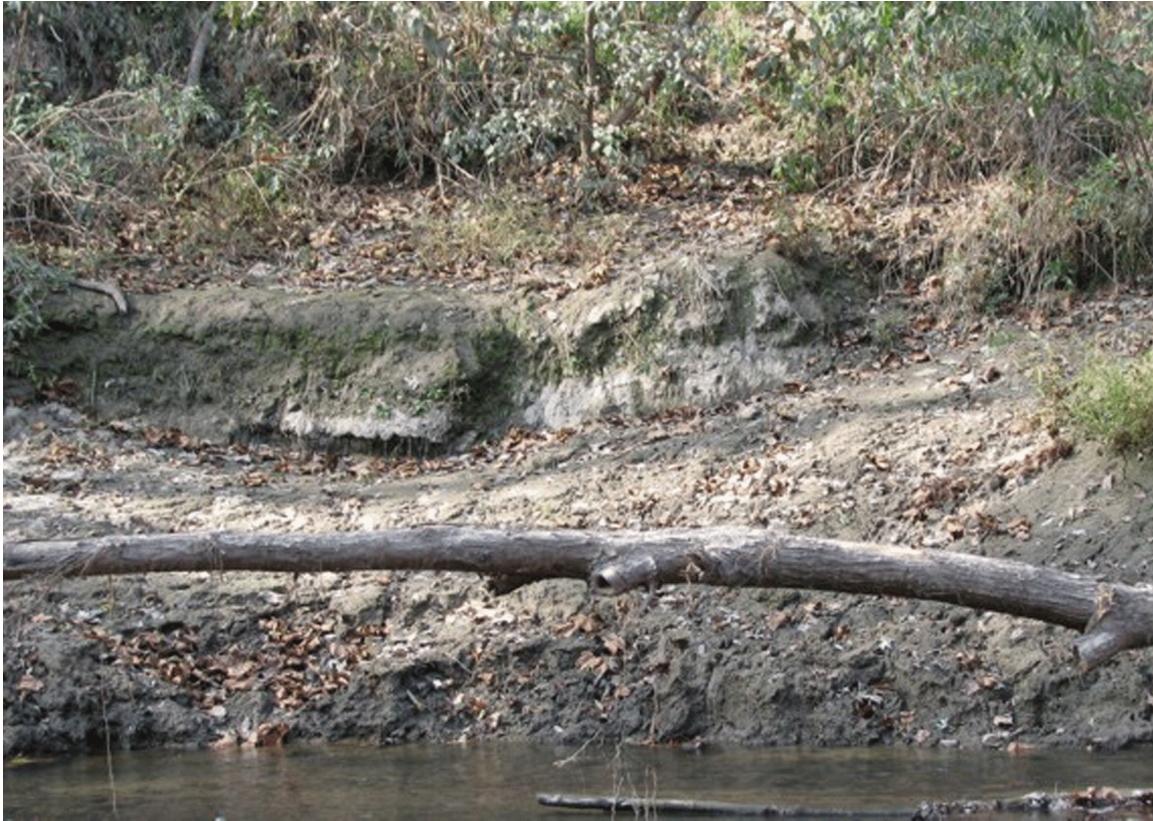
Figure No. 9—Non-Tectonic Deformation at Waypoint 008

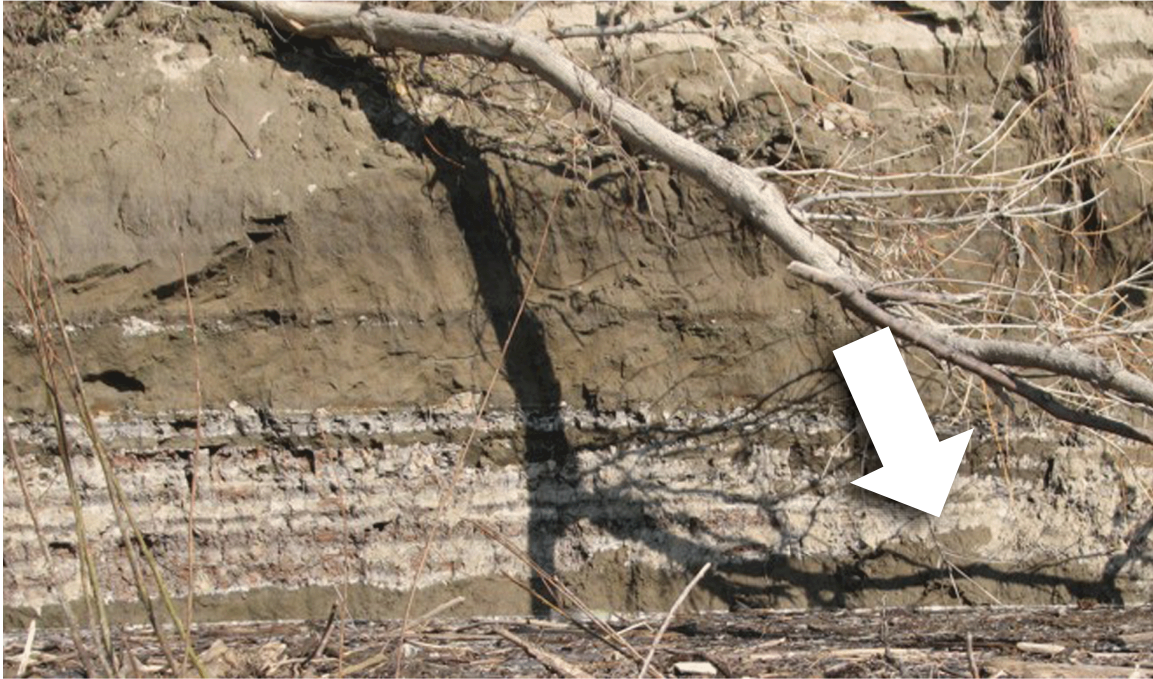
Figure No. 10—Riverbank with Stratified Sediment and Feature at Waypoint 47

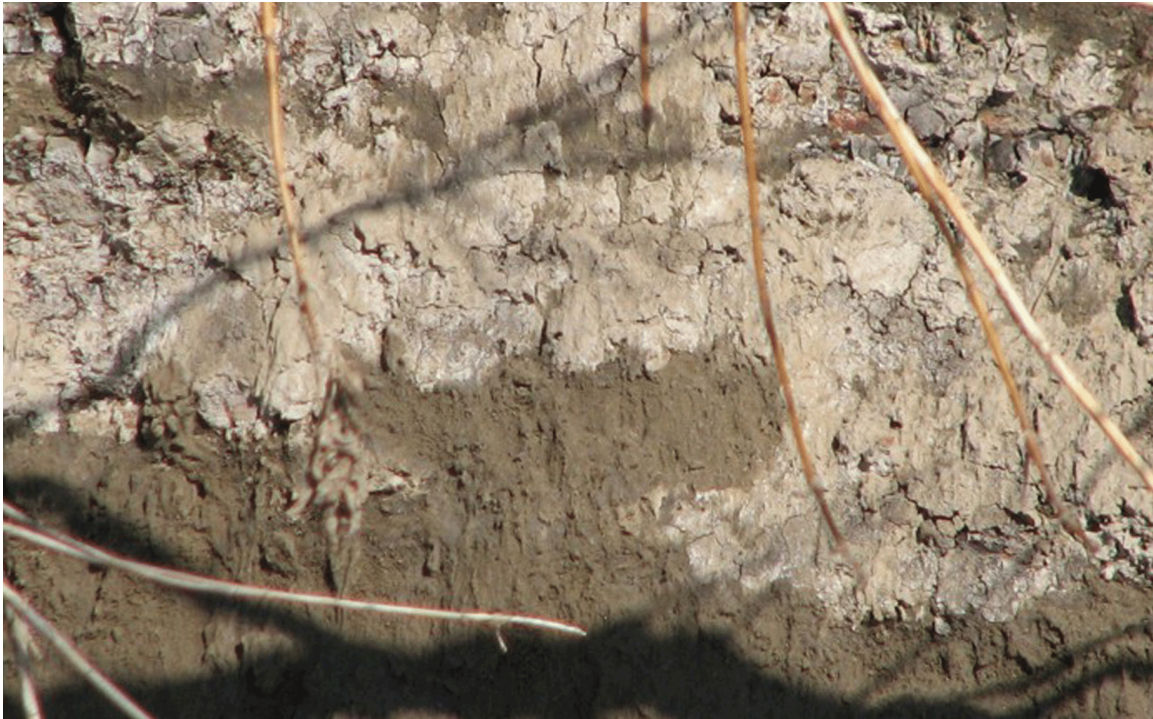
Figure No. 11—Close-up of Interesting Feature at Waypoint 47

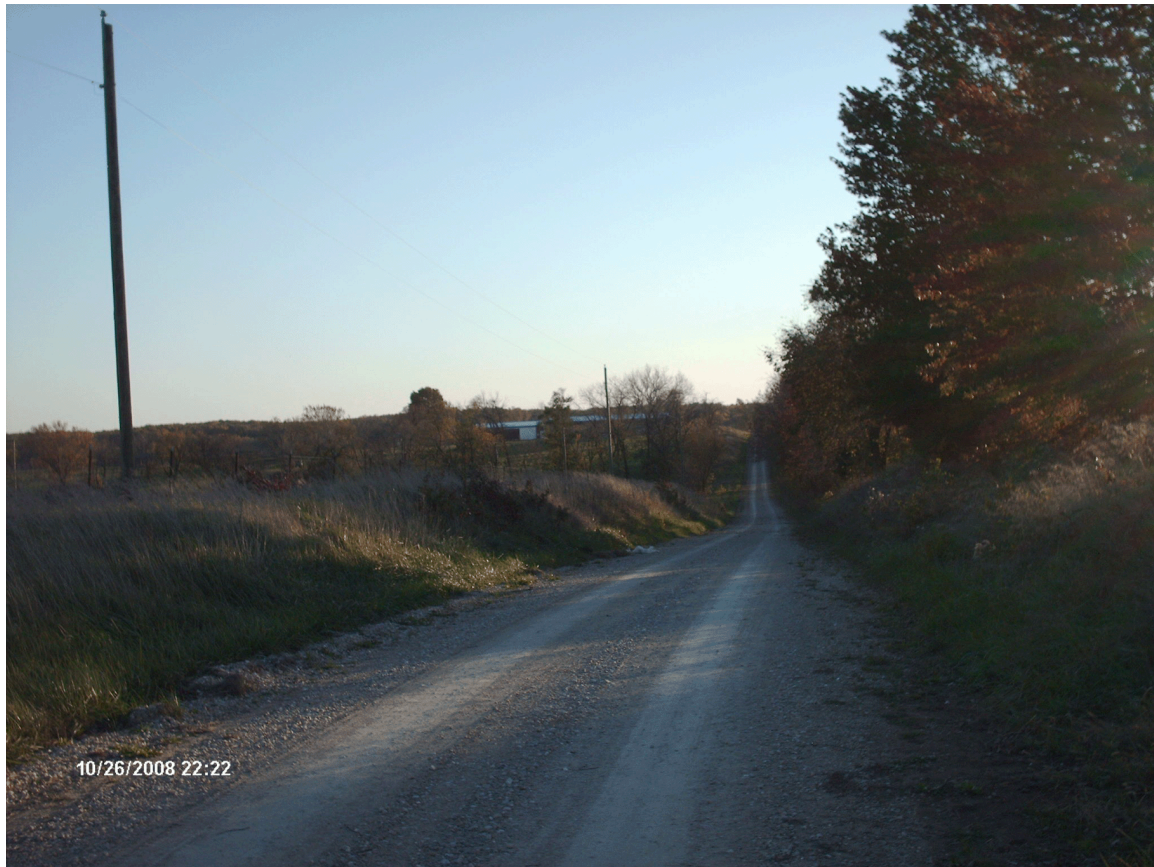
Figure No. 16—Topography Along Route 127, 0.25 miles (.4 km) from the Kingdom City Fault (Waypoint 1)

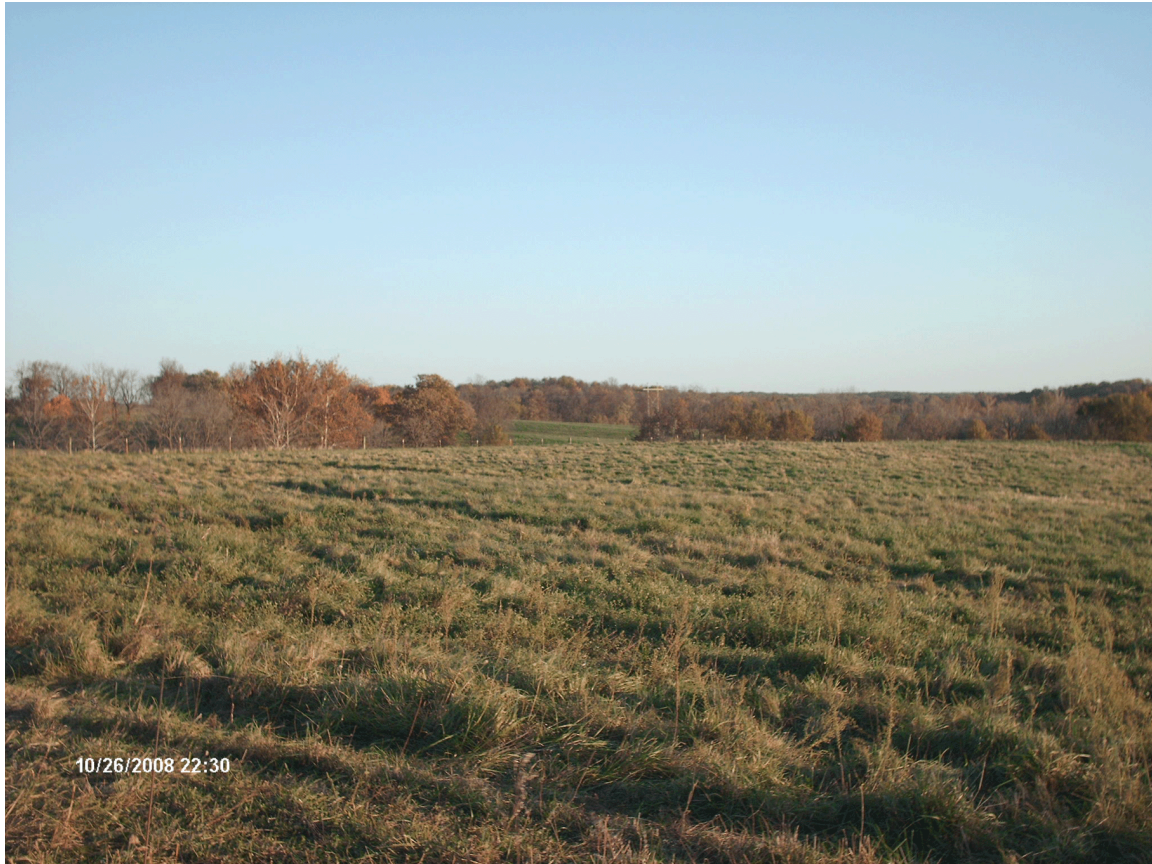
The evidence that the Kingdom City Fault actually exists is minimal (a single boring log of unknown quality) and possibly questionable. Regardless of its suspect origins, this feature is not seismogenic and has no influence on the seismic behavior, the seismic response or the seismic hazard of the Callaway Plant Site.

**Figure No. 17—Topography at Mapped Location for the Kingdom City Fault
(Waypoint 3)**

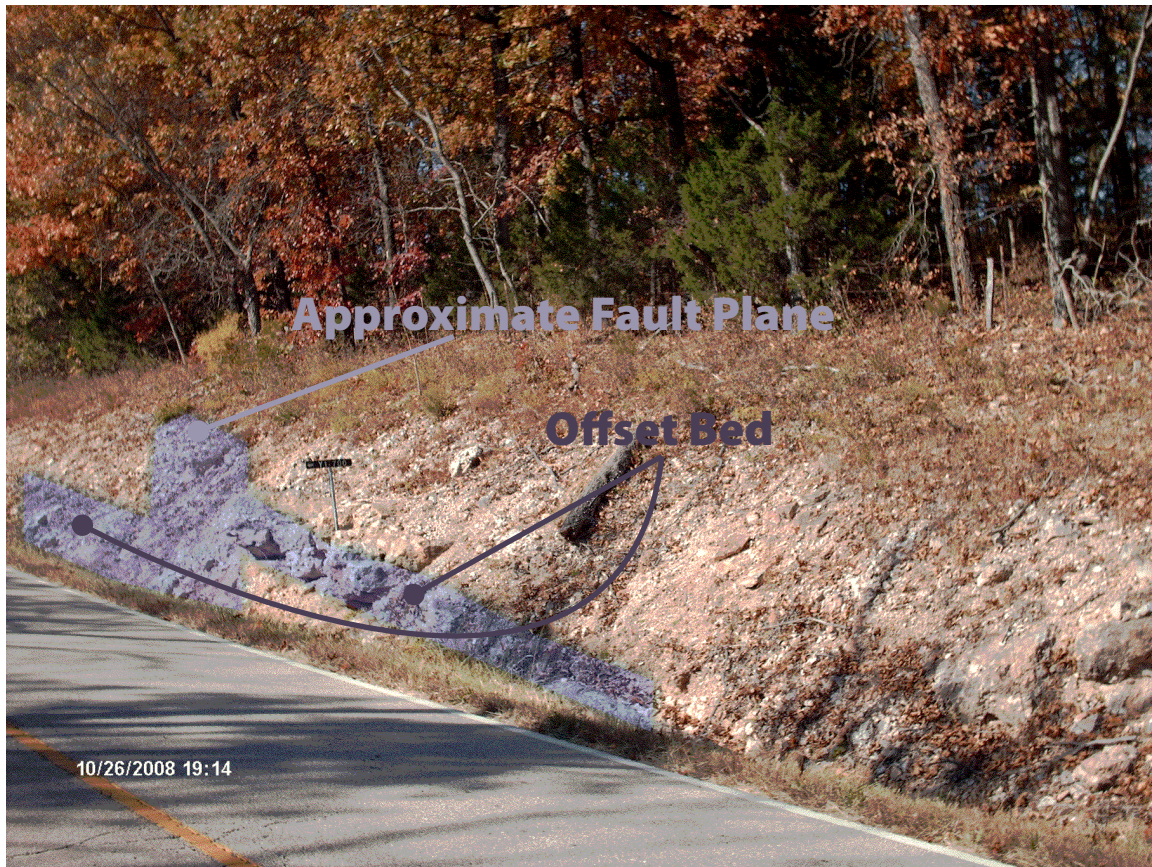
**Figure No. 19—Road Cut with 3 - 4 ft of Offset for the Cuba Fault
(Waypoint 6)**

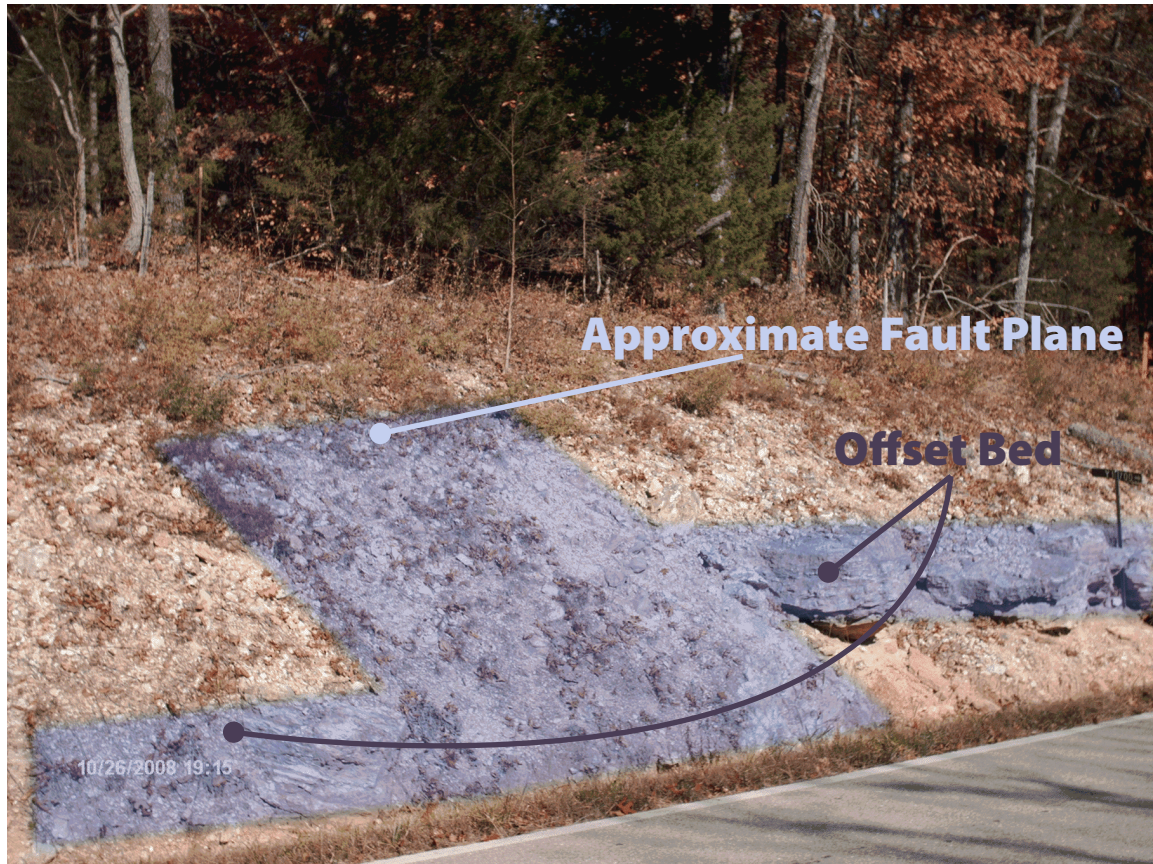
At Waypoint 8 (Figure No. 20), a road cut along Highway A near Peaceful Valley Lake, the deformation on the north side of the road cut is intense, but very old. At another road cut on Highway A, Waypoint 9 (Figure No. 18), the road cut indicates massive, undisturbed limestone with no evidence of deformation. No deformation was observed in road cuts at Waypoints 10 and 11, both of which intersect the reported fault trace (Figure No. 18).

**Figure No. 20—Road Cut on Highway “A” near Peaceful Valley Lake (Cuba Fault)
(Waypoint 8)**

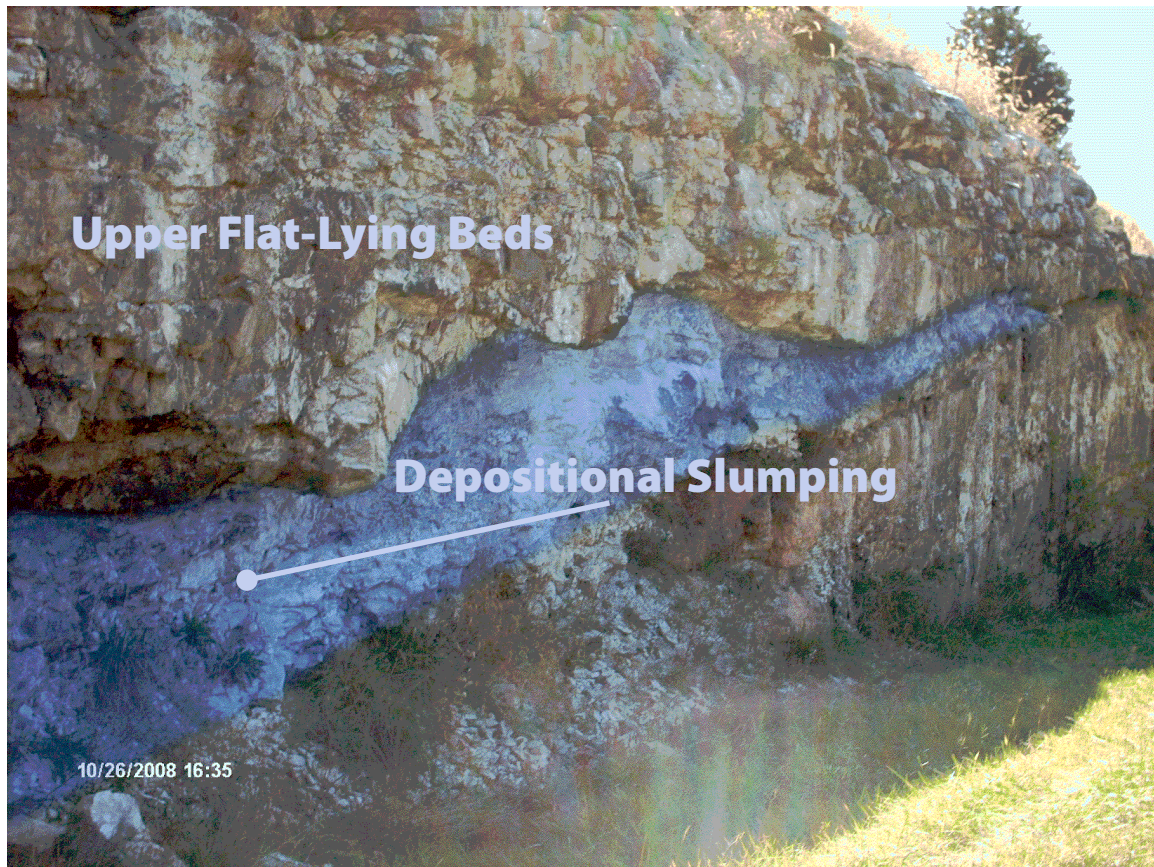
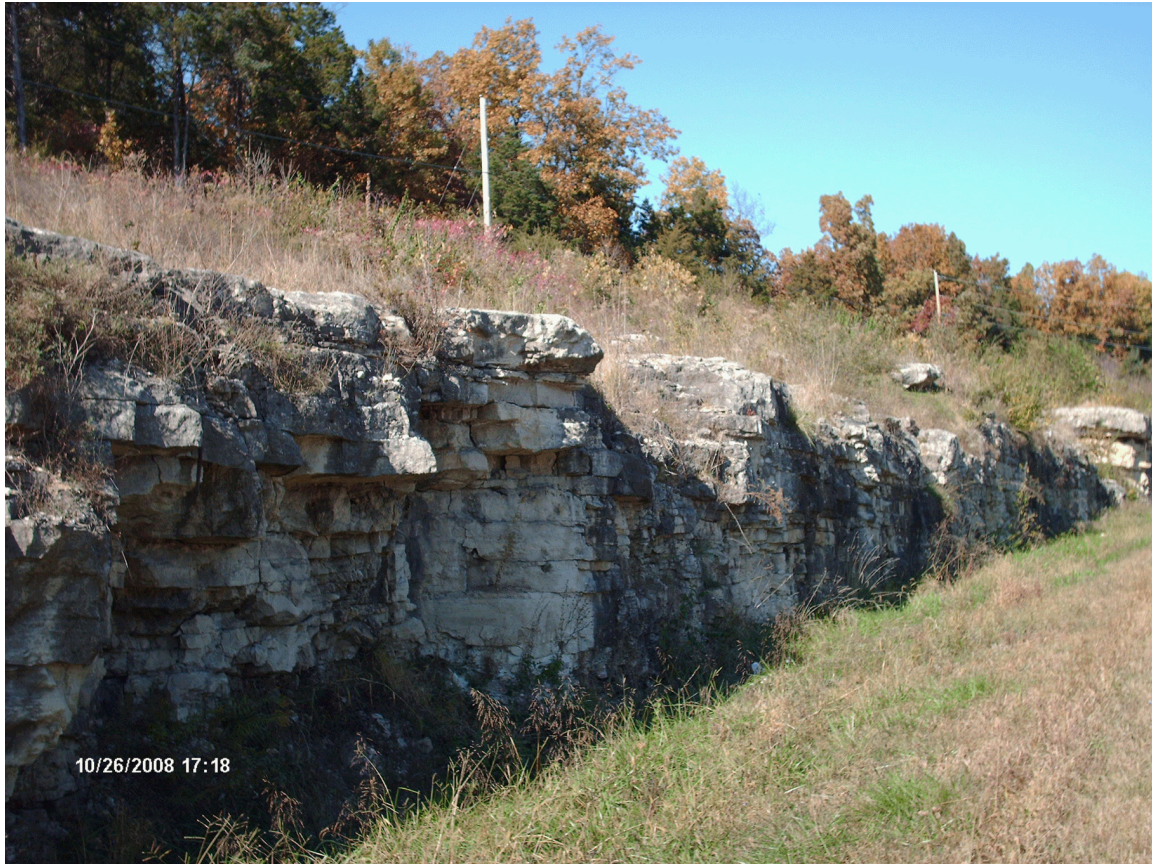
At the other waypoints along the Fault alignment (Figure No. 22 and Figure No. 23), the vegetation is heavy and the ground surface has been reworked for agriculture. No evidence of the feature was observed in any road cuts in the area and no surface manifestation of the feature was observed at any of the waypoints.

**Figure No. 22—Depositional Unconformity on Route 63, No Offset for Fox Hollow
Fault
(Waypoint 6)**

**Figure No. 23—No Offset for Fox Hollow Fault in Road Cut on Route 63
(Waypoint 6)**

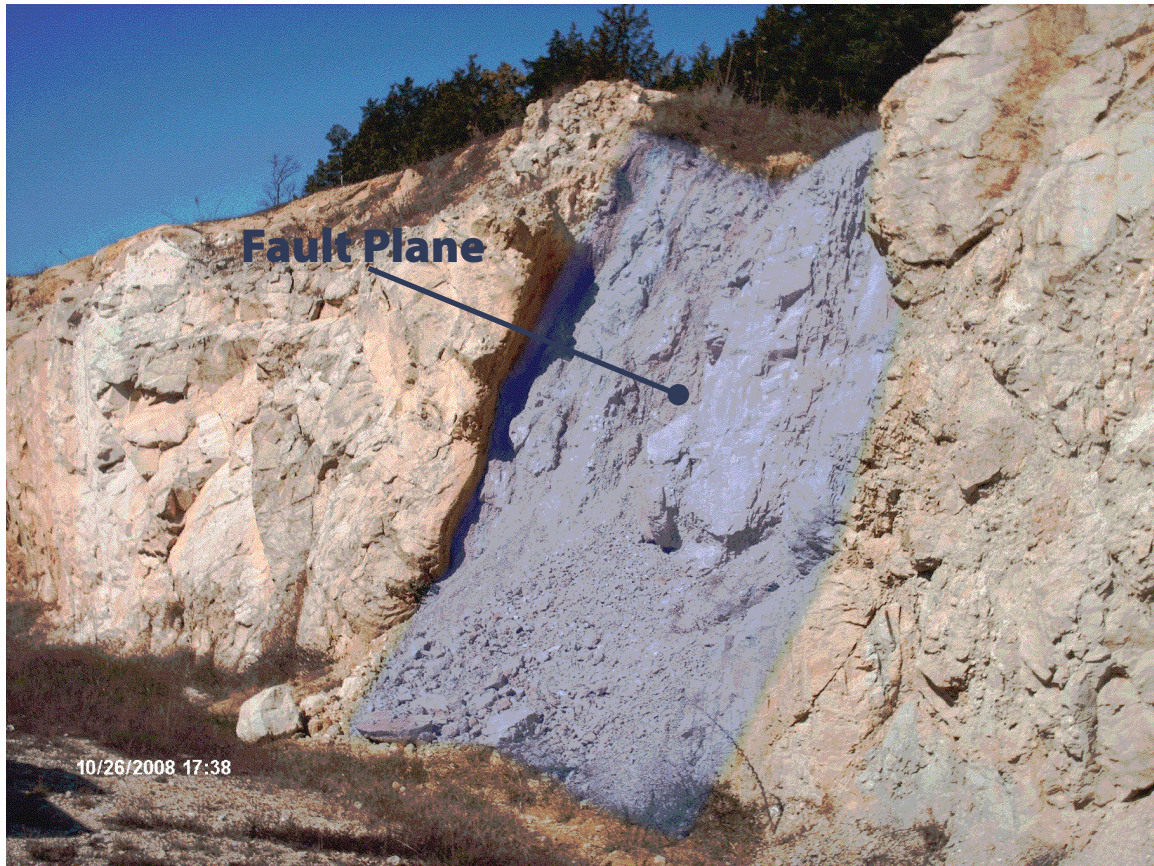
**Figure No. 25—View of Wardsville Fault Trace on Lorenzo Green Road
(Waypoint 3)**

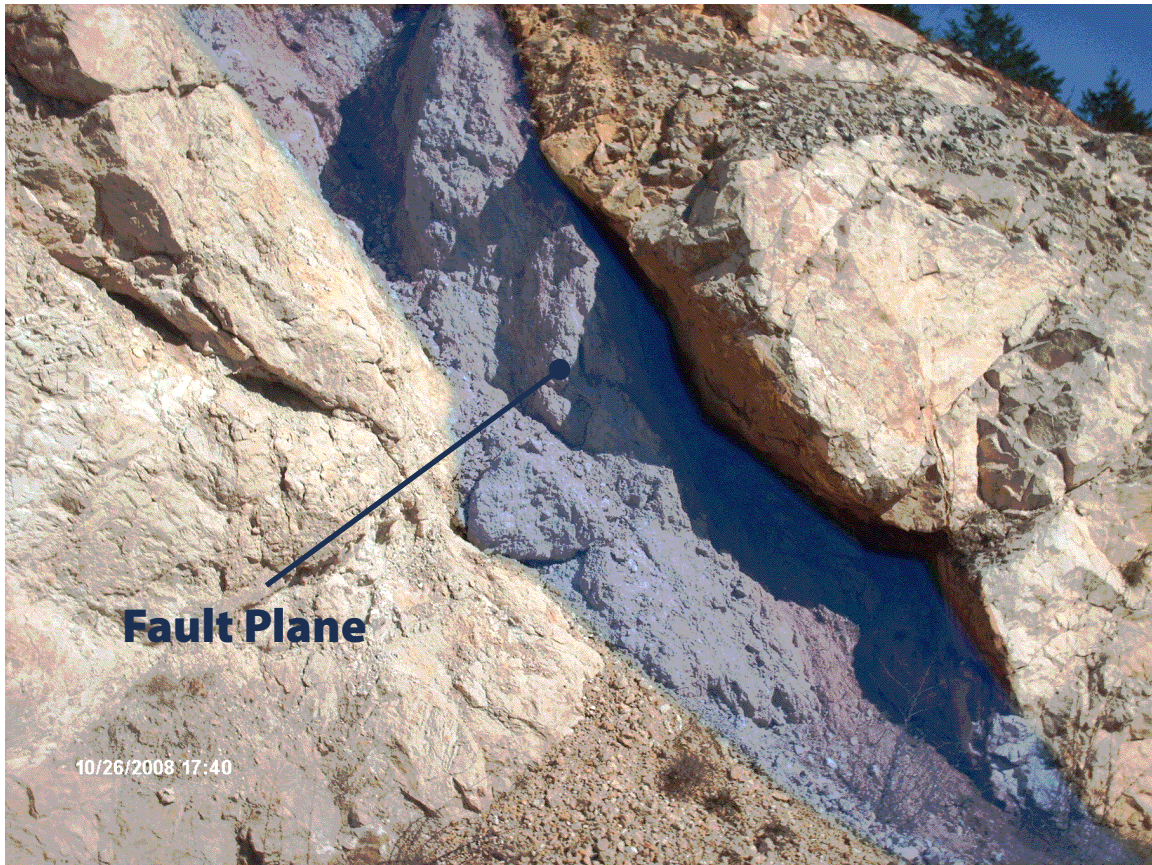
**Figure No. 26—Additional View of Wardsville Fault Trace on Lorenzo Green Road
(Waypoint 4)**
